**GRAND VALLEY WIND FARMS –  
PHASE 3 WIND PROJECT**  
WATER ASSESSMENT AND WATER  
BODY REPORT

File No. 160960698

April 2013

*REVISED - November 2013*

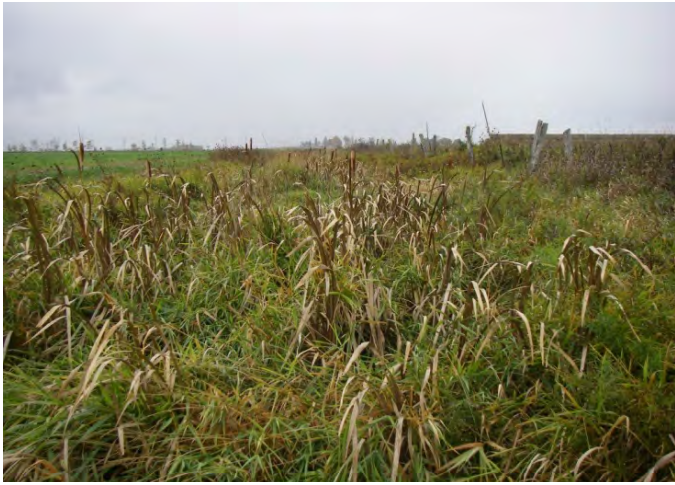
Photo 1: Station 7-1 – Galbraith Extension Drainage Works (Fall 2012)  
- Facing upstream (southwest) from Concession 12 &13,  
showing channel within cattails and grasses.

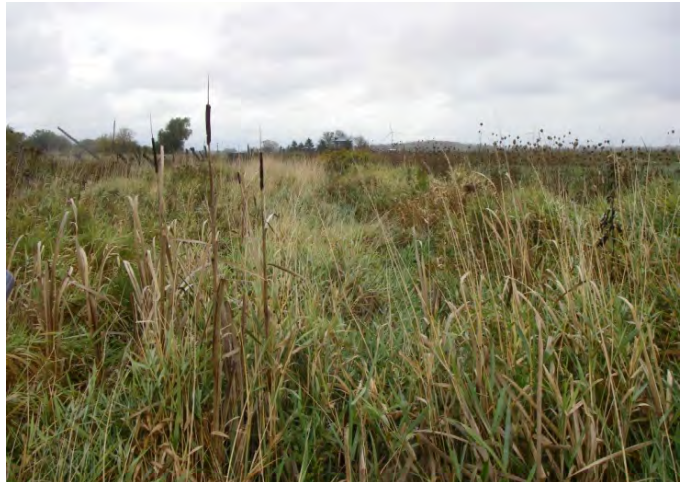
Photo 2: Station 7-1 – Galbraith Extension Drainage Works (Fall 2012)  
- Facing downstream (northeast) from Concession 12 &13,  
showing channel within cattails and grasses.

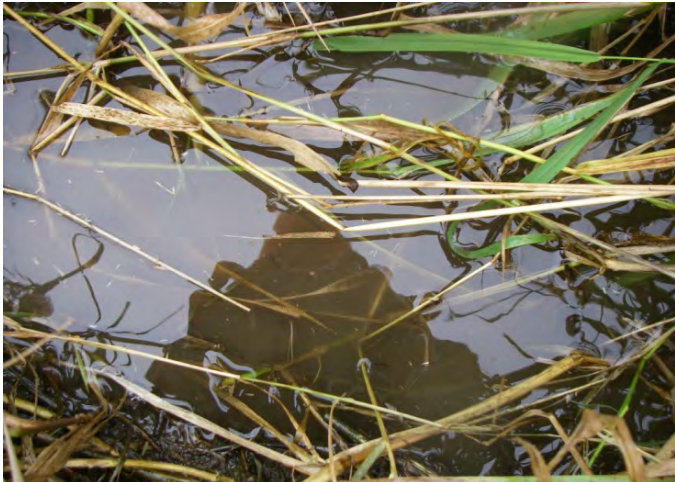
Photo 3: Station 7-1 – Galbraith Extension Drainage Works (Fall 2012)  
- At Concession 12 &13, showing water in channel.

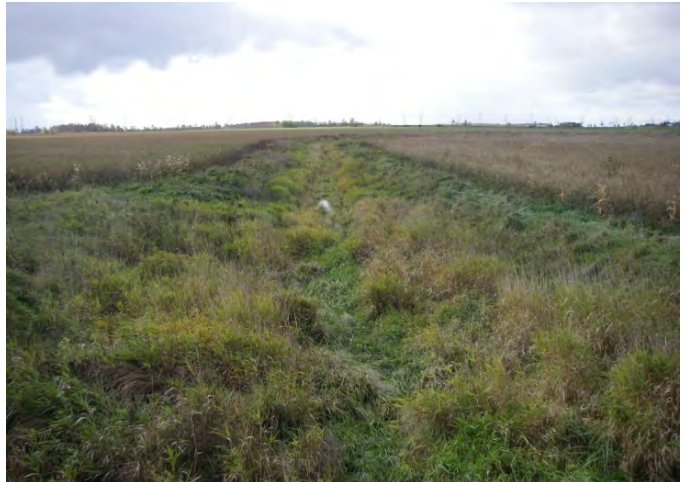
Photo 4: Station 7-2 – Galbraith Drain (Fall 2012) - Facing upstream  
(west) from Sideroad 24 &25, showing channel overview.

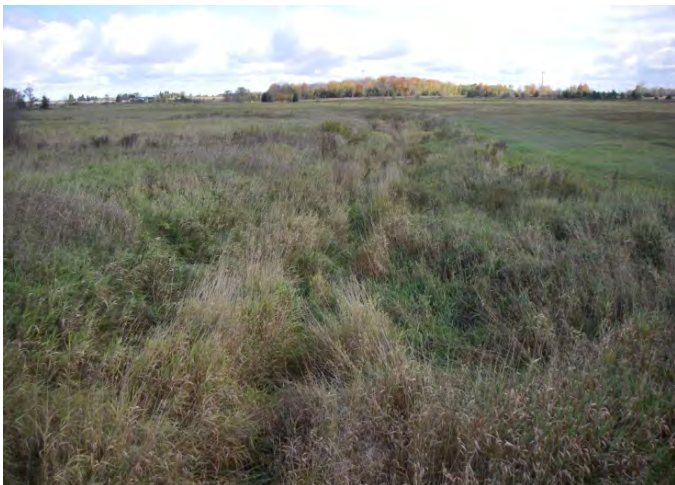
Photo 5: Station 7-2 – Galbraith Drain (Fall 2012) - Facing  
downstream (east) from Sideroad 24 &25, showing channel  
overview and adjacent field.

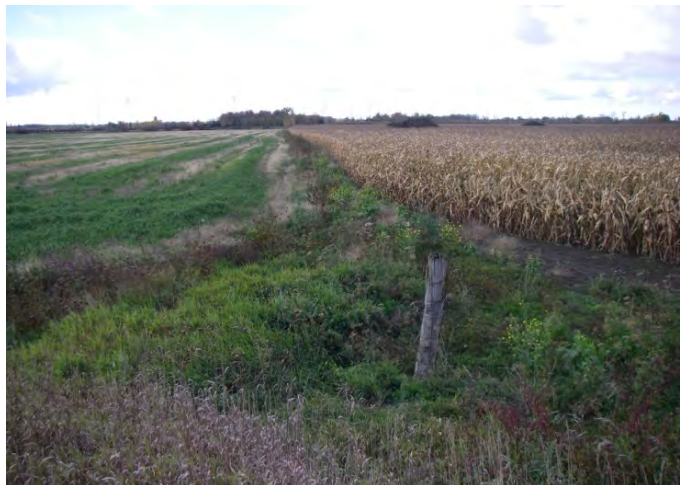
Photo 6: Station 7-3 – Unnamed Tributary of No. 16 Drainage Works  
(Fall 2012) - Facing upstream (west) from Sideroad 24 & 25,  
showing non-water body.

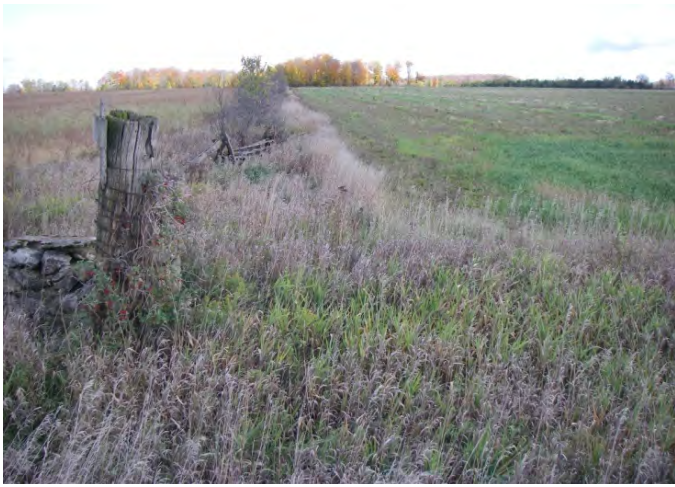
Photo 7: Station 7-3 – Unnamed Tributary of No. 16 Drainage Works (Fall 2012) - Facing downstream (east) from Sideroad 24 & 25, showing non-water body.

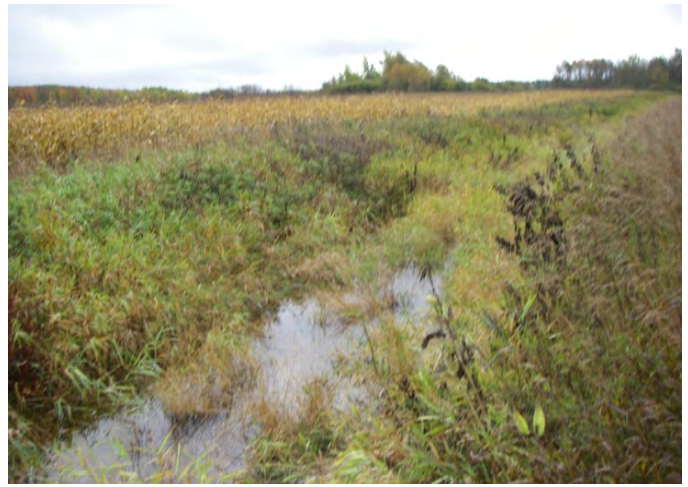
Photo 8: Station 6-1 – No. 21 Drainage (Fall 2012) - Facing upstream (west) from Concession 8 & 9, showing channel overview.

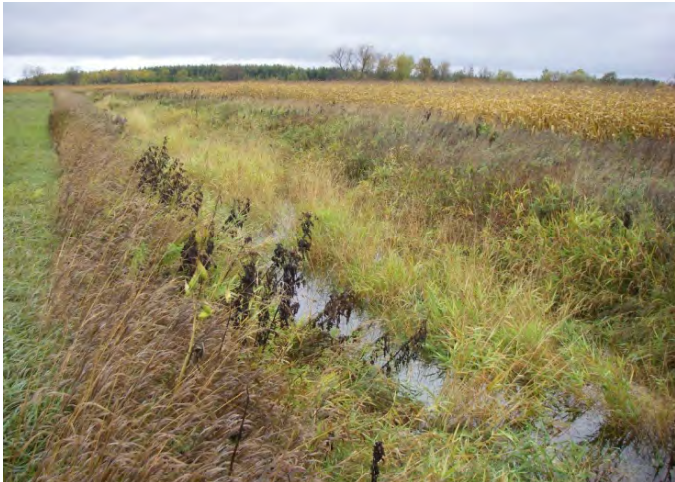
Photo 9: Station 6-1 – No. 21 Drainage (Fall 2012) - Facing downstream (east) south of 20th Sideroad, showing channel overview.

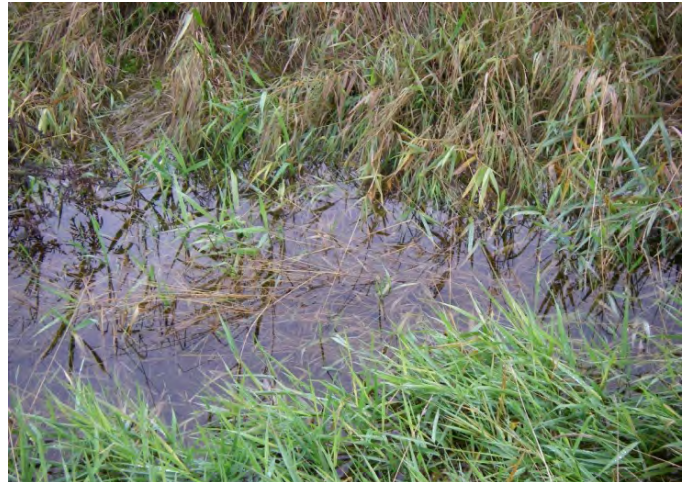
Photo 10: Station 6-1 – No. 21 Drainage Works (Fall 2012) - South of 20th Sideroad, showing channel substrate.

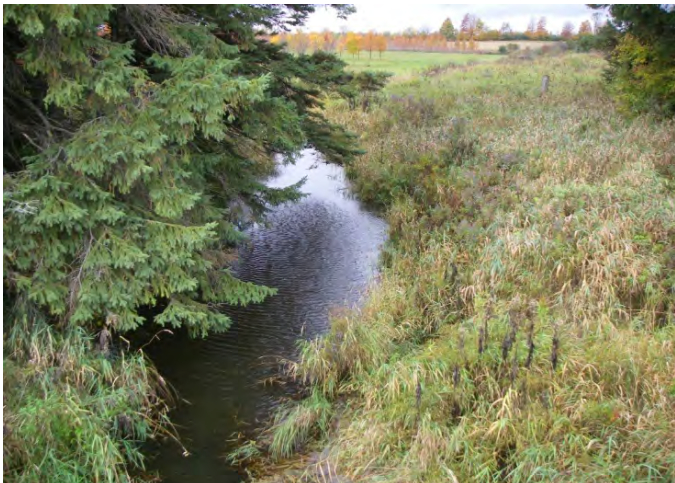
Photo 11: Station 6-2 – No. 21 Drainage Works (Fall 2012) - Facing upstream (west) south of 20th Sideroad, showing channel overview.

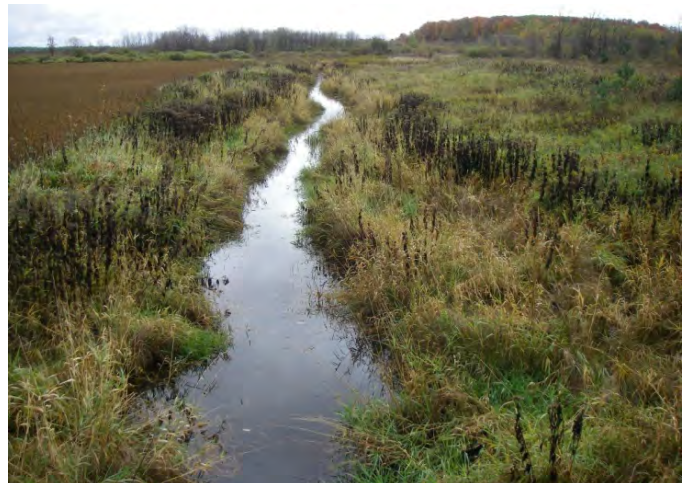
Photo 12: Station 6-2 – No. 21 Drainage Works (Fall 2012) - Facing downstream (east) south of 20th Sideroad, showing channel overview and adjacent fields.

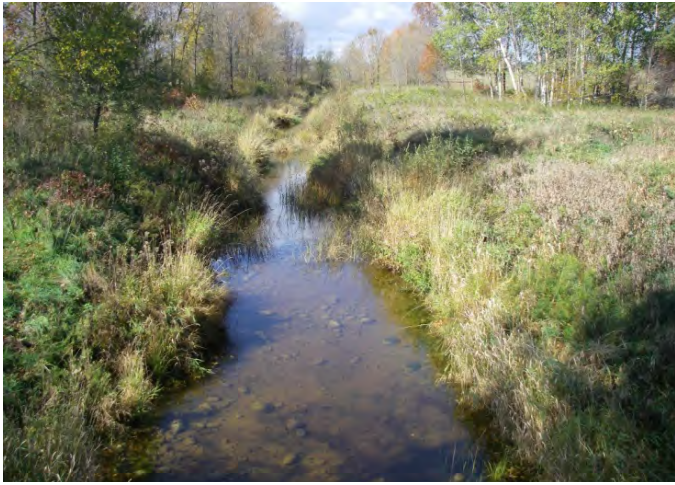
Photo 13: Station 19-1 – No. 16 Drainage Works (Fall 2012) - Facing upstream (west) from Sideroad 24 & 25, showing channel overview.

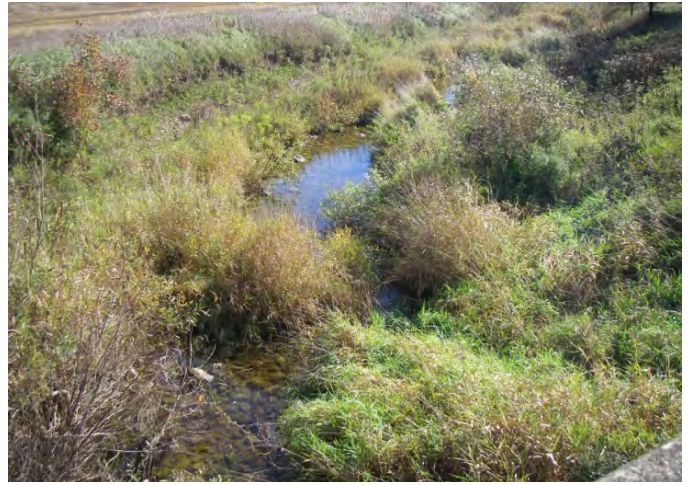
Photo 14: Station 19-1 – No. 16 Drainage Works (Fall 2012) - Facing downstream (east) from Sideroad 24 & 25, showing channel overview.

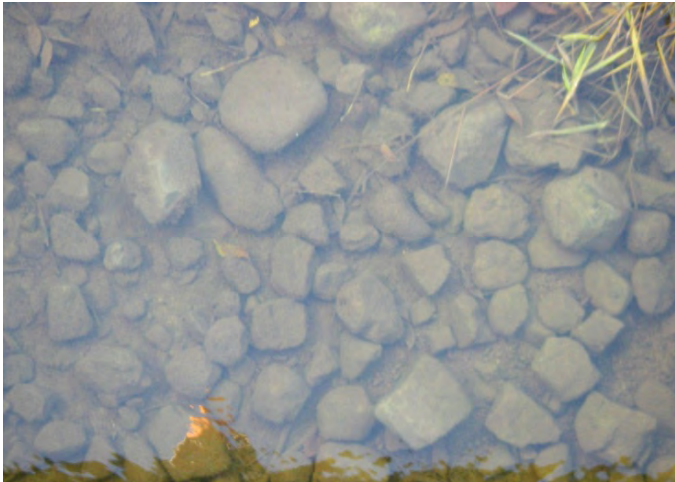
Photo 15: Station 19-1 – No. 16 Drainage Works (Fall 2012) - At Sideroad 24 & 25, showing channel substrate.

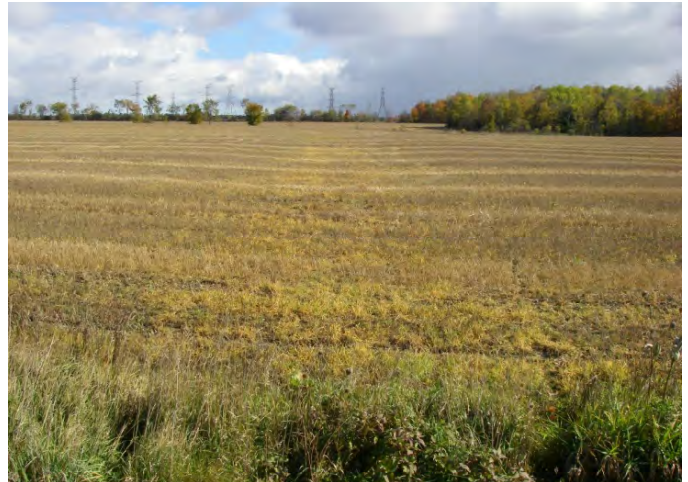
Photo 16: Station 19-2 – No. 16 Drainage Works (Fall 2012) - Facing downstream (east) from Sideroad 24 & 25, showing surficial drainage.

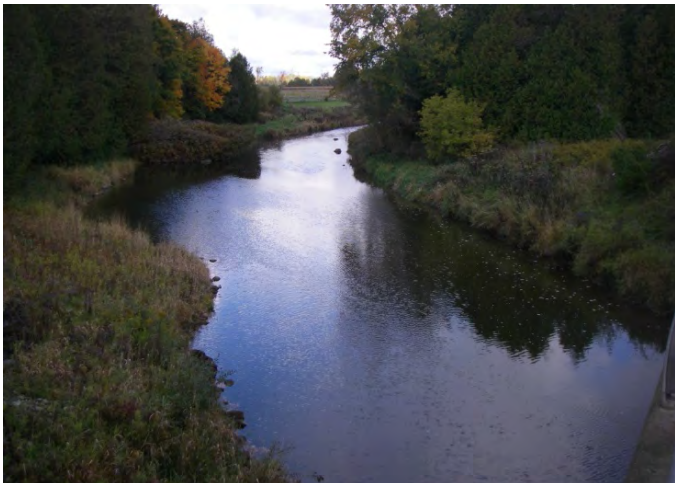
Photo 17: Station 18-1 – Grand River (Fall 2012) - Facing upstream (northwest) at the intersection of Sideroad 27 & 28 and Concession 8 & 9, showing channel overview.

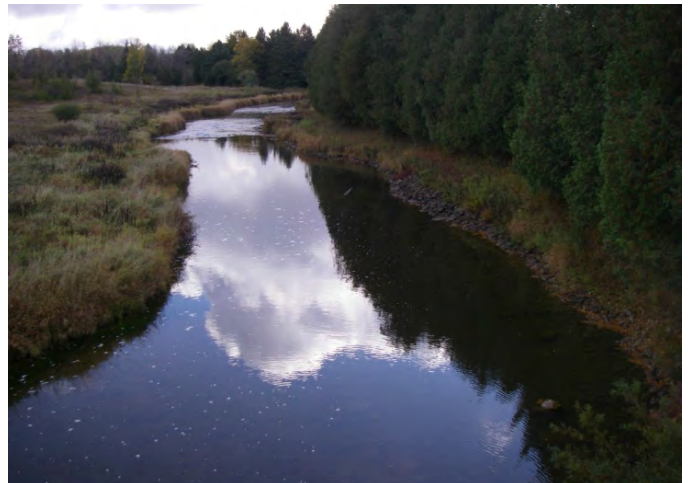
Photo 18: Station 18-1 – Grand River (Fall 2012) - Facing downstream (southeast) at the intersection of Sideroad 27 & 28 and Concession 8 & 9, showing channel overview.

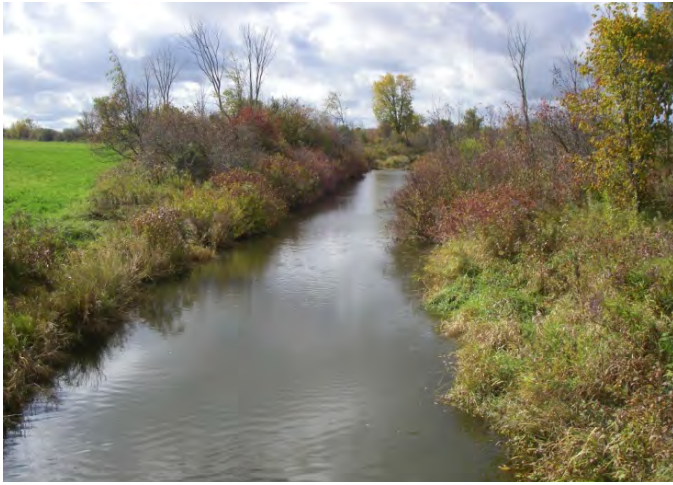
Photo 19: Station 18-2 – Palmer Drain (Fall 2012) - Facing upstream (west) from Concession 8 & 9, showing channel overview.

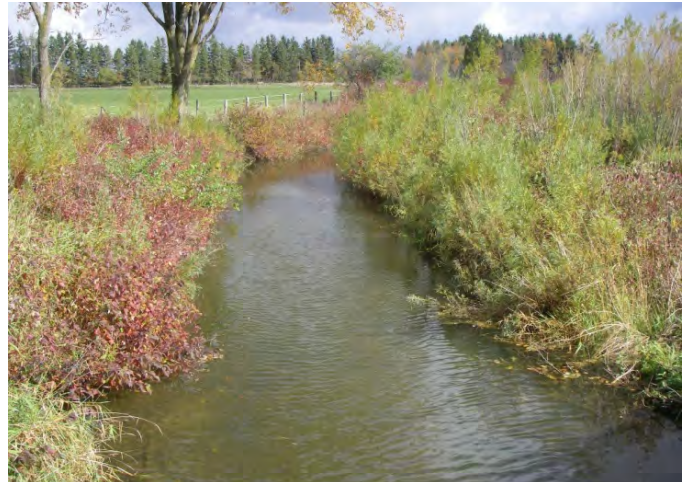
Photo 20: Station 18-2 – Palmer Drain (Fall 2012) - Facing downstream (east) from Concession 8 & 9, showing channel overview and surrounding riparian vegetation.

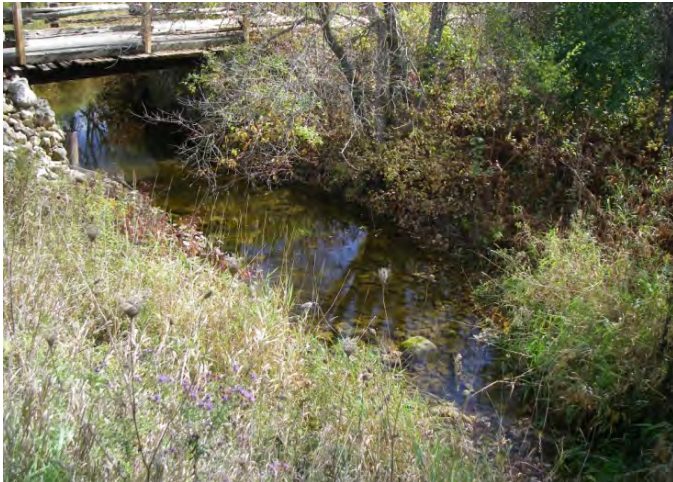
Photo 21: Station 18-3a – No. 21 Drainage Works (Fall 2012) - Facing upstream (southeast) from Concession 8 & 9, showing channel overview.

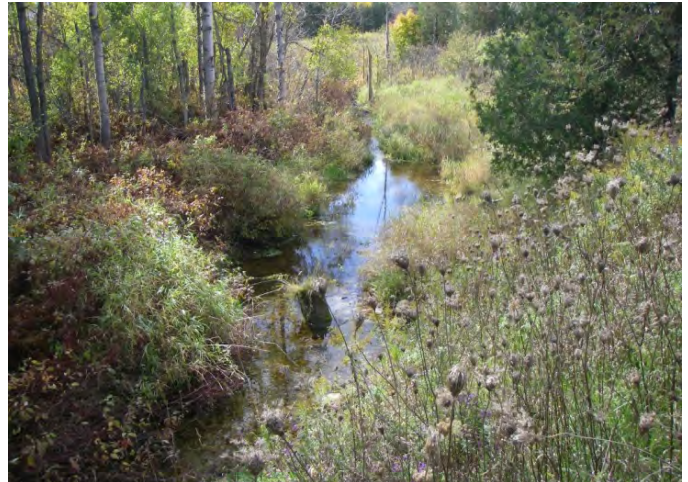
Photo 22: Station 18-3a – No. 21 Drainage Works (Fall 2012) - Facing downstream (southwest) from Concession 8 & 9, showing channel overview and surrounding riparian vegetation.

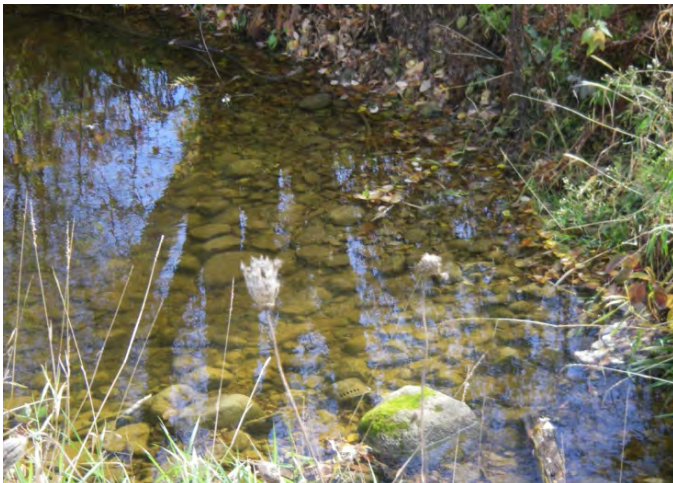
Photo 23: Station 18-3a – No. 21 Drainage Works (Fall 2012) - From Concession 8 & 9, showing channel substrate.

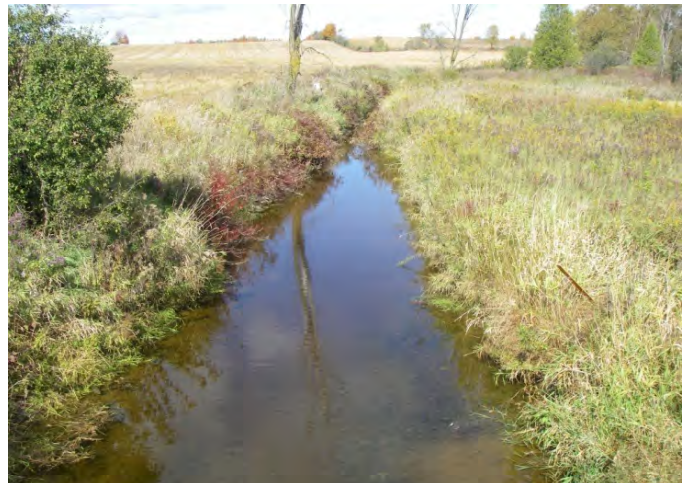
Photo 24: Station 5-3 – No. 21 Drainage Works (Fall 2012) - Facing upstream (northeast) from Concession 8 & 9, showing channel overview, adjacent fields and forest.

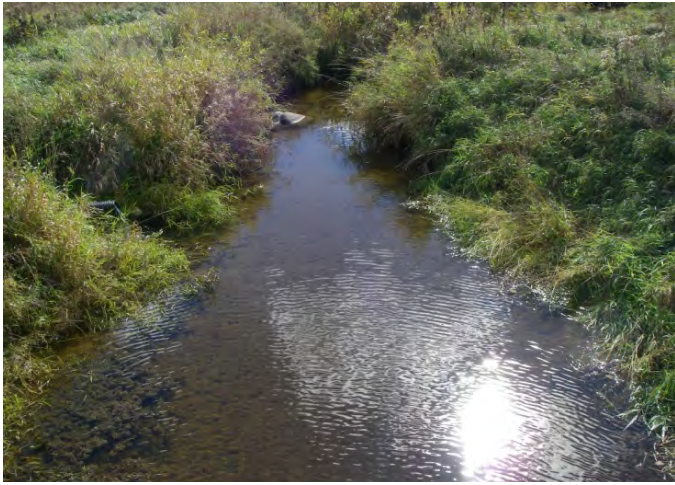
Photo 25: Station 5-3 – No. 21 Drainage Works (Fall 2012) - Facing downstream (southwest) from Concession 8 & 9, showing channel overview.

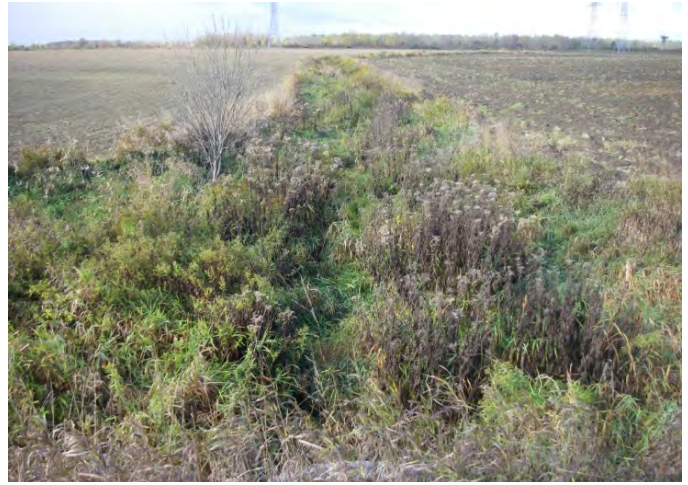
Photo 26: Station 17-1 – Gajtani Drainage Works (Fall 2012) - Facing upstream (west) from Sideroad 27 & 28, showing channel overview and adjacent agricultural fields.

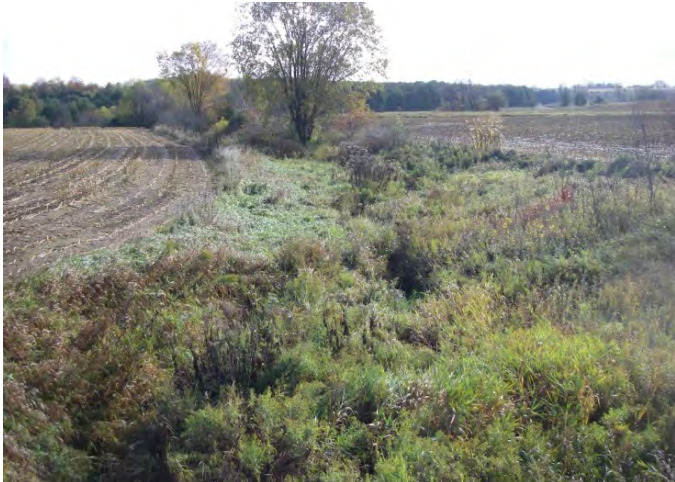
Photo 27: Station 17-1 – Gajtani Drainage Works (Fall 2012) - Facing downstream (east) from Sideroad 27 & 28, showing channel overview and adjacent agricultural fields.

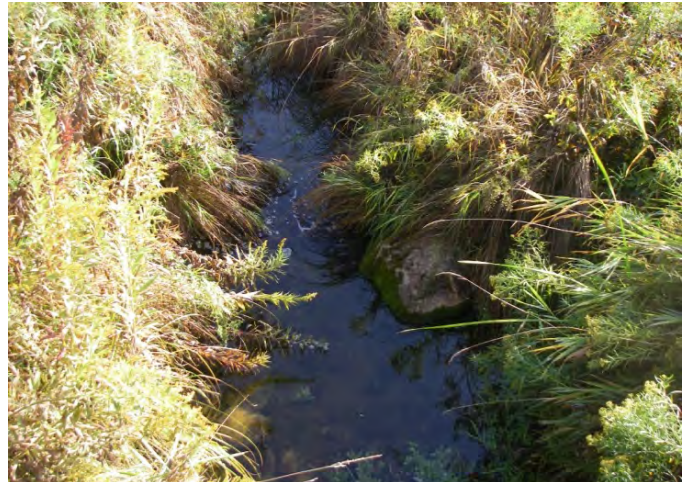
Photo 28: Station 17-1 – Gajtani Drainage Works (Fall 2012) at Sideroad 27 & 28, showing water in channel and bank definition.

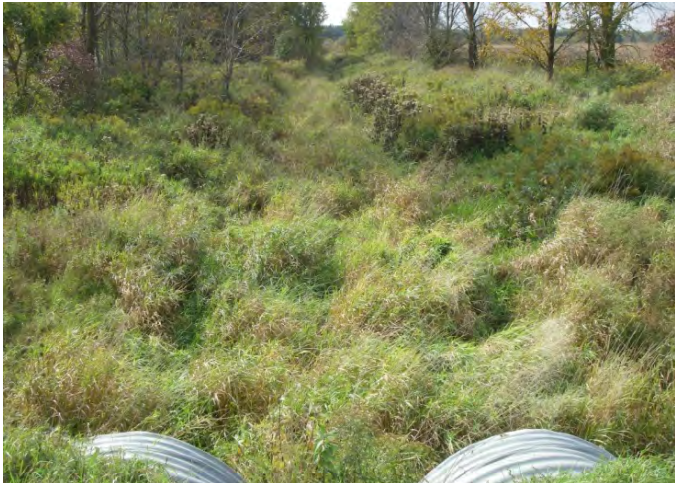
Photo 29: Station 12-4 – No. 7 Drainage Works (Fall 2012) - Facing upstream (west) from Sideroad 27 & 28, showing channel overview and surrounding forest.

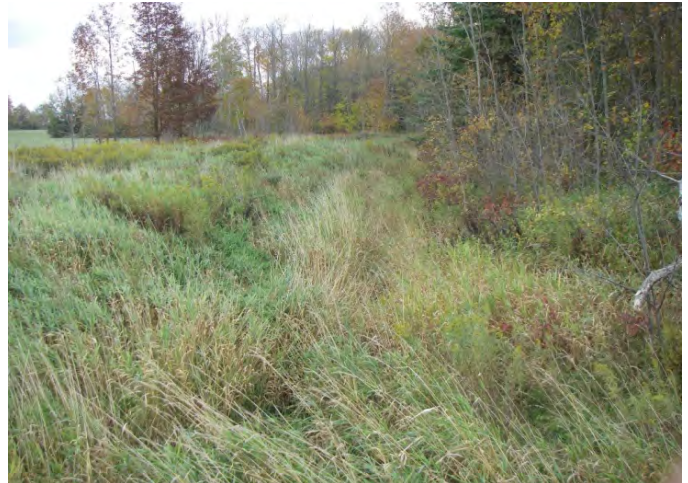
Photo 30: Station 12-4 – No. 7 Drainage Works (Fall 2012) - Facing downstream (northeast) from Sideroad 27 & 28, showing channel overview and surrounding forest.

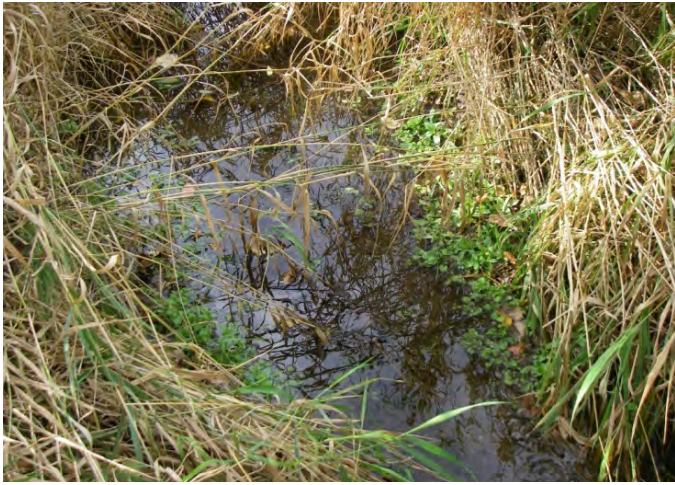
Photo 31: Station 12-4 – No. 7 Drainage Works (Fall 2012) - From Sideroad 27 & 28, showing water in channel.

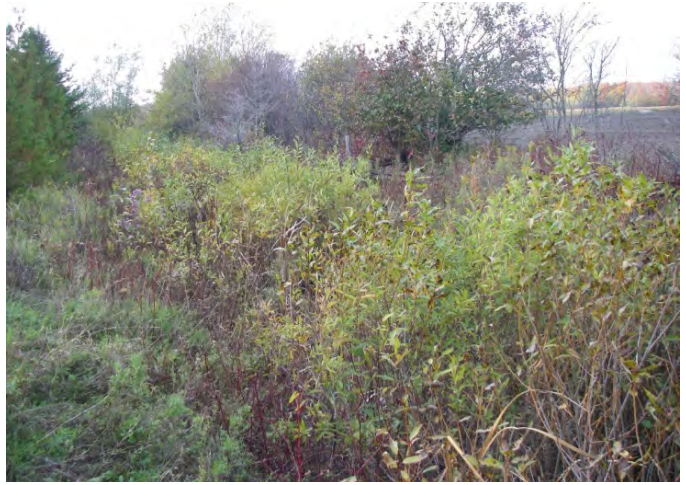
Photo 32: Station 12-1 – Potter Drain (Fall 2012) - Facing upstream (east) from Sideroad 27 & 28, showing dense in-channel vegetation.

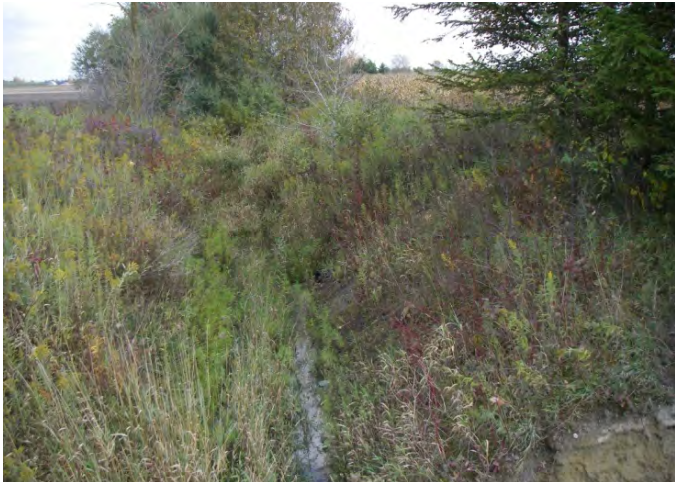
Photo 33: Station 12-1 – Potter Drain (Fall 2012) - Facing downstream (west) from Sideroad 27 & 28, showing dense in-channel vegetation and bank definition.

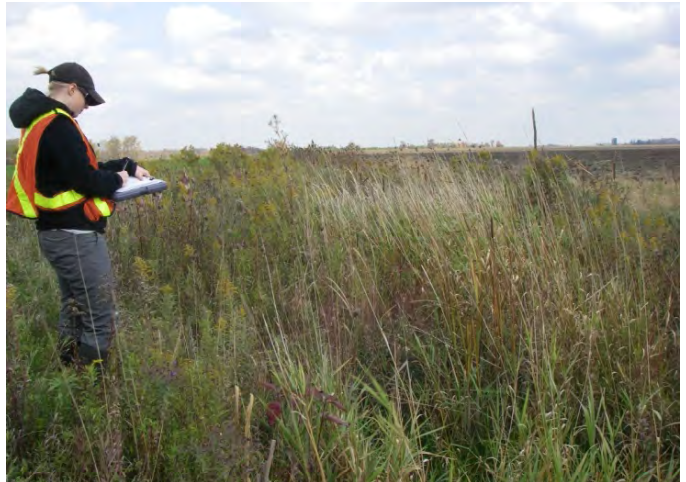
Photo 34: Station 12-3 – Potter Drain (Fall 2012) - Facing upstream (northeast) from Sideroad 27 & 28, showing non-water body.

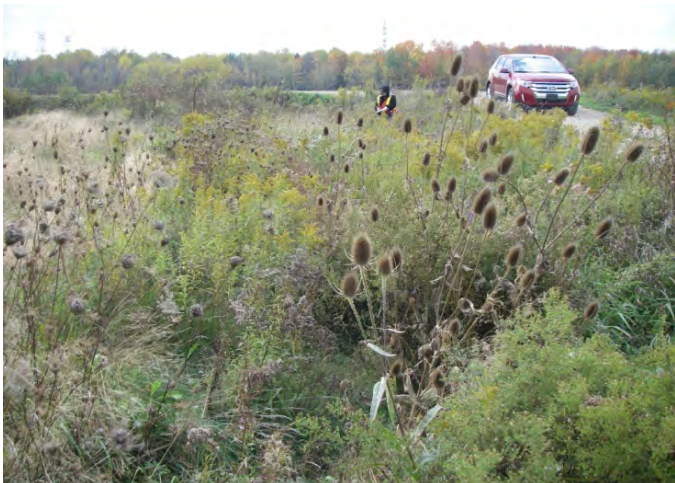
Photo 35: Station 12-3 – Potter Drain (Fall 2012) - Facing downstream (southwest) from Sideroad 27 & 28, showing non-water body.

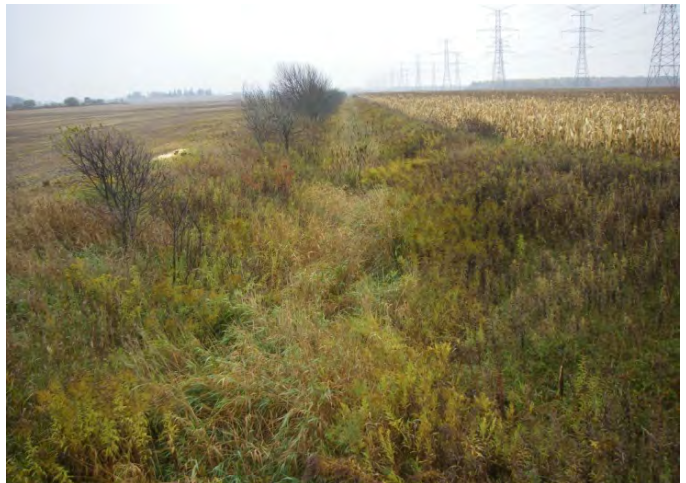
Photo 36: Station 3-2 – Atkinson Drainage Works (Fall 2012) - Facing downstream (south) from Concession Road 4 & 5, showing channel and surrounding agricultural fields.

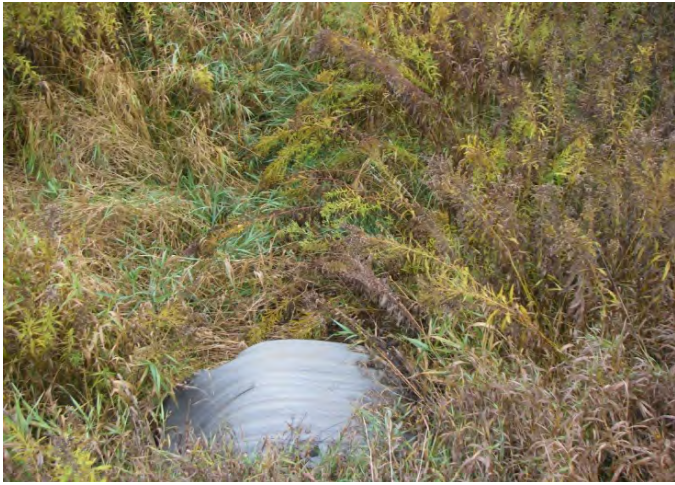
Photo 37: Station 3-2 – Atkinson Drainage Works (Fall 2012) at Concession Road 4 & 5, showing channel definition at culvert.

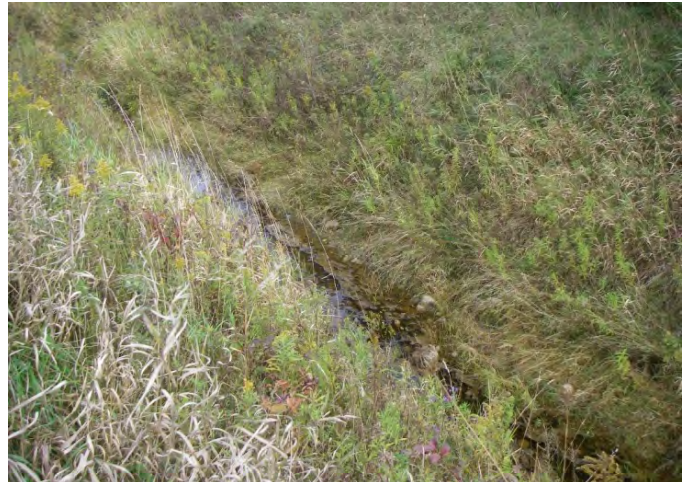
Photo 38: Station 2-1 – No. 1 Drain (Boyne Creek) (Fall 2012) - Facing upstream (west) from Amaranth East Luther Townline, showing channel overview.

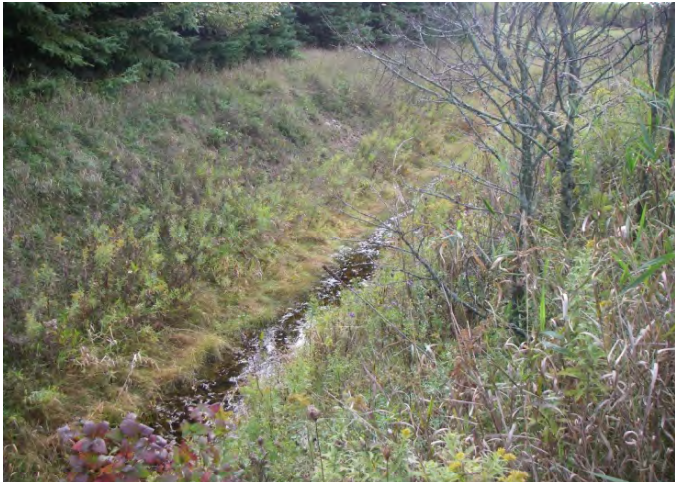
Photo 39: Station 2-1 – No. 1 Drain (Boyne Creek) (Fall 2012) - Facing downstream (east) from Amaranth East Luther Townline, showing channel overview.

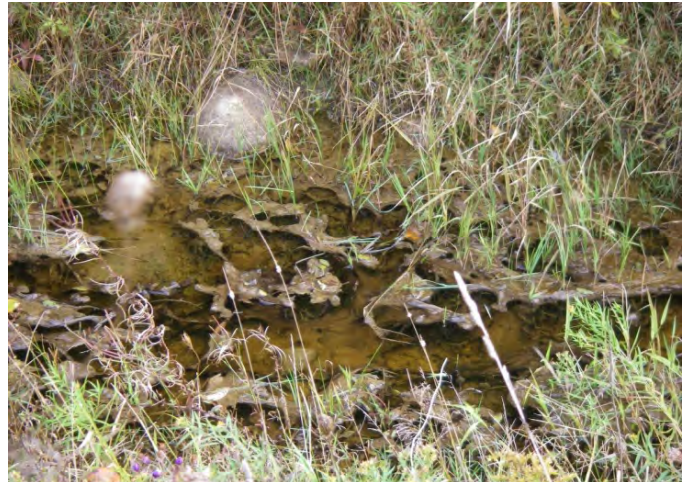
Photo 40: Station 2-1 – No. 1 Drain (Boyne Creek) (Fall 2012) at Amaranth East Luther Townline, showing water and algae within channel.

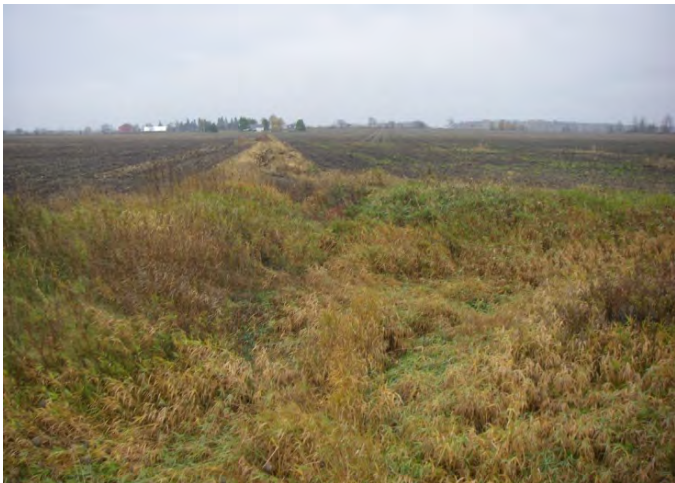
Photo 41: Station 1-3 – No. 2 Drainage Works (Fall 2012) - Facing upstream (south) from Concession 2 & 3, showing channel overview.

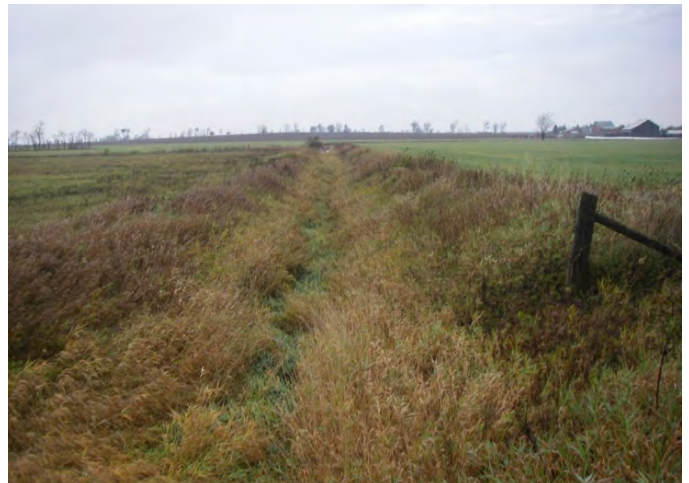
Photo 42: Station 1-3 – No. 2 Drainage Works (Fall 2012) - Facing downstream (north) from Concession 2 & 3, showing channel overview.

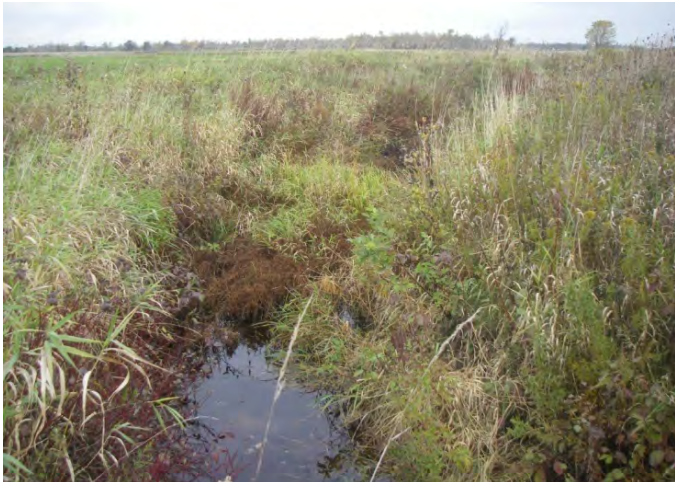
Photo 43: Station 1-1 – No. 2 Drainage Works (Fall 2012) - Facing upstream (north) from Concession 2 & 3, showing channel overview.

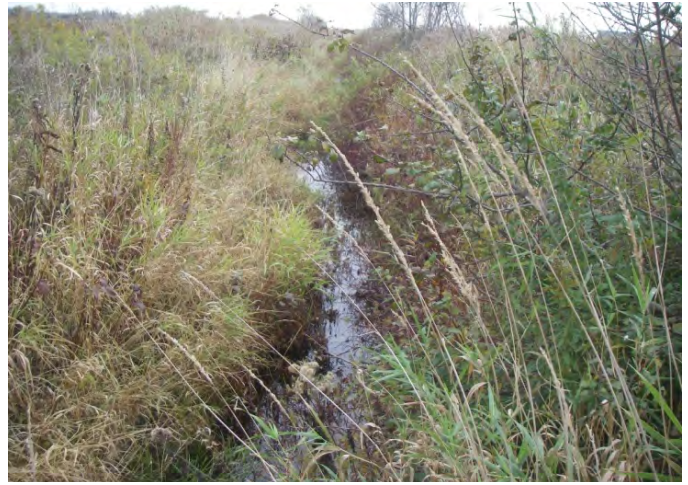
Photo 44: Station 1-1 – No. 2 Drainage Works (Fall 2012) - Facing downstream (east) from Concession 2 & 3, showing channel overview and surrounding riparian vegetation.

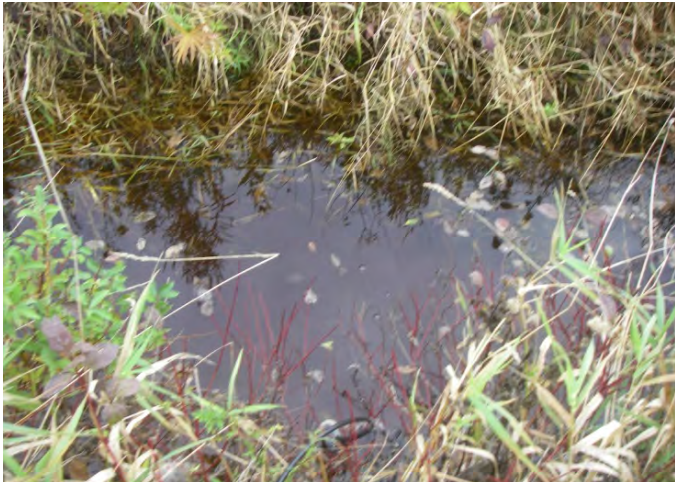
Photo 45: Station 1-1 – No. 2 Drainage Works (Fall 2012) at Concession 2 & 3, showing water in channel and bank definition.

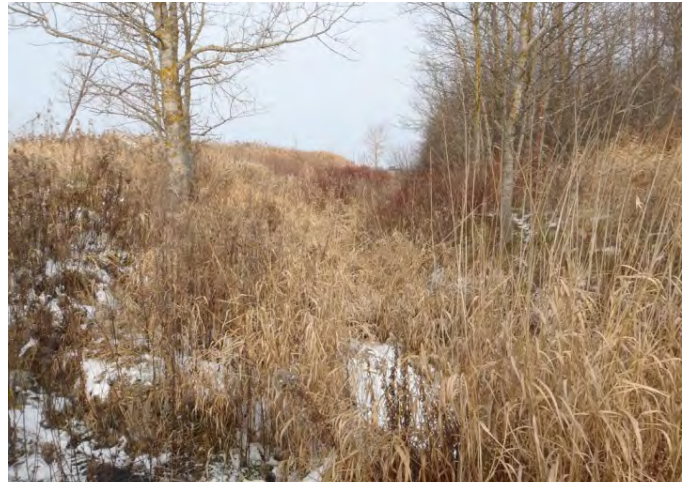
Photo 46: Station V9-1 – Young Drainage Works (Fall 2012) - Facing upstream (north) south of Concession 4 & 5, showing channel overview.

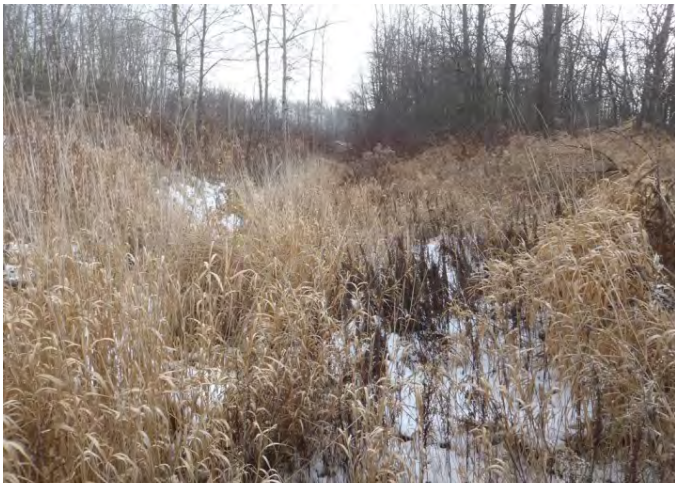
Photo 47: Station V9-1 – Young Drainage Works (Fall 2012) - Facing downstream (east) south of Concession 4 & 5, showing channel overview.
