**RE: Grand Valley Wind Farms – Phase 3 Wind Project**  
**Location: Dufferin County**  
**FIT number: FIT-FBK61WV**  
**MTC DPR File no. 22EA019**

#### **9 RECOMMENDATIONS FOR FURTHER WORK**

GRAND VALLEY WIND FARMS – PHASE 3 WIND PROJECT  
HERITAGE ASSESSMENT REPORT

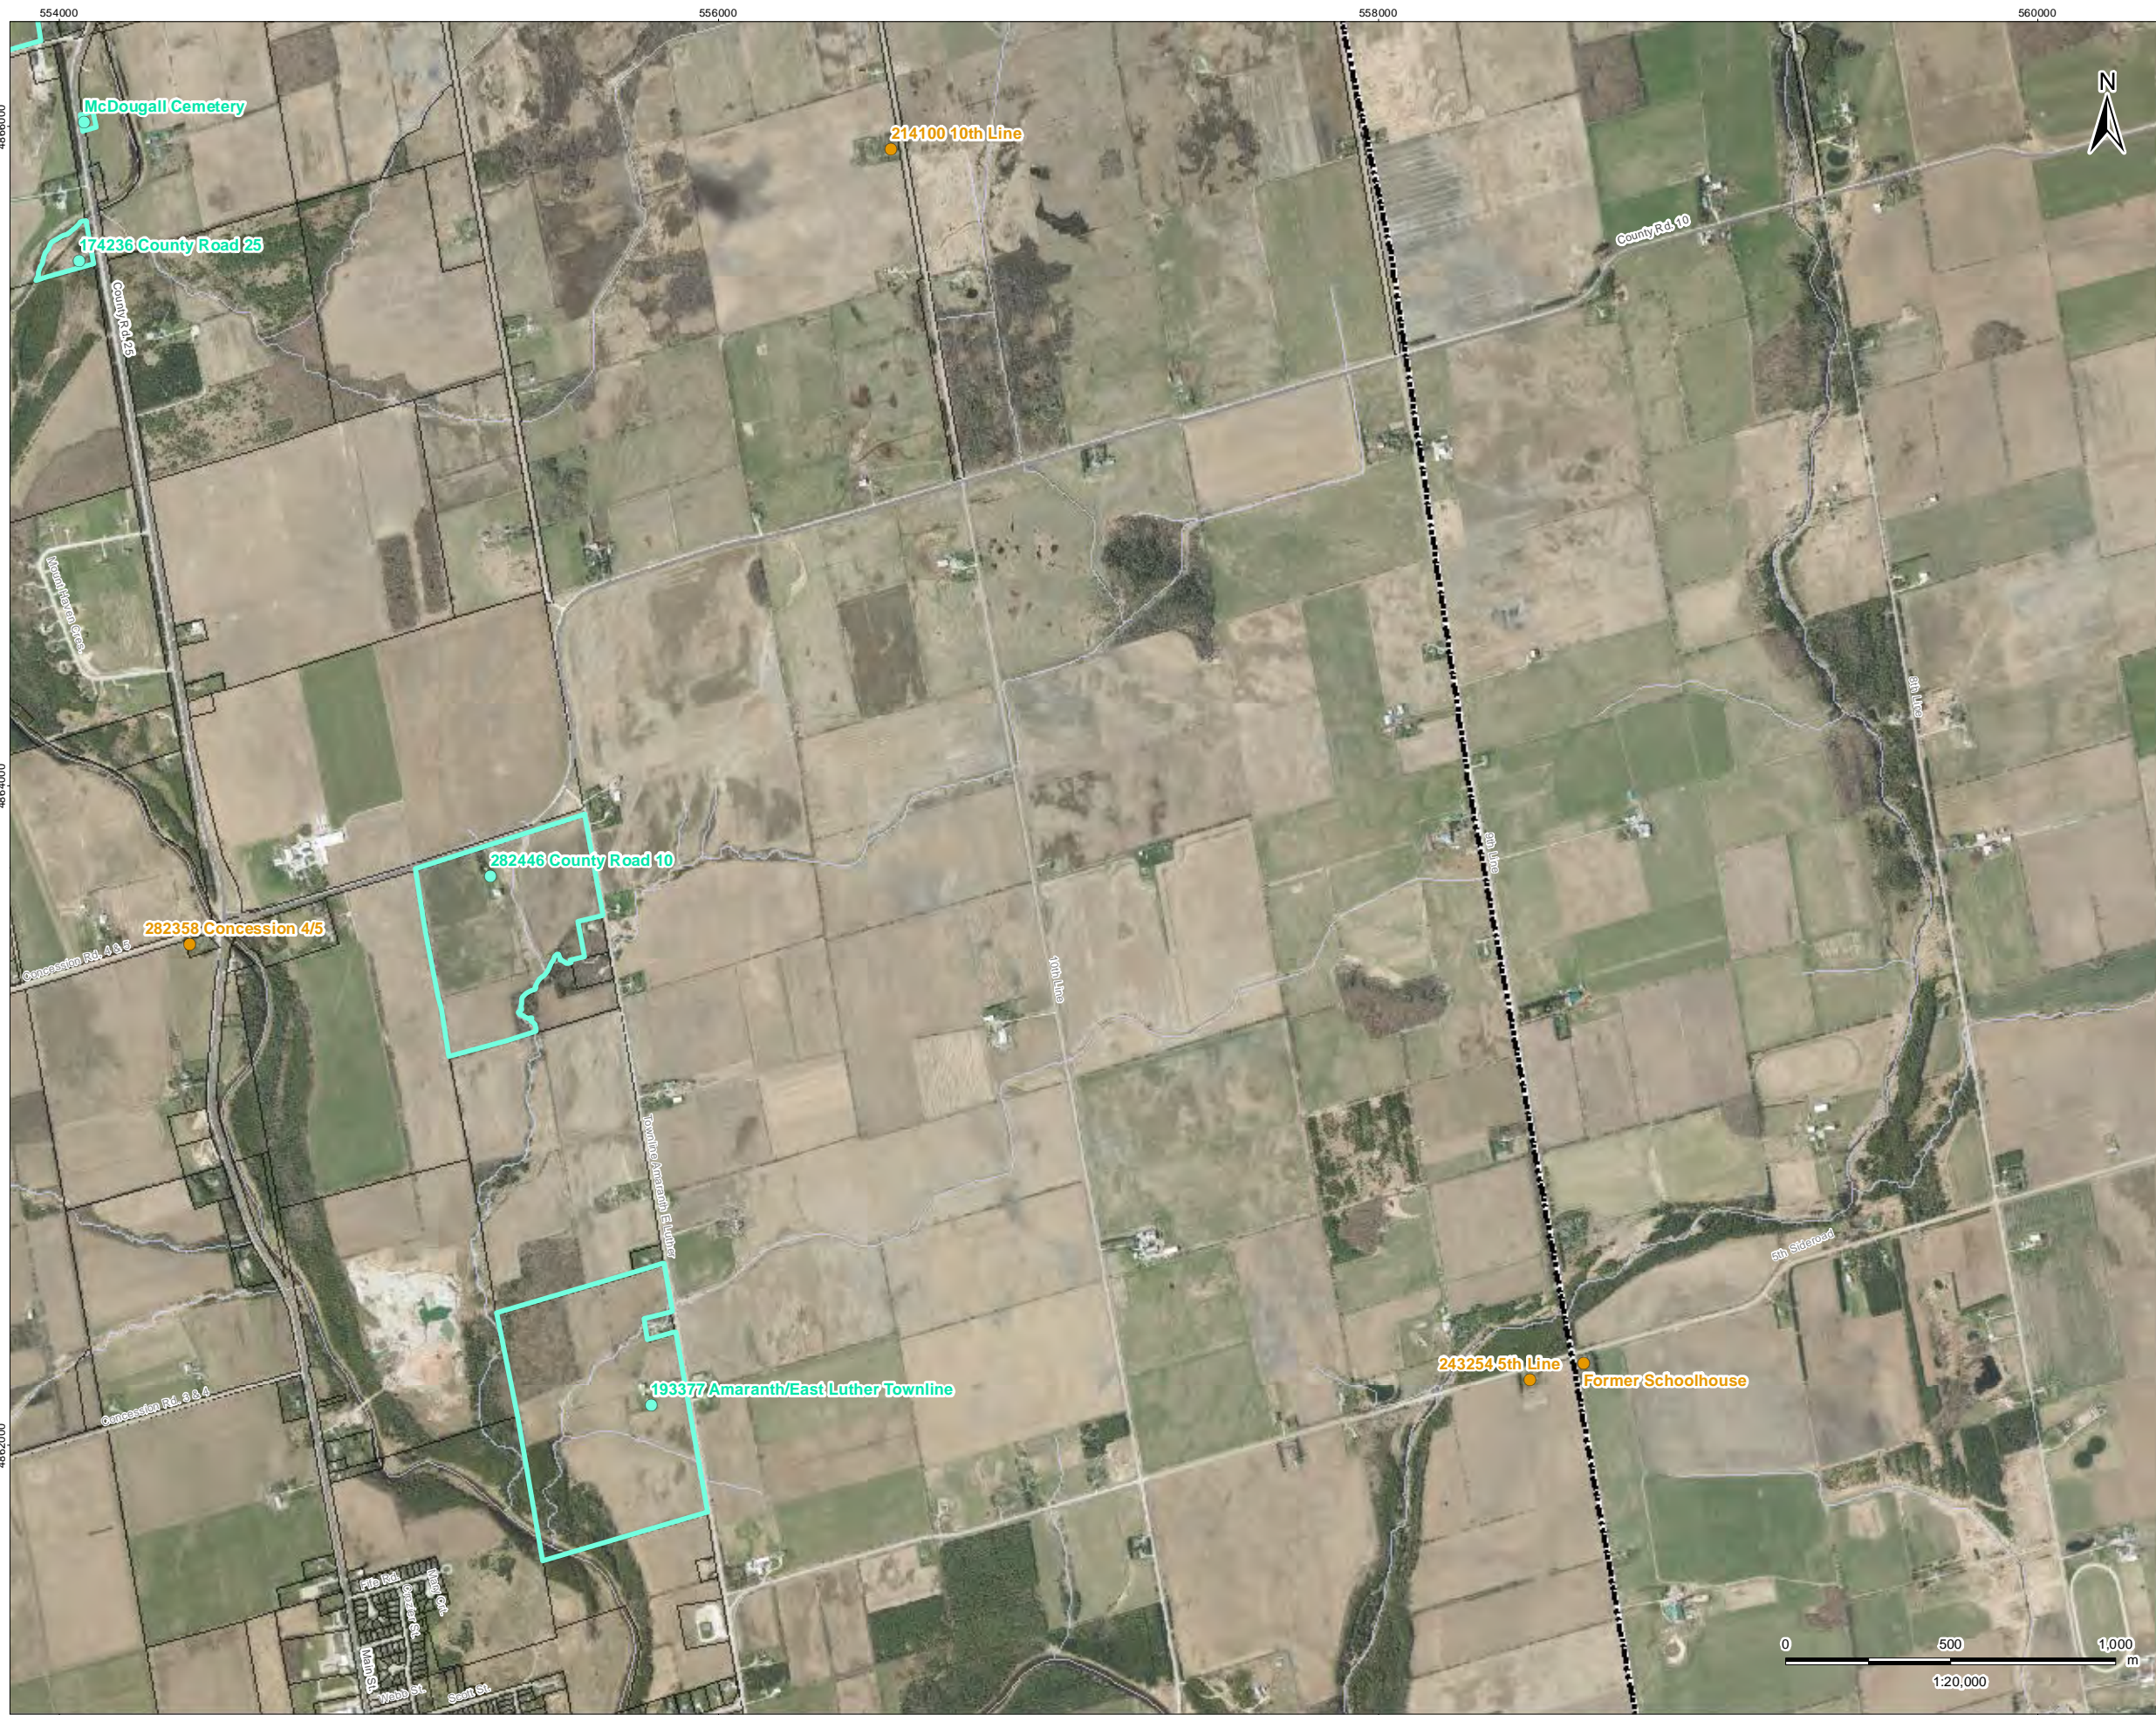
Figure No.  
 7

Title  
**Evaluated Heritage Resources  
 Map 6 of 9**

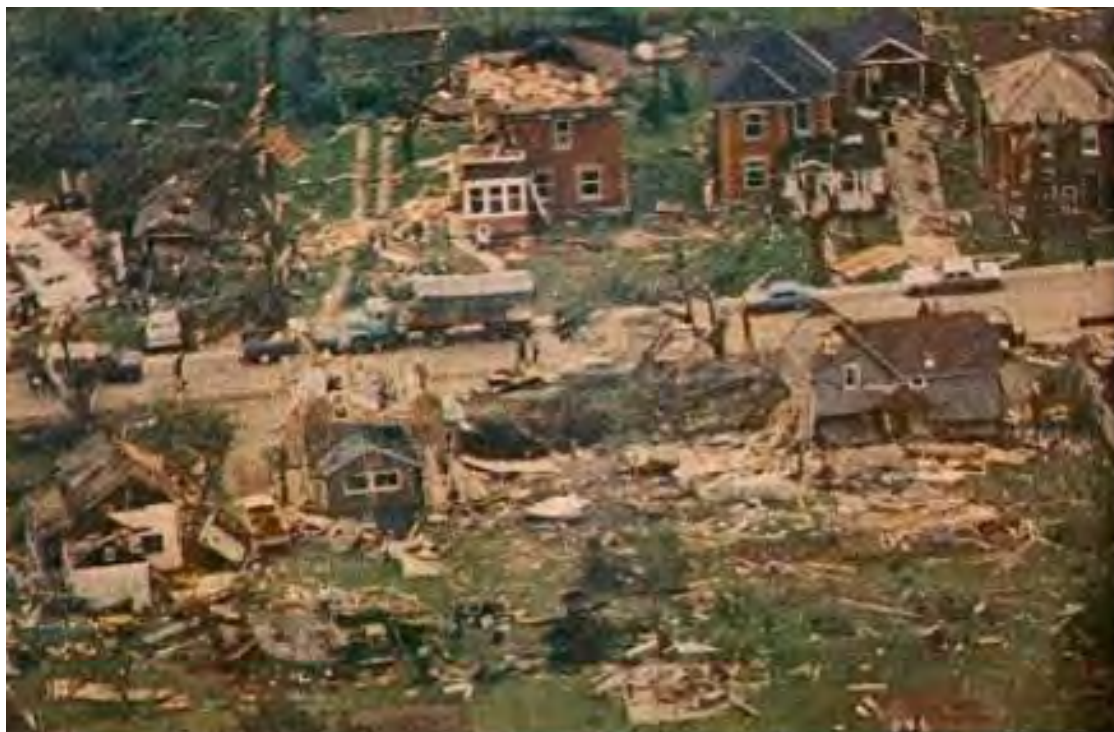
**Plate 1: Photograph of Amaranth Street, Grand Valley following 1985 tornado (Bruineman, 2010).**

In 1985 an F5 tornado swept through southern East Luther Grand Valley. Throughout the Study Area, many trees with halved trunks still bear evidence of its destruction. Over one hundred buildings, many historic, were destroyed in Grand Valley (Record-Journal, 1985).

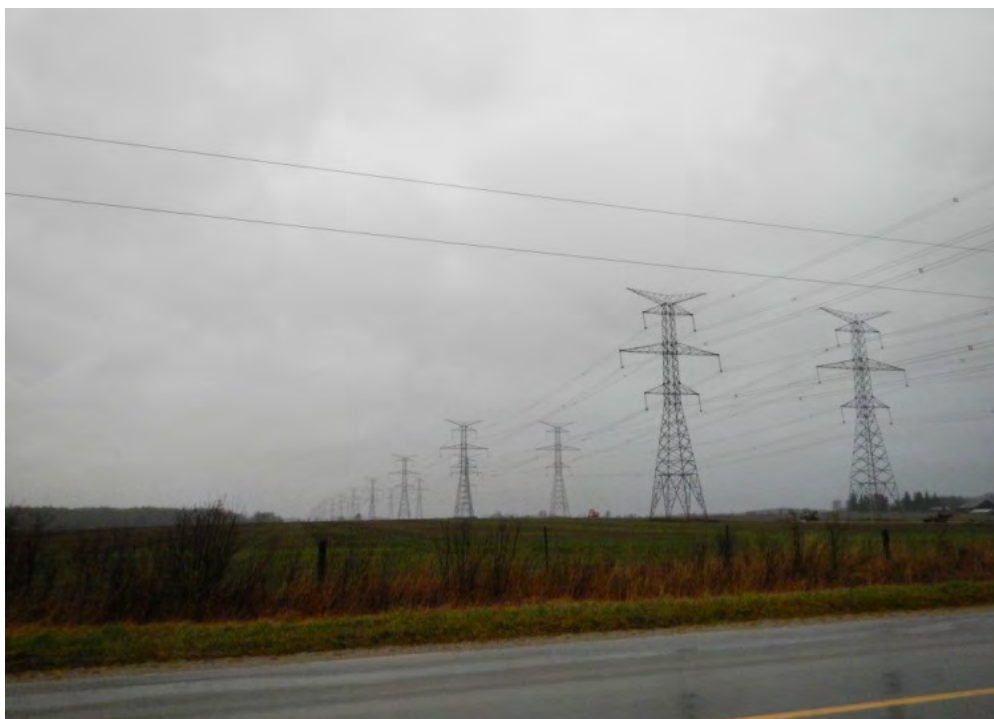
**Plate 7: Transmission Corridor**

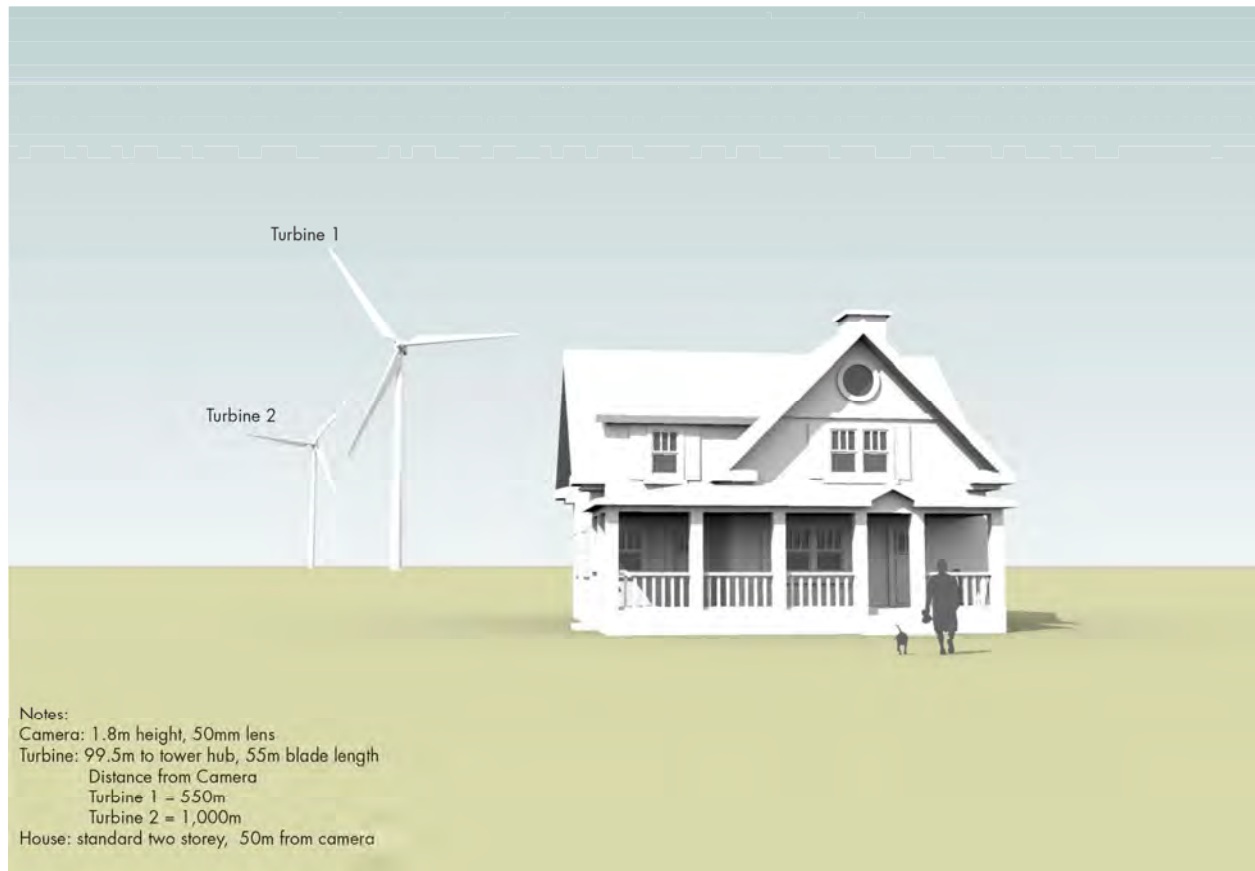
The hub height of the proposed wind turbines will be 99.5 m with a blade length of 55 m. In order to evaluate the potential visual impact of turbines, general topographical conditions and land-use recorded during the site visit, aerial imagery, and comparative examples from similar projects were reviewed, particularly those projects within and around the Study Area.

Visual Aid 1: Wind Turbine Scale Schematic

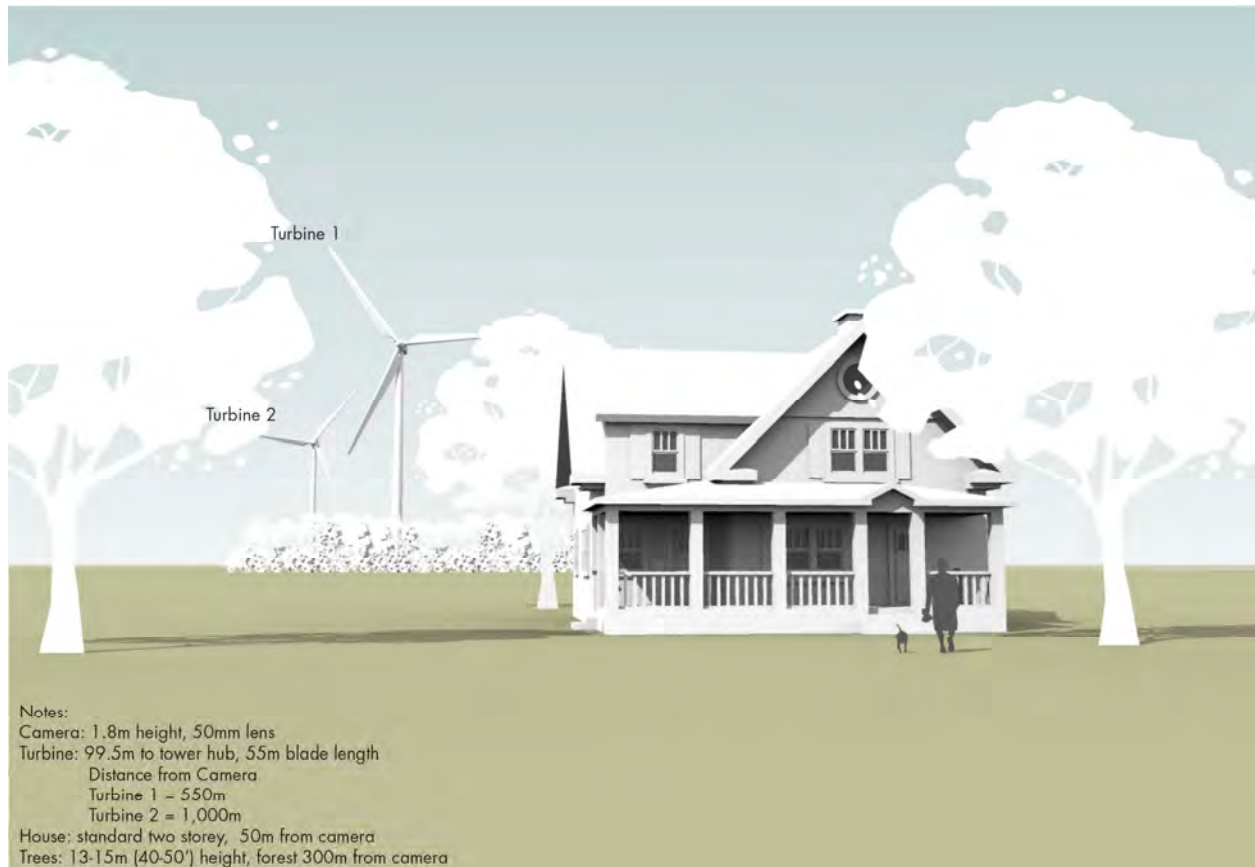
**Visual Aid 2: Wind Turbine Scale Schematic, with trees****8.1.3 Isolation, Change in Land Use, Land Disturbances**

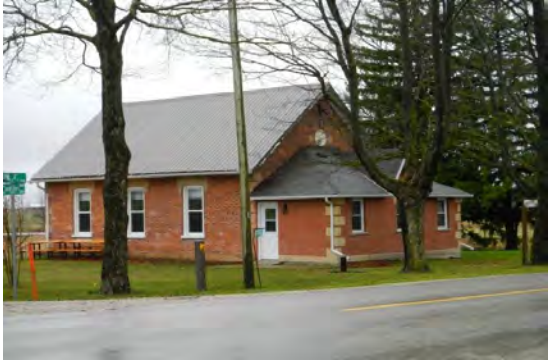
<b>Built Heritage Resource Name:</b> U.S.S. No. 2 (South Luther)

<b>Municipal Address:</b> 8749 Concession 2/3		
<b>Lot:</b>	<b>Concession:</b>	
<b>Municipality:</b> West Luther		
<b>County/RM:</b> Dufferin		
<b>Resource Type:</b> Institutional		<b>Landmark (Y/N?)</b> Yes
<b>Associated Dates:</b>		
<b>Description of Resource (physical design):</b> <p>One storey brick schoolhouse set on southwest corner of intersection. School features: a three bay side elevation with vinyl windows; pale brick quoins and window headers; a peaked roof front portico addition and a round central window with no labelstone. Property is lined with mature deciduous trees, and features a small baseball diamond to the south of the school. A small tree break demarcates the southern and western boundary of the property.</p>		
<b>Notable Features:</b> <p>Pale/painted brick quoins. Round window on front elevation.</p>		
<b>Associations:</b>

<b>Context:</b> <p>8746 Concession 2/3 is located on the northwest corner of the intersection. Generally open, gently rolling terrain. Intersection features mature trees along all sides of roads.</p>		
<b>Completed by (name):</b> N. Oakley		<b>Heritage Resource/Landscape Number:</b>
<b>Date Completed:</b> Nov. 12, 2012		
		BHR 1

BHR/ CHL #	Address/Name	Figure #	Potential Negative Impact						Recommended Mitigation
			Destruction	Alteration	Shadows	Isolation	Obstruction of Views	Change in Land Use	
BHR1	8749 Concession 2/3	9	N	N	N	N	N	N	No further mitigation recommended.
BHR2	114408 Sideroad 27/28	6	I	I	N	N	N	N	<ul style="list-style-type: none"> <li>• Avoid construction within a 60 m bufferzone of structures on the property;</li> <li>• in the event that construction within a 60 m bufferzone cannot be avoided, it is recommended that maximum acceptable vibration, or peak particle velocity (PPV), levels be determined by a qualified engineer prior to Project construction and that construction activities be monitored to ensure that maximum PPV levels are not exceeded.</li> </ul>
BHR3	073333 Sideroad 24/25	9	I	I	N	N	R	N	<ul style="list-style-type: none"> <li>• Avoid construction within a 60 m bufferzone of structures on the property;</li> <li>• in the event that construction within a 60 m bufferzone cannot be avoided, it is recommended that maximum acceptable vibration, or peak particle velocity (PPV), levels be determined by a qualified engineer prior to Project construction and that construction activities be monitored to ensure that maximum PPV levels are not exceeded.</li> </ul>

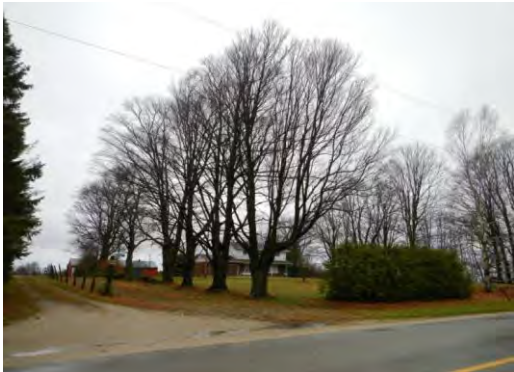
<b>Municipal Address:</b> 241077 and 241081 Concession 2/3		
<b>Lot:</b>	<b>Concession:</b>	
<b>Municipality:</b> Grand Valley		
<b>County/RM:</b> Dufferin		
<b>Resource Type:</b> Farm complex		<b>Landmark (Y/N?)</b> No
<b>Associated Dates:</b> No known associated dates.		
<b>Description of Resource (physical design):</b> Farm complex located on north side of road. 1 1/2 storey contemporary farmhouse set amid mature deciduous trees features a gabled roof and attached garage. Outbuildings include a large, gabled barn and smaller gabled sheds to rear of property. Associated gabled bank barn and two rows of mature conifers are located on south side of road.		
<b>Notable Features:</b> No notable features.		
<b>Associations:</b> No known associations.		
<b>Context:</b> Gently rolling terrain. Open, cultivated fields to south and west. Tree stand located across field to west. Property located on a small rise sloping in an easterly direction, into hilly, sparsely treed terrain. Mature conifers line road to west of property.

<b>Completed by (name):</b> N. Oakley		<b>Heritage Resource/Landscape Number:</b> does not meet criteria
<b>Date Completed:</b> 12-Nov-12

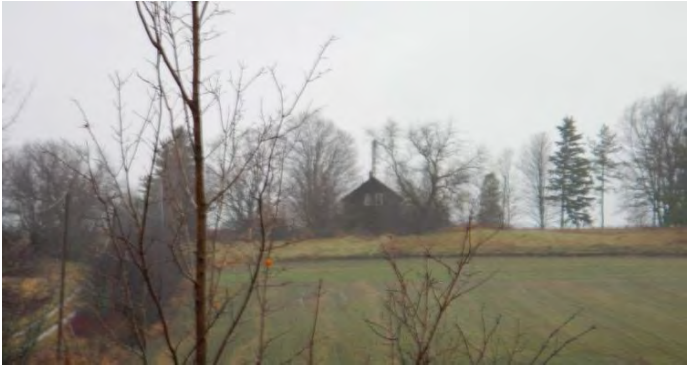
<b>Municipal Address:</b> unknown municipal address Concession 2/3		
<b>Lot:</b>	<b>Concession:</b>	
<b>Municipality:</b> Grand Valley		
<b>County/RM:</b> Dufferin		
<b>Resource Type:</b> House		<b>Landmark (Y/N?)</b> No
<b>Associated Dates:</b> No known associated dates.		
<b>Description of Resource (physical design):</b> No address given. One and a half storey cottage set among mature conifers and deciduous trees on ridge at end of long driveway, on north side of road. Full visual assessment obscured.		
<b>Notable Features:</b> No notable features.		
<b>Associations:</b> No known associations.		
<b>Context:</b> Rolling terrain features a ridge running east-west. Line of deciduous trees along driveway; open, cultivated fields surround property.		
<b>Completed by (name):</b> N. Oakley		<b>Heritage Resource/Landscape Number:</b> does not meet criteria
<b>Date Completed:</b> Nov. 12, 2012

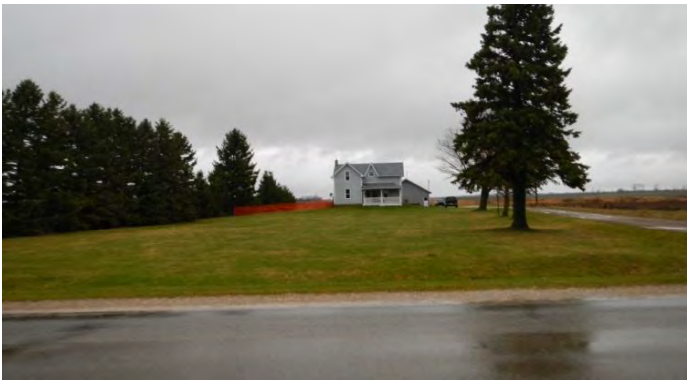
<b>Municipal Address:</b> 241265 Concession 2/3		
<b>Lot:</b>	<b>Concession:</b>	
<b>Municipality:</b> Grand Valley		
<b>County/RM:</b> Dufferin		
<b>Resource Type:</b> House		<b>Landmark (Y/N?)</b> No
<b>Associated Dates:</b> No associated dates.		
<b>Description of Resource (physical design):</b> 1 1/2 storey, ell-shaped Gothic Revival farmhouse located on north side of road. House features: covered front porch; vinyl siding and windows; and associated gabled steel garage.		
<b>Notable Features:</b> No notable features.		
<b>Associations:</b> No known associations.		
<b>Context:</b> Generally flat, open terrain. Tree break of mature conifers located to west of house. Transmisison line located to east of property.		
<b>Completed by (name):</b> N. Oakley		<b>Heritage Resource/Landscape Number:</b> does not meet criteria
<b>Date Completed:</b> Nov. 12, 2012

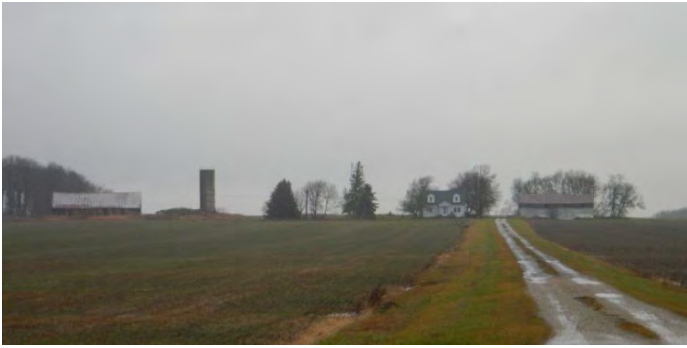
<b>Municipal Address:</b> 242231 Concession 2/3		
<b>Lot:</b>	<b>Concession:</b>	
<b>Municipality:</b> Grand Valley		
<b>County/RM:</b> Dufferin		
<b>Resource Type:</b> Farm complex		<b>Landmark (Y/N?)</b> No
<b>Associated Dates:</b> No associated dates		
<b>Description of Resource (physical design):</b> Farm complex located on north side of road, set on long driveway. 1 1/2 storey farmhouse features central portico and two gabled dormers on front façade. Outbuildings include two gabled barns and a concrete silo. Several conifers and deciduous trees located around house.		
<b>Notable Features:</b> No notable features		
<b>Associations:</b> No known associations.		
<b>Context:</b> Open, rolling terrain with cultivated fields. Tree stand located to north and west of property; transmission line to west of property.		
<b>Completed by (name):</b> N. Oakley		<b>Heritage Resource/Landscape Number:</b> does not meet criteria

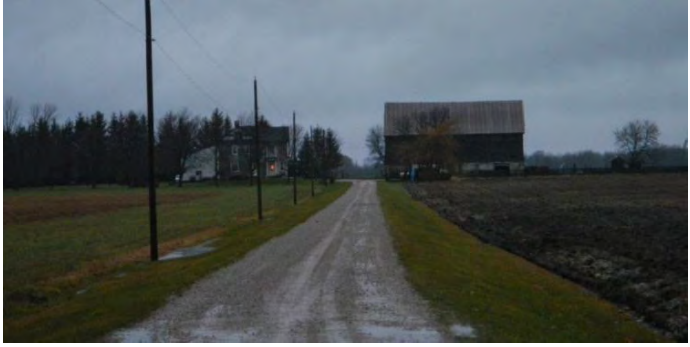
<b>Municipal Address:</b> 242277 Concession 2/3		
<b>Lot:</b>	<b>Concession:</b>	
<b>Municipality:</b> Grand Valley		
<b>County/RM:</b> Dufferin		
<b>Resource Type:</b> Farm complex		<b>Landmark (Y/N?)</b> No
<b>Associated Dates:</b> No associated dates		
<b>Description of Resource (physical design):</b> Farm complex located on north side of road, set on long driveway. Two storey, ell-shaped farmhouse features: side and rear additions and two storey corner balcony. Outbuildings include a large gabled barn.		
<b>Notable Features:</b> No notable features		
<b>Associations:</b> No known associations.		
<b>Context:</b> Generally flat, open terrain. Property set on outskirts of Grand Valley, with transmission line to the west. Large stand of mature conifers located immediately west of farmhouse.		
<b>Completed by (name):</b> N. Oakley		<b>Heritage Resource/Landscape Number:</b> does not meet criteria

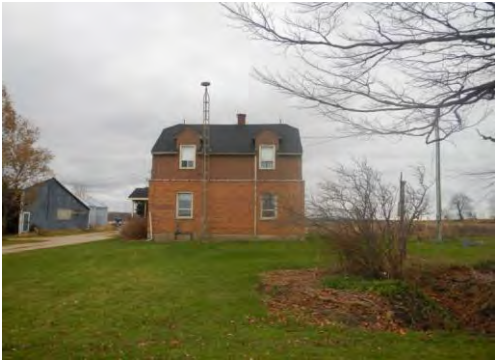
<b>Municipal Address:</b> 242072 Concession 2/3		
<b>Lot:</b>	<b>Concession:</b>	
<b>Municipality:</b> Grand Valley		
<b>County/RM:</b> Dufferin		
<b>Resource Type:</b> Farm complex		<b>Landmark (Y/N?)</b> No
<b>Associated Dates:</b> No associated dates		
<b>Description of Resource (physical design):</b> Farm complex located on south side of the road. One and a half storey farmhouse features: hipped roof; two gabled dormers on front façade; brick and steel exterior cladding and a central chimney. Outbuildings include several steel barns and sheds, and steel and concrete silos.		
<b>Notable Features:</b> No notable features		
<b>Associations:</b> No known associations.		
<b>Context:</b> Gently rolling, open terrain. A small creek and transmission lines to the east. Line of mature deciduous trees along road to west of property.		
<b>Completed by (name):</b> N. Oakley		<b>Heritage Resource/Landscape Number:</b> does not meet criteria

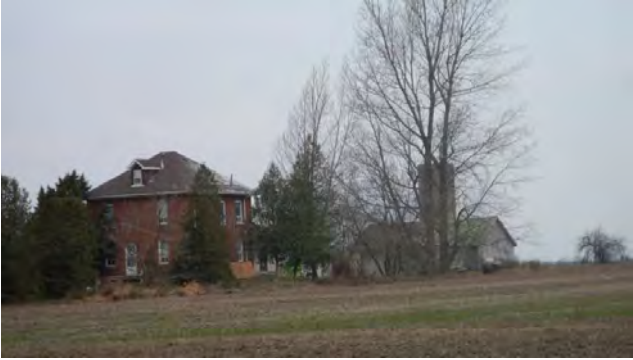
<b>Municipal Address:</b> 202469 County Road 109		
<b>Lot:</b>	<b>Concession:</b>	
<b>Municipality:</b> Grand Valley		
<b>County/RM:</b> Dufferin		
<b>Resource Type:</b> Farm complex		<b>Landmark (Y/N?)</b> No
<b>Associated Dates:</b> No associated dates		
<b>Description of Resource (physical design):</b> Farm complex located on north side of highway, set on long driveway. Two storey brick farmhouse features: hipped roof with central gabled dormer; and rear addition. Outbuildings include a concrete silo and gabled wooden barn to rear of property. Several conifer and deciduous trees set around farmhouse.		
<b>Notable Features:</b> No notable features		
<b>Associations:</b> No known associations.		
<b>Context:</b> Gently rolling, open terrain. Property set on small incline from highway. Driveway and western property line bounded by mature conifers.		
<b>Completed by (name):</b> N. Oakley		<b>Heritage Resource/Landscape Number:</b> does not meet criteria

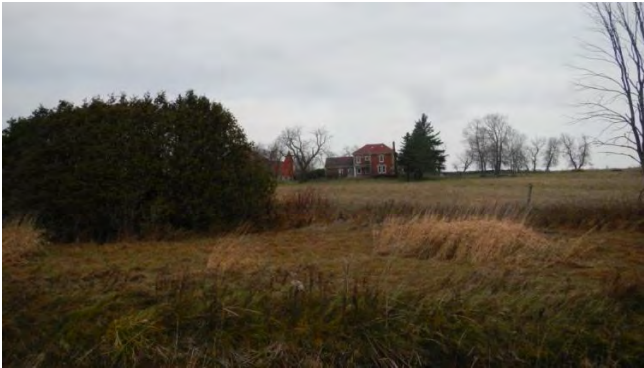
<b>Municipal Address:</b> 202289 County Road 109		
<b>Lot:</b>	<b>Concession:</b>	
<b>Municipality:</b> Grand Valley		
<b>County/RM:</b> Dufferin		
<b>Resource Type:</b> Farm complex		<b>Landmark (Y/N?)</b> No
<b>Associated Dates:</b> No associated dates		
<b>Description of Resource (physical design):</b> Farm complex located on north side of road, set on long driveway. Two storey, ell-shaped brick farmhouse features: hipped roof with brick chimney; stone quoins and voussiors; dual eave brackets; one storey side addition with stone voussiors; and front porch. Several mature conifers and deciduous trees set around farmhouse. Outbuildings include a large gabled barn with a stone foundation and paddock area, and a small wooden shed.		
<b>Notable Features:</b> No notable features		
<b>Associations:</b> No known associations.		
<b>Context:</b> Gently rolling, open terrain. Property set on small incline from highway. Line of mature cedar hedges set along highway in front of property.

<b>Completed by (name):</b> N. Oakley		<b>Heritage Resource/Landscape Number:</b>  CHL 5
<b>Date Completed:</b> Nov. 12, 2012

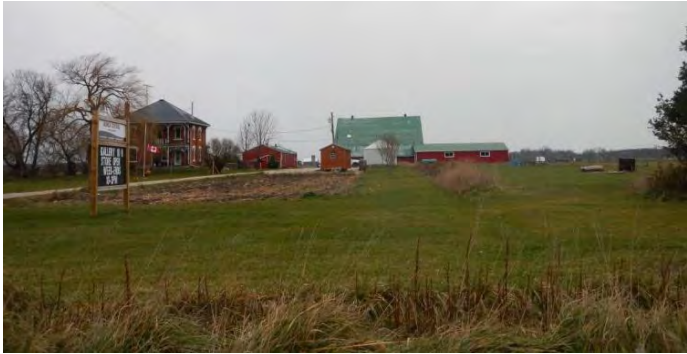
<b>Built Heritage Resource Name:</b> Alpaca Central

<b>Municipal Address:</b> 201215 County Road 109		
<b>Lot:</b>	<b>Concession:</b>	
<b>Municipality:</b> Grand Valley		
<b>County/RM:</b> Dufferin		
<b>Resource Type:</b> Farm complex		<b>Landmark (Y/N?)</b> No
<b>Associated Dates:</b> No associated dates		
<b>Description of Resource (physical design):</b> Farm complex specializing in breeding of alpacas, located on north side of road, set on long driveway. Two storey brick farmhouse features: hipped roof, two storey corner balcony with bargeboard; stone lintels and shaped voussoirs; paired eave brackets; and rear additions. Outbuildings include: a large, gabled bank barn; a small steel silo and several sheds. Large deciduous trees immediately to west of farmhouse.		
<b>Notable Features:</b> No notable features		
<b>Associations:</b> No known associations.		
<b>Context:</b> Gently rolling, open terrain. Property set on small incline from highway. Mature cedar hedge and stand of mature conifers shield property from highway immediately to east and west of driveway. Front yard features several large bushes and a garden.

<b>Completed by (name):</b> N. Oakley		<b>Heritage Resource/Landscape Number:</b>  CHL 6
<b>Date Completed:</b> Nov. 12, 2012

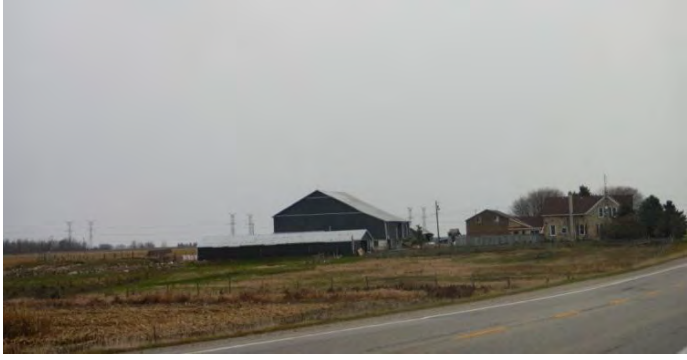
<b>Municipal Address:</b> 201347 County Road 109		
<b>Lot:</b>	<b>Concession:</b>	
<b>Municipality:</b> Grand Valley		
<b>County/RM:</b> Dufferin		
<b>Resource Type:</b> Farm complex		<b>Landmark (Y/N?)</b> No
<b>Associated Dates:</b> No associated dates		
<b>Description of Resource (physical design):</b> Farm complex located on north side of highway, at road. 1 1/2 storey polychromatic stone, Gothic Revival Cottage farmhouse features: stone lintels and voussoirs; central lancet window; central front door with transom; and large rear addition. Outbuildings include a large, gabled steel clad bank barn, sheds, and paddocks to rear of property. Stand of mature conifers located immediately east of house.		
<b>Notable Features:</b> No notable features		
<b>Associations:</b> No known associations.		
<b>Context:</b> Generally open, gently rolling terrain. Property set in small valley along highway. Transmission line to east.

<b>Completed by (name):</b> N. Oakley		<b>Heritage Resource/Landscape Number:</b>
<b>Date Completed:</b> Nov. 12, 2012		
		CHL 7

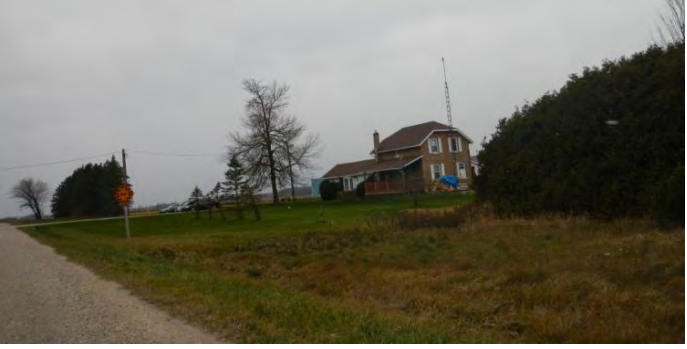
<b>Municipal Address:</b> 201079 County Road 109		
<b>Lot:</b>	<b>Concession:</b>	
<b>Municipality:</b> Grand Valley		
<b>County/RM:</b> Dufferin		
<b>Resource Type:</b> House	<b>Landmark (Y/N?)</b> No	
<b>Associated Dates:</b> No associated dates		
<b>Description of Resource (physical design):</b> Two storey brick house set on north side of highway. Features hipped roof, covered front porch, and side addition. Large deciduous tree and two steel clad garages located to the west of the house.		
<b>Notable Features:</b> No notable features		
<b>Associations:</b> No known associations.		
<b>Context:</b> Generally flat, open terrain. Large cedar hedge located immediately to east of property at road; stand of mature conifers located at road to west. A few small conifers located in front of house at road.		
<b>Completed by (name):</b> N. Oakley	<b>Heritage Resource/Landscape Number:</b>

<b>Date Completed:</b> Nov. 12, 2012	does not meet criteria

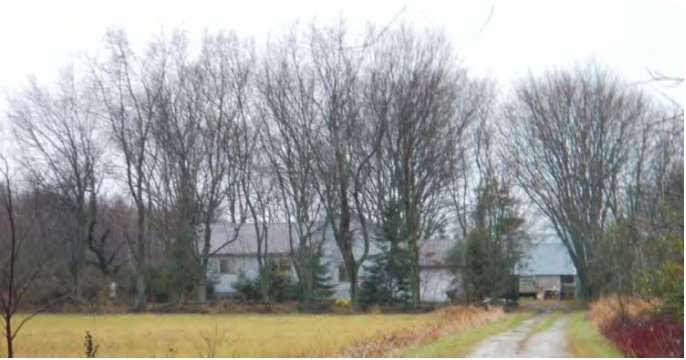
<b>Municipal Address:</b> 033344 Sideroad 21/22		
<b>Lot:</b>	<b>Concession:</b>	
<b>Municipality:</b> Grand Valley		
<b>County/RM:</b> Dufferin		
<b>Resource Type:</b> Farm complex		<b>Landmark (Y/N?)</b> No
<b>Associated Dates:</b> No associated dates		
<b>Description of Resource (physical design):</b> Farm complex set on west side of road. 1 1/2 storey farmhouse with side additions. Outbuildings include several steel clad barns and sheds. Property around house and along driveway is heavily treed.		
<b>Notable Features:</b> No notable features		
<b>Associations:</b> No known associations.		
<b>Context:</b> Generally flat terrain. Set on No Exit road. Low-lying, swampy area to the north of the property. 033350 Sideroad 21/22 located to the northeast of property, at road.		
<b>Completed by (name):</b> N. Oakley		<b>Heritage Resource/Landscape Number:</b> does not meet criteria

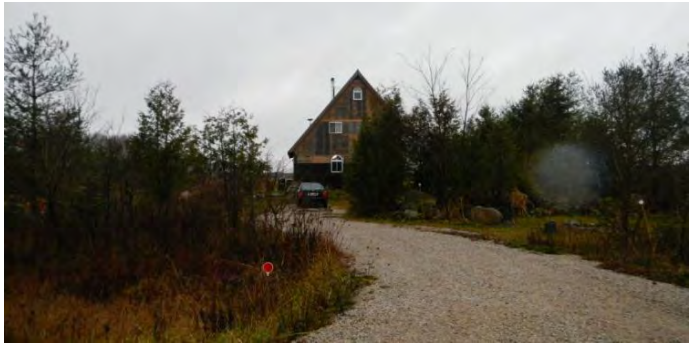
<b>Municipal Address:</b> 033350 Sideroad 21/22		
<b>Lot:</b>	<b>Concession:</b>	
<b>Municipality:</b> Grand Valley		
<b>County/RM:</b> Dufferin		
<b>Resource Type:</b> House		<b>Landmark (Y/N?)</b> No
<b>Associated Dates:</b> No associated dates		
<b>Description of Resource (physical design):</b> Two storey house with steep-pitched gable roof located on west side of road. Features vinyl windows, steel roofing and mix of exterior cladding. Small hedges and trees shield front of house from road.		
<b>Notable Features:</b> No notable features		
<b>Associations:</b> No known associations.		
<b>Context:</b> Generally flat terrain. Set on No Exit road. Low-lying, swampy area to the north of the property. 033344 Sideroad 21/22 located to the southwest of property, set back from road.		
<b>Completed by (name):</b> N. Oakley		<b>Heritage Resource/Landscape Number:</b>

<b>Date Completed:</b> Nov. 12, 2012		does not meet criteria

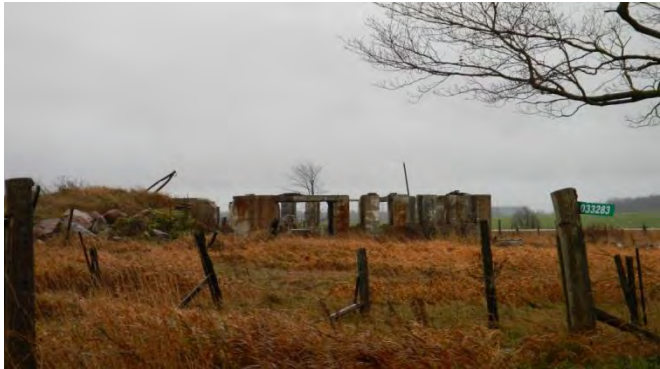
<b>Municipal Address:</b> 033283 Sideroad 21/22		
<b>Lot:</b>	<b>Concession:</b>	
<b>Municipality:</b> Grand Valley		
<b>County/RM:</b> Dufferin		
<b>Resource Type:</b> Ruins		<b>Landmark (Y/N?)</b> No
<b>Associated Dates:</b> No associated dates		
<b>Description of Resource (physical design):</b> Ruins of house and concrete bank barn foundations located on east side of road. House foundations located to the north of barn. Several mature deciduous trees located along road.		
<b>Notable Features:</b> No notable features		
<b>Associations:</b> No known associations.		
<b>Context:</b> Open, gently rolling terrain.		
<b>Completed by (name):</b> N. Oakley		<b>Heritage Resource/Landscape Number:</b> does not meet criteria
<b>Date Completed:</b> Nov. 12, 2012

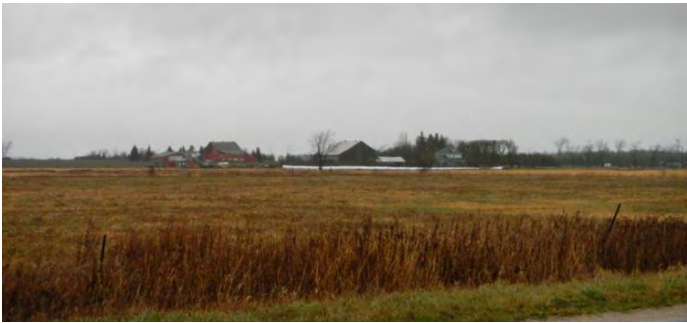
<b>Municipal Address:</b> 073320 Sideroad 24/25		
<b>Lot:</b>	<b>Concession:</b>	
<b>Municipality:</b> Grand Valley		
<b>County/RM:</b> Dufferin		
<b>Resource Type:</b> Farm complex		<b>Landmark (Y/N?)</b> No
<b>Associated Dates:</b> No associated dates		
<b>Description of Resource (physical design):</b> Farm complex located on west side of road. Two storey farmhouse features: hipped roof; large rear addition; enclosed sunroom and hipped attic dormer on south elevation; central brick chimney; enclosed and offset front portico; and vinyl siding. Outbuildings include a large, gabled wood barn set on stone foundation, paddock areas, and several sheds. Property enclosed by split rail fence, and features several large willow trees in front yard. Stone pillars set at driveway entrance. Line of deciduous trees along road.		
<b>Notable Features:</b> No notable features

<b>Associations:</b> No known associations.		
<b>Context:</b> Generally flat, open terrain. Wooded area and transmission line to east.		
<b>Completed by (name):</b> N. Oakley		<b>Heritage Resource/Landscape Number:</b> does not meet criteria
<b>Date Completed:</b> Nov. 12, 2012

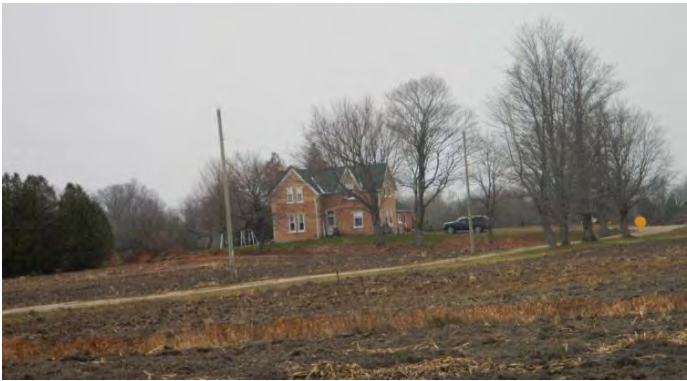
<b>Municipal Address:</b> 073084 Sideroad 24/25		
<b>Lot:</b>	<b>Concession:</b>	
<b>Municipality:</b> Grand Valley		
<b>County/RM:</b> Dufferin		
<b>Resource Type:</b> House		<b>Landmark (Y/N?)</b> No
<b>Associated Dates:</b> No associated dates		
<b>Description of Resource (physical design):</b> 1 1/2 storey, ell-shaped brick Gothic Revival farmhouse located on west side of road, set on long driveway. House features: dichromatic brickwork with brick quoins and voussoirs; central front door with transom; vinyl windows and rear addition. Foundation being constructed for barn to north of house. Several large deciduous trees located around house and driveway; southeast corner of property demarcated by stand of large conifers.		
<b>Notable Features:</b> No notable features		
<b>Associations:</b> No known associations.		
<b>Context:</b> Surrounded by generally flat, open terrain. Tree stand located to west (at rear) of property. Swampy bush to east.

<b>Completed by (name):</b> N. Oakley		<b>Heritage Resource/Landscape Number:</b> does not meet criteria
<b>Date Completed:</b> Nov. 12, 2012

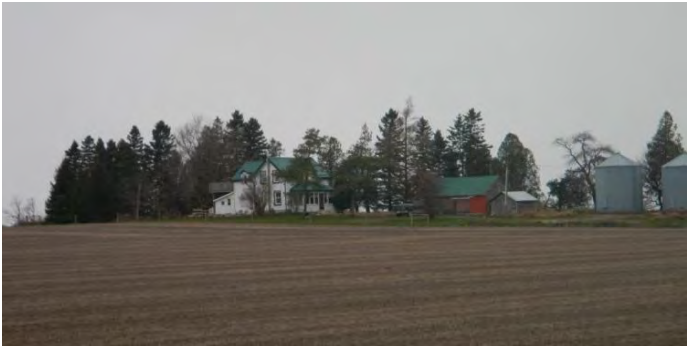
<b>Municipal Address:</b> 073174 Sideroad 24/25		
<b>Lot:</b>	<b>Concession:</b>	
<b>Municipality:</b> Grand Valley		
<b>County/RM:</b> Dufferin		
<b>Resource Type:</b> Farm complex		<b>Landmark (Y/N?)</b> No
<b>Associated Dates:</b> No associated dates		
<b>Description of Resource (physical design):</b> Farm complex located on west side of road, set on long, raised driveway. 1 1/2 storey Gothic Revival farmhouse features: enclosed, central front porch; lancet window with shaped trim; vinyl siding; and rear additions. Outbuildings located toward front of property and include: large, gabled, steel-clad barn, steel shed, concrete and steel silos and covered shed for hay. Farmhouse surrounded by mature conifers and deciduous trees. Driveway lined with large deciduous trees.		
<b>Notable Features:</b> No notable features		
<b>Associations:</b> No known associations.

<b>Context:</b> Open, gently rolling terrain. Set on small incline in middle of cultivated fields. Transmission line to east.		
<b>Completed by (name):</b> N. Oakley		<b>Heritage Resource/Landscape Number:</b> does not meet criteria
<b>Date Completed:</b> Nov. 12, 2012

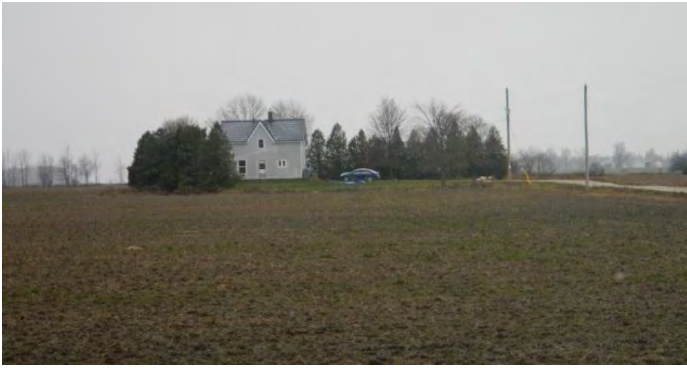
<b>Municipal Address:</b> 073226 Sideroad 24/25		
<b>Lot:</b>	<b>Concession:</b>	
<b>Municipality:</b> Grand Valley		
<b>County/RM:</b> Dufferin		
<b>Resource Type:</b> House		<b>Landmark (Y/N?)</b> No
<b>Associated Dates:</b> No associated dates		
<b>Description of Resource (physical design):</b> 1 1/2 storey Gothic Revival Cottage, located on west side of road, set on long driveway. House heavily modified with introduction of vinyl cladding and windows. House surrounded by line of mature conifers.		
<b>Notable Features:</b> No notable features		
<b>Associations:</b> No known associations.		
<b>Context:</b> Open, gently rolling terrain. Transmission line to east.		
<b>Completed by (name):</b> N. Oakley		<b>Heritage Resource/Landscape Number:</b> does not meet criteria
<b>Date Completed:</b> Nov. 12, 2012

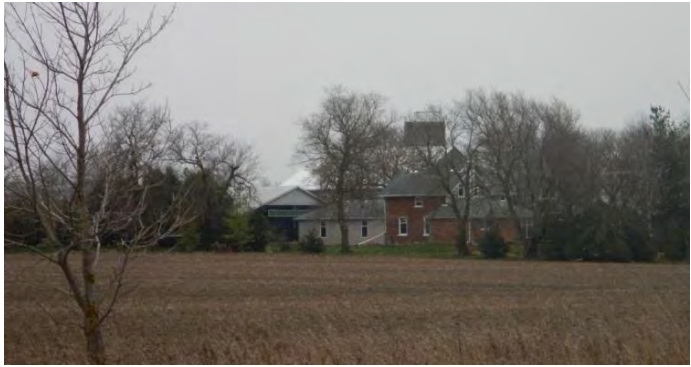
<b>Municipal Address:</b> 033097 Sideroad 21/22		
<b>Lot:</b>	<b>Concession:</b>	
<b>Municipality:</b> Grand Valley		
<b>County/RM:</b> Dufferin		
<b>Resource Type:</b> Farm complex		<b>Landmark (Y/N?)</b> No
<b>Associated Dates:</b> No associated dates		
<b>Description of Resource (physical design):</b> Farm complex located on east side of road, set on long driveway. 1 1/2 storey, ell-shaped brick farmhouse modified from original with introduction of rear vinyl clad and front brick additions. Original section retains dichromatic brickwork around windows, and front has been reclad with a stylized, dichromatic fishscale cladding. Outbuildings include: a large, gabled wood barn; concrete silo; and several sheds. Paddock area to south of driveway. Large front lawn, and several trees set around house and barns. Tree break of conifers along northern property line.

<b>Notable Features:</b> No notable features		
<b>Associations:</b> No known associations.		
<b>Context:</b> Open, gently rolling landscape. Some trees along ridge to the west. Large radio tower across road to south.		
<b>Completed by (name):</b> N. Oakley		<b>Heritage Resource/Landscape Number:</b> does not meet criteria
<b>Date Completed:</b> Nov. 12, 2012

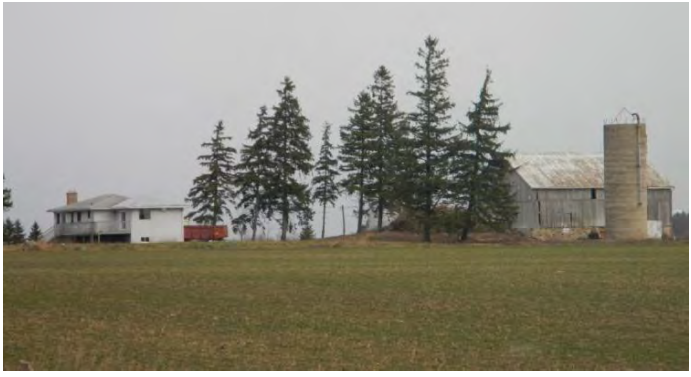
<b>Municipal Address:</b> 113118 Sideroad 27/28		
<b>Lot:</b>	<b>Concession:</b>	
<b>Municipality:</b> Grand Valley		
<b>County/RM:</b> Dufferin		
<b>Resource Type:</b> Farm complex		<b>Landmark (Y/N?)</b> No
<b>Associated Dates:</b> No associated dates		
<b>Description of Resource (physical design):</b> Farm complex located on east side of road, set on long driveway. Property features: one storey, contemporary bungalow; large, gabled wood barn and steel and concrete silos at rear of property. Mature conifers line southern side of driveway and behind house.		
<b>Notable Features:</b> No notable features		
<b>Associations:</b> No known associations.		
<b>Context:</b> Open, gently rolling terrain. Surrounded by cultivated fields. Upper Grand Trailway located to north. Transmission line to west.		
<b>Completed by (name):</b> N. Oakley		<b>Heritage Resource/Landscape Number:</b> does not meet criteria

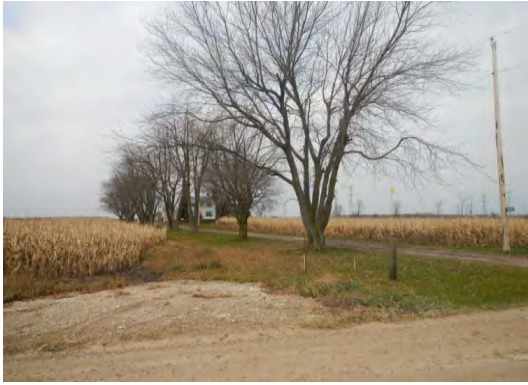
<b>Municipal Address:</b> 113122 Sideroad 27/28		
<b>Lot:</b>	<b>Concession:</b>	
<b>Municipality:</b> Grand Valley		
<b>County/RM:</b> Dufferin		
<b>Resource Type:</b> House		<b>Landmark (Y/N?)</b> No
<b>Associated Dates:</b> Farm established 1852		
<b>Description of Resource (physical design):</b> 1 1/2 storey, ell-shaped Gothic Revival farmhouse, set on long driveway at west side of road. House features: central front door with small overhang; vinyl siding and windows; and detached garage to rear of property. Driveway is lined by large deciduous trees, and stand of mature conifers and deciduous trees are located immediately north of the house.		
<b>Notable Features:</b> No notable features		
<b>Associations:</b> Century farm. Settled by the Taylor family, 1852		
<b>Context:</b> Open, gently rolling terrain. Surrounded by cultivated fields. Upper Grand Trailway located to north. Transmission line to west.

<b>Completed by (name):</b> N. Oakley		<b>Heritage Resource/Landscape Number:</b>  CHL 8
<b>Date Completed:</b> Nov. 12, 2012

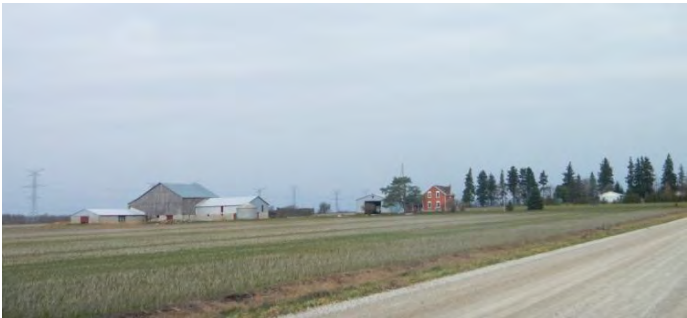
<b>Municipal Address:</b> 113318 Sideroad 27/28		
<b>Lot:</b>	<b>Concession:</b>	
<b>Municipality:</b> Grand Valley		
<b>County/RM:</b> Dufferin		
<b>Resource Type:</b> Farm complex		<b>Landmark (Y/N?)</b> No
<b>Associated Dates:</b> No associated dates		
<b>Description of Resource (physical design):</b> Farm complex located on west side of road, set on long driveway. 1 1/2 storey brick Gothic Revival cottage features: central front door with enclosed transom; painted brick voussoirs; chimney on north façade; and rear board and batten addition. Outbuildings include: a large, gabled wood barn set on a stone foundation with two concrete block and steel clad wings; and a gabled, steel shed. A few bushes, small trees and a steel weather vane are located in the immediate vicinity of the house. Several large deciduous trees line the property at the road.		
<b>Notable Features:</b> No notable features

<b>Associations:</b> No known associations.		
<b>Context:</b> Open, gently rolling terrain. Property set on small ridge running east-west. Transmission line to west. Tree break of mature conifers to north, and mature deciduous trees line both sides of road to north, at top of ridge.		
<b>Completed by (name):</b> N. Oakley		<b>Heritage Resource/Landscape Number:</b> does not meet criteria
<b>Date Completed:</b> Nov. 12, 2012

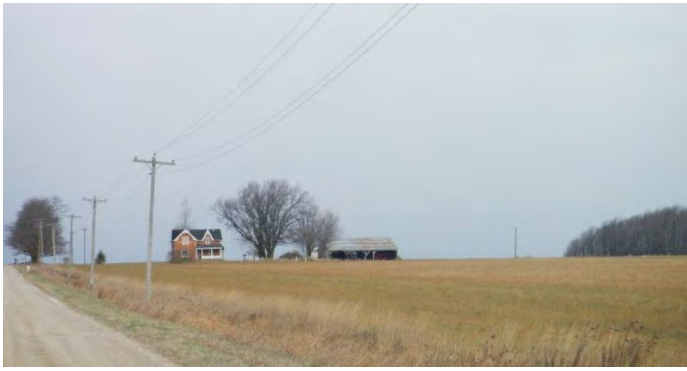
<b>Municipal Address:</b> 113339 Sideroad 27/28		
<b>Lot:</b>	<b>Concession:</b>	
<b>Municipality:</b> Grand Valley		
<b>County/RM:</b> Dufferin		
<b>Resource Type:</b> Farm complex		<b>Landmark (Y/N?)</b> No
<b>Associated Dates:</b> No associated dates		
<b>Description of Resource (physical design):</b> Farm complex located on east side of road. 1 1/2 storey, brick Gothic Revival cottage features: dichromatic brickwork, including detailed banding, quoins, and shaped voussoirs; gable bargeboard; one storey, brick side addition with central, diamond-shaped end window; and vinyl windows. Outbuildings include: a large, gabled, wood barn; steel silo; and gabled shed open to the south. Several large deciduous trees are located immediately behind the house, and along roadway at front of property.		
<b>Notable Features:</b> No notable features		
<b>Associations:</b> No known associations.

<b>Context:</b> Open, gently rolling terrain. Property set at top of small ridge running east-west. Transmission line to west. Tree stand of mature conifers located across road, immediately to west; tree stand across field to east.		
<b>Completed by (name):</b> N. Oakley		<b>Heritage Resource/Landscape Number:</b>
<b>Date Completed:</b> Nov. 12, 2012

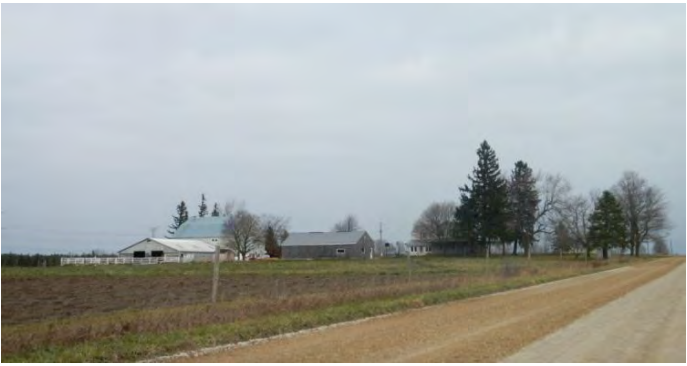
<b>Municipal Address:</b> 113482 Sideroad 27/28		
<b>Lot:</b>	<b>Concession:</b>	
<b>Municipality:</b> Grand Valley		
<b>County/RM:</b> Dufferin		
<b>Resource Type:</b> Farm complex		<b>Landmark (Y/N?)</b> No
<b>Associated Dates:</b> No associated dates		
<b>Description of Resource (physical design):</b> Farm complex located on west side of road. 1 1/2 storey Gothic Revival cottage features: board and batten and stone cladding; wraparound porch; vinyl windows and large, rear and side additions. Outbuildings include: gambrel roof bank barn with gabled, steel clad extension; gabled garage; and steel silo. Several mature conifers and deciduous trees located in front yard and around house and outbuildings.		
<b>Notable Features:</b> No notable features		
<b>Associations:</b> No known associations.		
<b>Context:</b> Open, gently rolling terrain. Property surrounded by cultivated fields. Transmission line to west. Tree stand to east, across field.

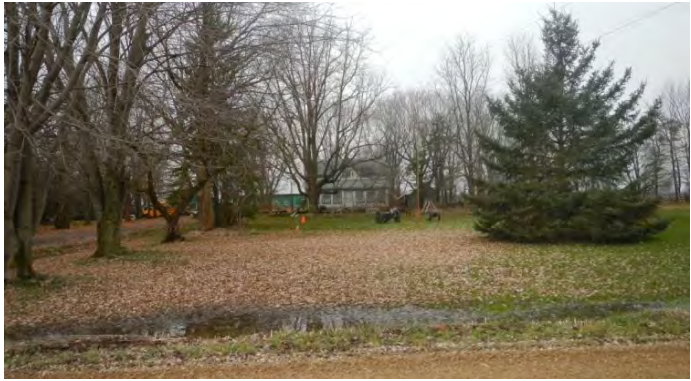
<b>Built Heritage Resource Name:</b> Rusty Wheel Ranch

<b>Municipal Address:</b> 114242 Sideroad 27/28		
<b>Lot:</b>	<b>Concession:</b>	
<b>Municipality:</b> Grand Valley		
<b>County/RM:</b> Dufferin		
<b>Resource Type:</b> Farm complex		<b>Landmark (Y/N?)</b> No
<b>Associated Dates:</b> No associated dates		
<b>Description of Resource (physical design):</b> Farm complex set on west side of road. 1 1/2 storey plaster clad Gothic Revival cottage features: enclosed front porch with central door and original 3-over-3 hung windows and wood shingle cladding; original lancet window; dual end chimneys; and rear addition. Outbuildings include: gabled barn and several sheds. Property lines delineated by split rail fencing. Property is thickly wooded, featuring a tree break of mature conifers along the southern property line; deciduous trees along driveway and northern and western property lines; and several trees in front and backyards. Various objects, including a cannon and several benches, located in front yard.

The most common potential negative impact is with respect to vibration caused by construction activities related to the construction of access roads and the underground collector line. It is recommended that construction activities be avoided within 60 m of identified cultural heritage resources. Where construction within 60 m cannot be avoided, it is recommended that maximum acceptable vibration levels, or peak particle velocity (PPV) levels, should be determined by a qualified engineer prior to any construction activities. Construction within the 60 m bufferzone should be monitored to ensure that acceptable PPV levels are not exceeded. All construction activities should cease if levels are exceeded until an acceptable solution can be identified.
