**RE: Grand Valley Wind Farms – Phase 3 Wind Project**  
**Location: Dufferin County**  
**FIT number: FIT-FBK61WV**  
**MTC DPR File no. 22EA019**

#### **9 RECOMMENDATIONS FOR FURTHER WORK**

GRAND VALLEY WIND FARMS – PHASE 3 WIND PROJECT  
HERITAGE ASSESSMENT REPORT

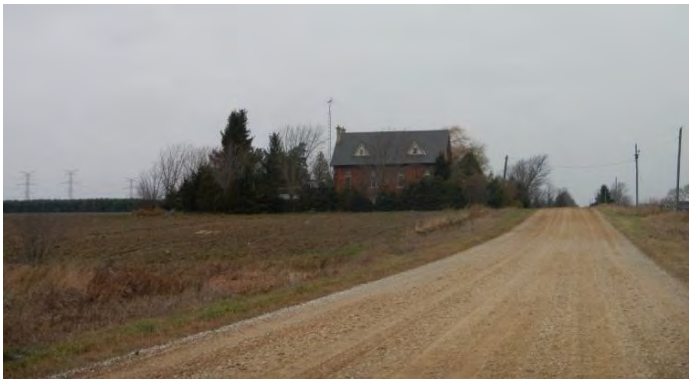
<b>Built Heritage Resource Name:</b> former Tarbet Presbyterian Church

<b>Municipal Address:</b> 114408 Sideroad 27/28		
<b>Lot:</b>	<b>Concession:</b>	
<b>Municipality:</b> Grand Valley		
<b>County/RM:</b> Dufferin		
<b>Resource Type:</b> Institutional		<b>Landmark (Y/N?)</b> Yes
<b>Associated Dates:</b> 1901 (labelstone, construction date)		
<b>Description of Resource (physical design):</b> Former church, now converted into residence, on west side of road. Gabled, brick and stone building remains generally unaltered, save for addition of gabled attic dormers. Design features include: four bay side elevations, featuring original lancet windows; front facade includes attic ventilator and label stone; central door with sidelights and shaped transom and hung windows with shaped brick voussoirs. Property heavily wooded and features large garden immediately to north; hedges along roadway.		
<b>Notable Features:</b> Original windows and doors; labelstone

<b>Associations:</b> Presbyterian church		
<b>Context:</b> Open, gently rolling terrain. Property set on small ridge, running east-east. Existing wind turbines to north and east. Grand River across road to east. Transmission line to west.		
<b>Completed by (name):</b> N. Oakley		<b>Heritage Resource/Landscape Number:</b>  BHR 2
<b>Date Completed:</b> Nov. 12, 2012

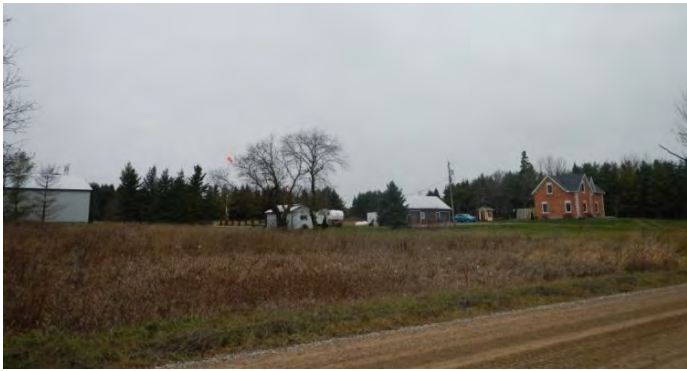
<b>Built Heritage Resource Name:</b> Grand Valley North Aerodrome

<b>Municipal Address:</b> 114520 Sideroad 27/28		
<b>Lot:</b>	<b>Concession:</b>	
<b>Municipality:</b> Grand Valley		
<b>County/RM:</b> Dufferin		
<b>Resource Type:</b> Airfield		<b>Landmark (Y/N?)</b> No
<b>Associated Dates:</b> No associated dates		
<b>Description of Resource (physical design):</b> Airfield located on west side of road. Structures include: a 1 1/2 storey, brick Gothic Revival farmhouse: a detached double garage; a gabled, steel hangar; and a couple of small sheds. House features: multiple gables, a lancet window; stone lintels; painted brick quoins and voussoirs; and vinyl windows. Property features a line of mature deciduous trees along road, wind socks and a runway running northwest/southeast. Rear of property is heavily wooded.		
<b>Notable Features:</b> Small, functioning airfield		
<b>Associations:</b> No known associations.

<b>Context:</b> Generally flat terrain. Open fields to south and north of property. Existing wind turbines to north and east; transmission line to west. South of Leggatt.		
<b>Completed by (name):</b> N. Oakley		<b>Heritage Resource/Landscape Number:</b>  CHL 11
<b>Date Completed:</b> Nov. 12, 2012

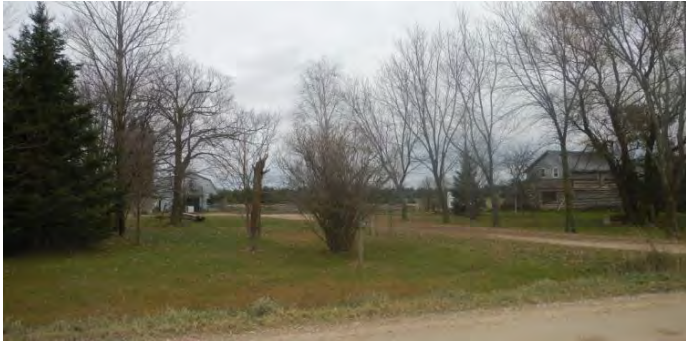
<b>Municipal Address:</b> 073333 Sideroad 24/25		
<b>Lot:</b>	<b>Concession:</b>	
<b>Municipality:</b> Grand Valley		
<b>County/RM:</b> Dufferin		
<b>Resource Type:</b> Farm complex		<b>Landmark (Y/N?)</b> No
<b>Associated Dates:</b> No associated dates		
<b>Description of Resource (physical design):</b> Farm complex located on east side of road. 1 1/2 storey log cabin features gable roof, rear addition and shingled upper storey. Outbuildings include a steel clad, gambrel roof barn with associated paddock area and concrete silo. Property is thickly treed, with a large stand of mature conifers to north.		
<b>Notable Features:</b> No notable features		
<b>Associations:</b> No known associations.		
<b>Context:</b> Open, generally flat terrain. Tree stand and transmission line to east. Small creek to south of property.		
<b>Completed by (name):</b> N. Oakley		<b>Heritage Resource/Landscape Number:</b>  BHR 3

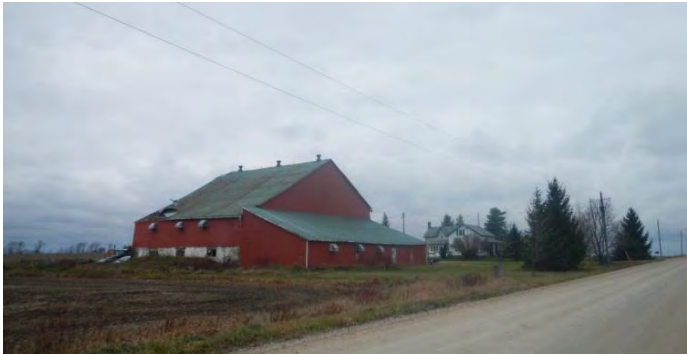
<b>Municipal Address:</b> 073346 Sideroad 24/25		
<b>Lot:</b>	<b>Concession:</b>	
<b>Municipality:</b> Grand Valley		
<b>County/RM:</b> Dufferin		
<b>Resource Type:</b> Farm complex		<b>Landmark (Y/N?)</b> No
<b>Associated Dates:</b> No associated dates		
<b>Description of Resource (physical design):</b> Farm complex located on west side of road. 1 1/2 storey vernacular farmhouse features: gable roof; front porch; and vinyl siding and windows. Outbuilding include: a large, gabled bank barn and a large steel garage. Several large conifers and deciduous trees are located along property line to north and around front lawn. Three large, concrete blocks located on front lawn along road.		
<b>Notable Features:</b> No notable features		
<b>Associations:</b> No known associations.		
<b>Context:</b> Generally flat, open terrain. Property surrounded by cultivated fields. Small creek to south. Replanted pine stand and transmission line to east.

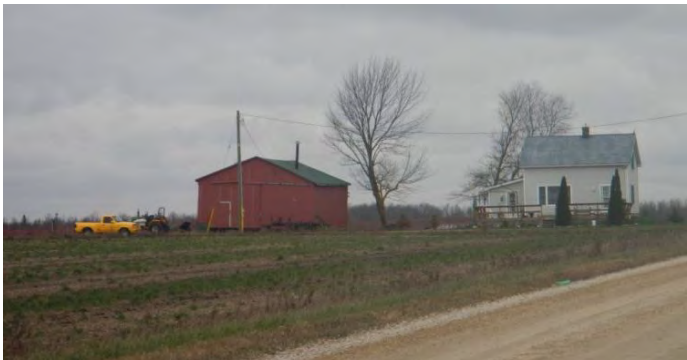
<b>Municipal Address:</b> 073506 Sideroad 24/25		
<b>Lot:</b>	<b>Concession:</b>	
<b>Municipality:</b> Grand Valley		
<b>County/RM:</b> Dufferin		
<b>Resource Type:</b> House		<b>Landmark (Y/N?)</b> No
<b>Associated Dates:</b> No associated dates		
<b>Description of Resource (physical design):</b> Farm complex located on west side of road. 1 1/2 storey vernacular farmhouse features: gable roof; central brick chimney; small rear addition; and vinyl siding and windows. Gable roofed, steel garage located to rear of house. Property generally open with a few deciduous trees located at the rear of the house. Tree break of small conifers to north of house.		
<b>Notable Features:</b> No notable features		
<b>Associations:</b> No known associations.		
<b>Context:</b> Open, gently rolling terrain. Property surrounded by cultivated fields. Reforested area across field to the west; transmission line to east.

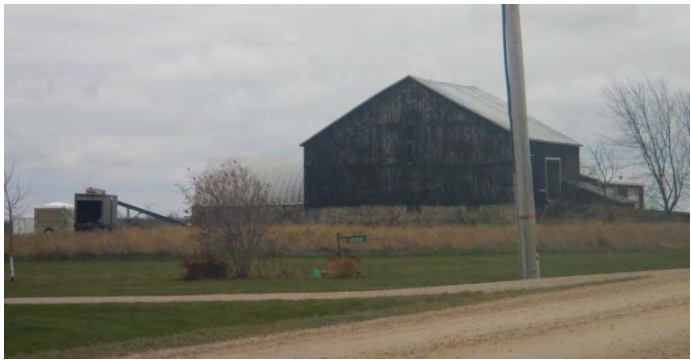
<b>Municipal Address:</b> 073515 Sideroad 24/25		
<b>Lot:</b>	<b>Concession:</b>	
<b>Municipality:</b> Grand Valley		
<b>County/RM:</b> Dufferin		
<b>Resource Type:</b> Farm complex		<b>Landmark (Y/N?)</b> No
<b>Associated Dates:</b> No associated dates		
<b>Description of Resource (physical design):</b> Farm complex located on east side of road. Property features: one storey, gable roof contemporary bungalow with vinyl siding and windows; large, gable roof bank barn; steel silos; and large steel garage. Some conifers and deciduous trees located around farmhouse; northern property line delineated by deciduous tree break.		
<b>Notable Features:</b> No notable features		
<b>Associations:</b> No known associations.		
<b>Context:</b> Open, gently rolling terrain. Reforested area to west, across field; transmission line to east.		
<b>Completed by (name):</b> N. Oakley		<b>Heritage Resource/Landscape Number:</b> does not meet criteria

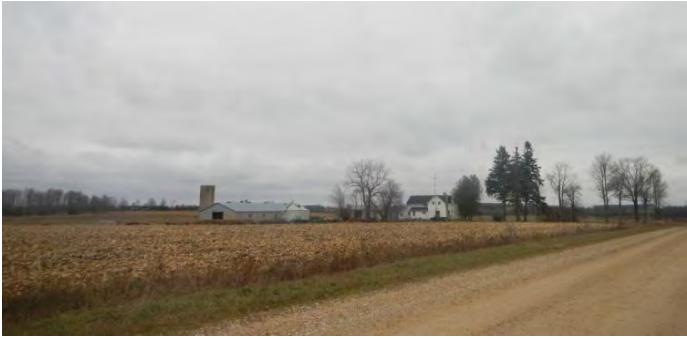
<b>Municipal Address:</b> 074430 Sideroad 24/25		
<b>Lot:</b>	<b>Concession:</b>	
<b>Municipality:</b> Grand Valley		
<b>County/RM:</b> Dufferin		
<b>Resource Type:</b> Farm complex		<b>Landmark (Y/N?)</b> No
<b>Associated Dates:</b> No associated dates		
<b>Description of Resource (physical design):</b> Farm complex located on west side of road. 1 1/2 storey Gothic Revival farmhouse features: faux stone cladding and quoins; large, vinyl clad rear addition; central door with transom; two chimneys; and vinyl windows. Outbuildings include: two large, gabled barns; a gabled, steel clad garage, and a concrete silo. Driveway and roadway lined with deciduous trees, with several large conifers around house.		
<b>Notable Features:</b> No notable features		
<b>Associations:</b> No known associations.		
<b>Context:</b> Open, rolling terrain. Property set on small incline. Drainage ditch to south of property, and creek to north.

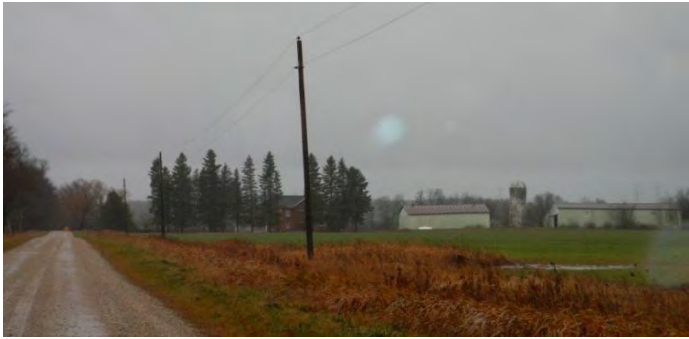
<b>Municipal Address:</b> 133184 Sideroad 29		
<b>Lot:</b>	<b>Concession:</b>	
<b>Municipality:</b> Grand Valley		
<b>County/RM:</b> Dufferin		
<b>Resource Type:</b> Farm complex		<b>Landmark (Y/N?)</b> No
<b>Associated Dates:</b> No associated dates		
<b>Description of Resource (physical design):</b> Farm complex located on west side of road. 2 storey brick farmhouse features: hipped roof; large rear addition; wraparound porch with gazebo; central brick chimney; vinyl windows. Outbuildings include several large, steel clad barns and a concrete silo. Tree break of mature conifers located immediately north of house. Large conifers and deciduous trees set in front lawn and along road.		
<b>Notable Features:</b> No notable features		
<b>Associations:</b> No known associations.		
<b>Context:</b> Open, gently rolling terrain. Property overlooks lightly treed area with small valley and creek immediately to the south. Transmission line to west. Mature trees along east side of Sideroad 29.

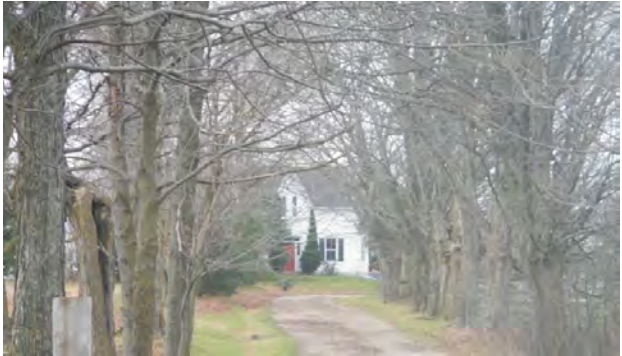
<b>Municipal Address:</b> unknown municipal address Sideroad 29		
<b>Lot:</b>	<b>Concession:</b>	
<b>Municipality:</b> Grand Valley		
<b>County/RM:</b> Dufferin		
<b>Resource Type:</b> House		<b>Landmark (Y/N?)</b> No
<b>Associated Dates:</b> No associated dates		
<b>Description of Resource (physical design):</b> Address unknown. 1 1/2 storey Gothic Revival cottage on east side of road, set at end of long driveway. Full visual assessment obscured. House features central doorway with sidelights and transom and two central lancet windows. Mature deciduous line both sides of driveway; property heavily treed.		
<b>Notable Features:</b> No notable features		
<b>Associations:</b> No known associations.		
<b>Context:</b> Open, gently rolling terrain. Property overlooks treed area and small creek immediately to the south. Transmission line to west. Mature trees along east side of Sideroad 29. Tree stand located to the east behind property.

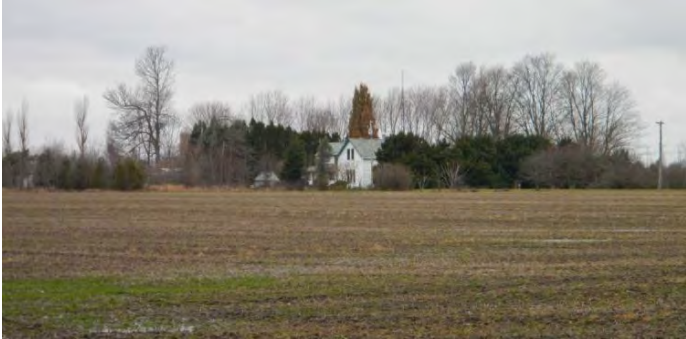
<b>Municipal Address:</b> 075094 Sideroad 24/25		
<b>Lot:</b>	<b>Concession:</b>	
<b>Municipality:</b> Grand Valley		
<b>County/RM:</b> Dufferin		
<b>Resource Type:</b> House		<b>Landmark (Y/N?)</b> No
<b>Associated Dates:</b> No associated dates		
<b>Description of Resource (physical design):</b> 1 1/2 storey, ell-shaped vernacular farmhouse located on west side of road, set at end of long driveway. Full visual assessment obscured. House site thickly treed, with mature conifers and deciduous trees. Small deciduous trees located along both sides of driveway.		
<b>Notable Features:</b> No notable features		
<b>Associations:</b> No known associations.		
<b>Context:</b> Open, gently rolling terrain. Small creek located immediately north of the property. Transmission line to north and east. Property surrounded by open fields.		
<b>Completed by (name):</b> N. Oakley		<b>Heritage Resource/Landscape Number:</b>  CHL 12

CHL12	075094 Sideroad 24/25	5	I	I	N	N	N	N	<ul style="list-style-type: none"> <li>• Avoid construction within a 60 m bufferzone of structures on the property;</li> <li>• in the event that construction within a 60 m bufferzone cannot be avoided, it is recommended that maximum acceptable vibration, or peak particle velocity (PPV), levels be determined by a qualified engineer prior to Project construction and that construction activities be monitored to ensure that maximum PPV levels are not exceeded.</li> </ul>
CHL13	South Luther Cemetery	9	N	N	N	N	N	N	No further mitigation recommended.
CHL14	193077 Amaranth/East Luther Townline	10	N	N	N	N	N	N	No further mitigation recommended.
CHL15	193377 Amaranth/East Luther Townline	8	N	N	N	N	N	N	No further mitigation recommended.
CHL16	282446 County Road 10	8	N	N	N	N	N	N	No further mitigation recommended.
CHL17	Upper Grand Trailway	9 and 10	N	N	N	N	N	N	No further mitigation recommended.

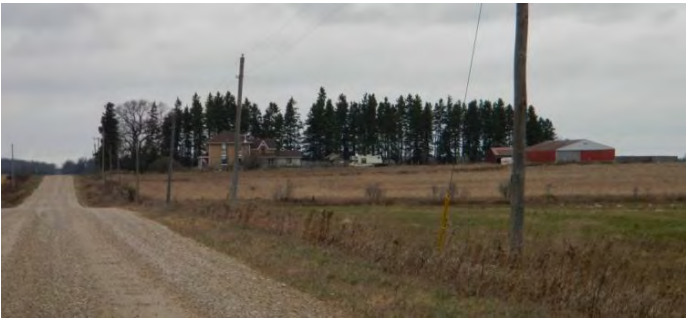
<b>Municipal Address:</b> 075293 Sideroad 24/25		
<b>Lot:</b>	<b>Concession:</b>	
<b>Municipality:</b> Grand Valley		
<b>County/RM:</b> Dufferin		
<b>Resource Type:</b> Farm complex		<b>Landmark (Y/N?)</b> No
<b>Associated Dates:</b> No associated dates		
<b>Description of Resource (physical design):</b> Farm complex located on east side of road. 2 storey brick vernacular farmhouse features: hipped roof; large rear addition; central front porch; and modern vinyl windows. Outbuildings include several steel barns and sheds. Property line demarcated by split rail fence. House site features a few small trees and bushes.		
<b>Notable Features:</b> No notable features		
<b>Associations:</b> No known associations.		
<b>Context:</b> Open, gently rolling terrain. Property set at top of small rise. Existing wind turbines visible to the east. Tree break of large conifers immediately north of house.

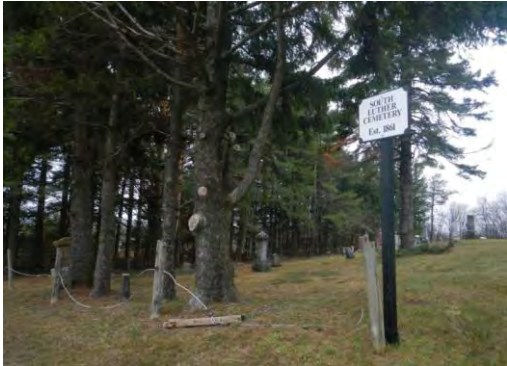
<b>Built Heritage Resource Name:</b> South Luther Cemetery

<b>Municipal Address:</b>		
<b>Lot:</b> 21	<b>Concession:</b> 3	
<b>Municipality:</b> Grand Valley		
<b>County/RM:</b> Dufferin		
<b>Resource Type:</b> Cemetery		<b>Landmark (Y/N?)</b> Yes
<b>Associated Dates:</b> 1861 (established)		
<b>Description of Resource (physical design):</b> Small cemetery set on hill on north side of road. Cemetery no longer in use and is maintained by the Town of Grand Valley. Site surrounded by mature conifers and deciduous trees. Some grave markers located among trees to west side of property. Small wood post and wire fence along south side of site.		
<b>Notable Features:</b> Grave markers dating back to 1877.		
<b>Associations:</b> Associated with the settlement and development of the local community.		
<b>Context:</b> Hilly terrain. Cemetery set at top of hill. Marshy ditch across road to south. Mix of treed areas and open fields in surrounding landscape.

<b>Completed by (name):</b> N. Oakley		<b>Heritage Resource/Landscape Number:</b>  CHL 13
<b>Date Completed:</b> Nov. 12, 2012

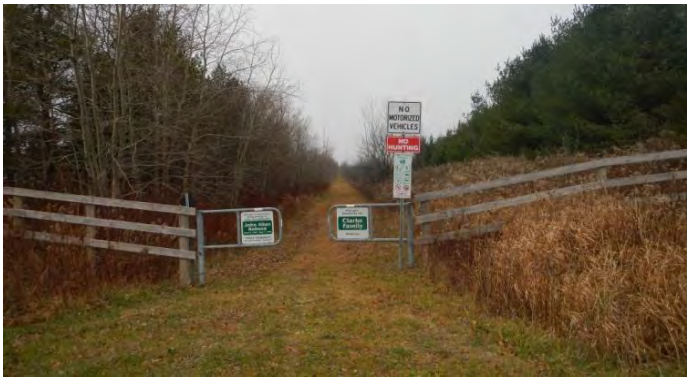
<b>Built Heritage Resource Name:</b> Upper Grand Trailway

<b>Municipal Address:</b> multiple		
<b>Lot:</b>	<b>Concession:</b>	
<b>Municipality:</b> Grand Valley		
<b>County/RM:</b> Dufferin		
<b>Resource Type:</b> Linear		<b>Landmark (Y/N?)</b> Yes
<b>Associated Dates:</b>		
<b>Description of Resource (physical design):</b> Former Toronto Grey and Bruce/CPR rail line converted to a 10.5km. Trailway begins in Waldemar and terminates at Sideroad 24/25, with an east-west alignment. Multiple trailheads where trailway crosses sideroads. Trail gates sponsored or donated by various members of the public, often in memoriam. Trailbed raised from surrounding landscape, and generally lined with bushes or trees.		
<b>Notable Features:</b> Comemorative trail gates.		
<b>Associations:</b> Associated with the construction and operation of the Toronto Grey and Bruce, later CPR, railway.		
<b>Context:</b> Passes through a variety of terrain, though generally open fields.

<b>Completed by (name):</b> N. Oakley		<b>Heritage Resource/Landscape Number:</b>  CHL 17
<b>Date Completed:</b> Nov. 12, 2012

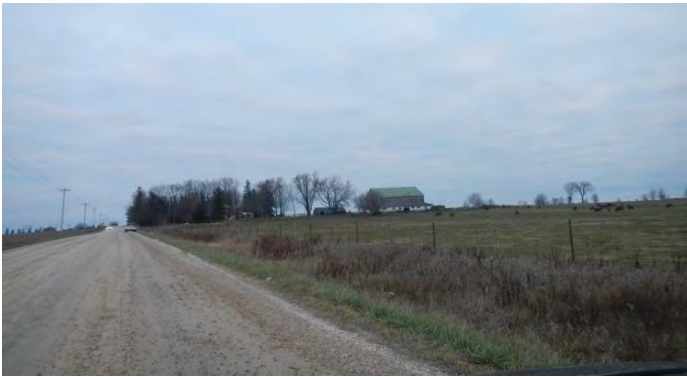
<b>Municipal Address:</b> 193031 Amaranth/East Luther Townline		
<b>Lot:</b>	<b>Concession:</b>	
<b>Municipality:</b> Amaranth		
<b>County/RM:</b> Dufferin		
<b>Resource Type:</b> Farm Complex		<b>Landmark (Y/N?)</b> No
<b>Associated Dates:</b> No associated dates.		
<b>Description of Resource (physical design):</b> Farm complex located on east side of road. 2 storey brick vernacular farmhouse features: hipped roof; rear addition; gabled attic dormer on south elevation; and front porch with balcony and bargeboard detailing. Visual assessment of house obscured. Outbuildings include: a large, gabled barn with stone foundation to rear; and large gable shed between house and barn. House surrounded by mature conifers and deciduous trees. Wooden split rail fencing around paddock at barn and along property line to south.		
<b>Notable Features:</b> No notable features.

<b>Associations:</b> No known associations.		
<b>Context:</b> Open, gently rolling terrain. Line of mature conifers along County Road 109 to south.		
<b>Completed by (name):</b> N. Oakley		<b>Heritage Resource/Landscape Number:</b> does not meet criteria
<b>Date Completed:</b> Nov. 12, 2012

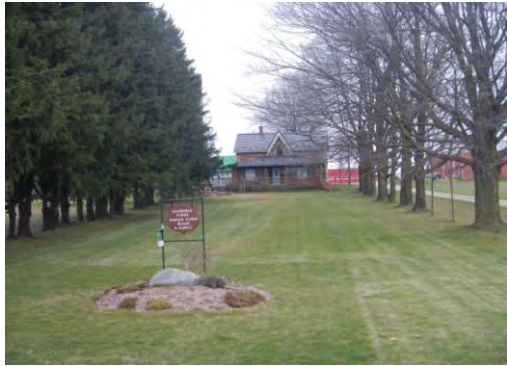
<b>Built Heritage Resource Name:</b> Loamfield Farms

<b>Municipal Address:</b> 193077 Amaranth/East Luther Townline		
<b>Lot:</b>	<b>Concession:</b>	
<b>Municipality:</b> Amaranth		
<b>County/RM:</b> Dufferin		
<b>Resource Type:</b> Farm complex		<b>Landmark (Y/N?)</b> No
<b>Associated Dates:</b> No associated dates.		
<b>Description of Resource (physical design):</b> Farm complex located on east side of road. 1 1/2 storey brick Gothic Revival farmhouse features: dichromatic brickwork including banding, quoins, and voussoirs; central lancet window; bargeboard at gables; and one storey front addition. Outbuildings include: two large, gabled steel barns at rear of property; smaller shed/garage near house; and concrete silo. Southern property line demarcated by split rail fence. Front lawn demarcated by line of mature conifer and deciduous trees.		
<b>Notable Features:</b> No notable features.

<b>Associations:</b> No known associations.		
<b>Context:</b> Open, gently rolling terrain. Contemporary infill residence with associated industrial building across road to west, with some trees. Line of trees at far end of western field behind contemporary house. Ridge to west, across fields.		
<b>Completed by (name):</b> N. Oakley		<b>Heritage Resource/Landscape Number:</b>  CHL 14
<b>Date Completed:</b> Nov. 12, 2012

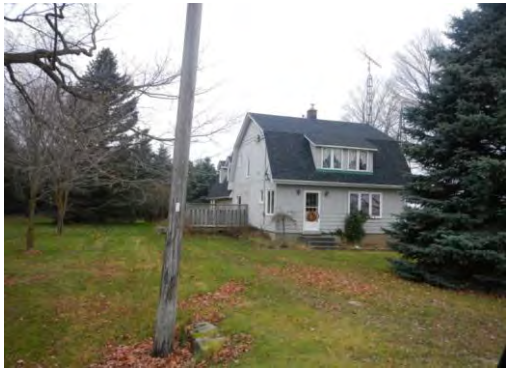
<b>Municipal Address:</b> 193098 Amaranth/East Luther Townline		
<b>Lot:</b>	<b>Concession:</b>	
<b>Municipality:</b> Grand Valley		
<b>County/RM:</b> Dufferin		
<b>Resource Type:</b> Farm Complex		<b>Landmark (Y/N?)</b> No
<b>Associated Dates:</b> No associated dates.		
<b>Description of Resource (physical design):</b> Farm complex located on west side of road. 1 1/2 storey farmhouse features: gambrel roof; shedded front dormer; central chimney; and vinyl windows and cladding. Outbuildings include: a large, gabled barn set on a stone foundation and a gabled garage. Property features line of large deciduous trees along road, three stone markers at driveway, and a former driveway to south of building.		
<b>Notable Features:</b> No notable features.		
<b>Associations:</b> No known associations.		
<b>Context:</b> Open, gently rolling terrain. Small, treed valley located to west. Large hill/valley to north.

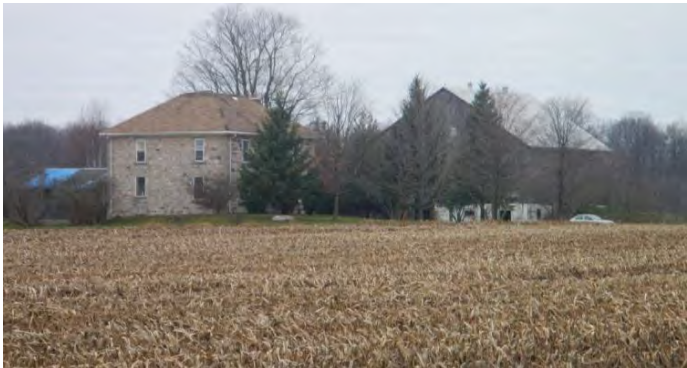
<b>Municipal Address:</b> 193377 Amaranth/East Luther Townline		
<b>Lot:</b>	<b>Concession:</b>	
<b>Municipality:</b> Grand Valley		
<b>County/RM:</b> Dufferin		
<b>Resource Type:</b> Farm Complex		<b>Landmark (Y/N?)</b> No
<b>Associated Dates:</b> No associated dates.		
<b>Description of Resource (physical design):</b> Farm complex located on west side of road, set on long driveway. Two storey stone farmhouse features: hipped roof; stone quoins; overhang above central front door; and offset brick chimney. Outbuildings include: large, gabled bank barn and small shed. Line of mature deciduous trees line driveway and road. Several conifers and deciduous trees set around house.		
<b>Notable Features:</b> Stone house construction		
<b>Associations:</b> No known associations.		
<b>Context:</b> Open, gently rolling terrain. Property set on a small rise. Town of Grand Valley water tower and treed valley to west.

<b>Completed by (name):</b> N. Oakley		<b>Heritage Resource/Landscape Number:</b>  CHL 15
<b>Date Completed:</b> Nov. 12, 2012

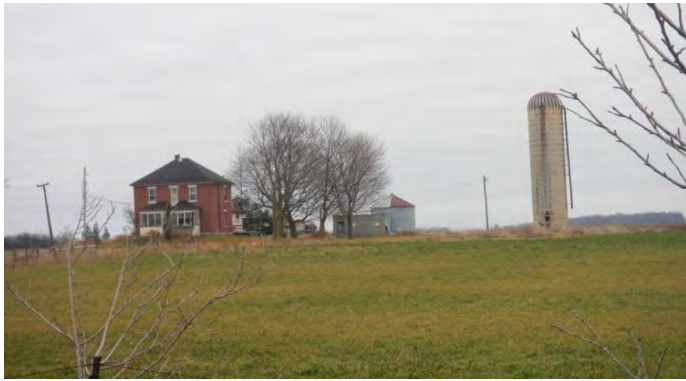
<b>Municipal Address:</b> 193415 Amranth/East Luther Townline		
<b>Lot:</b>	<b>Concession:</b>	
<b>Municipality:</b> Amaranth		
<b>County/RM:</b> Dufferin		
<b>Resource Type:</b> House		<b>Landmark (Y/N?)</b> No
<b>Associated Dates:</b> No associated dates.		
<b>Description of Resource (physical design):</b> Two storey, brick vernacular farmhouse on east side of road, set on long driveway. House features: hipped roof; enclosed front porch with original windows; stone lintels and shaped window headers; and rear extension. Associated shed and steel and concrete silos to rear of property. Wood fence along south side of long driveway. A few deciduous trees near house and along north side of driveway.		
<b>Notable Features:</b> No notable features.		
<b>Associations:</b> No known associations.		
<b>Context:</b> Open, gently rolling terrain. Small creek to south.

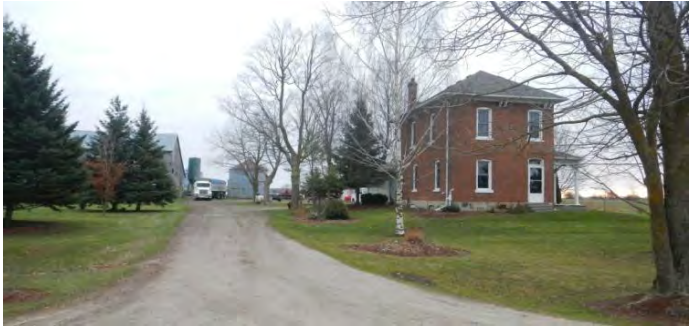
<b>Municipal Address:</b> 193457 Amaranth/East Luther Townline		
<b>Lot:</b>	<b>Concession:</b>	
<b>Municipality:</b> Amaranth		
<b>County/RM:</b> Dufferin		
<b>Resource Type:</b> Farm Complex		<b>Landmark (Y/N?)</b> No
<b>Associated Dates:</b> No associated dates.		
<b>Description of Resource (physical design):</b> Farm complex located on east side of road. Two storey, ell-shaped brick vernacular farmhouse features: front porch with bargeboarding; bracketed eaves; stone lintels and brick voussoirs; vinyl windows; and a one storey rear addition. Outbuildings include: a large, gabled bank barn; large gabled steel barn; and several steel silos. Small and large trees in front lawn and along road.		
<b>Notable Features:</b> No notable features.		
<b>Associations:</b> No known associations.		
<b>Context:</b> Open, gently rolling terrain. Tree stand to northwest of property.

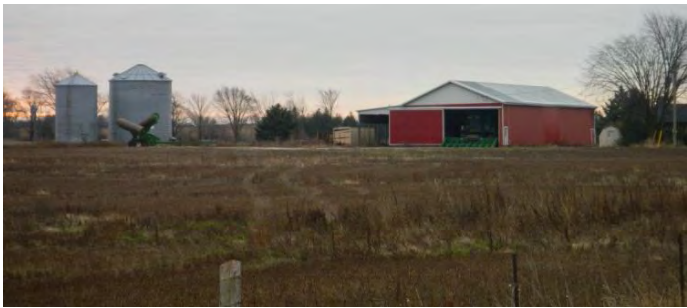
<b>Municipal Address:</b> 194003 Amaranth/East Luther Townline		
<b>Lot:</b>	<b>Concession:</b>	
<b>Municipality:</b> Amaranth		
<b>County/RM:</b> Dufferin		
<b>Resource Type:</b> Farm Complex		<b>Landmark (Y/N?)</b> No
<b>Associated Dates:</b> No associated dates.		
<b>Description of Resource (physical design):</b> Farm complex located on east side of road. Full visual assessment obscured. 1 1/2 storey vernacular farmhouse features green vinyl or metal cladding and several one storey additions to rear of house. Outbuildings include a large, steel clad gabled barn and several steel silos. House set among thick stand of mature conifers.		
<b>Notable Features:</b> No notable features.		
<b>Associations:</b> No known associations.		
<b>Context:</b> Open, gently rolling landscape. Property set on curve in road as it meets County Road 10.		
<b>Completed by (name):</b> N. Oakley		<b>Heritage Resource/Landscape Number:</b> does not meet criteria

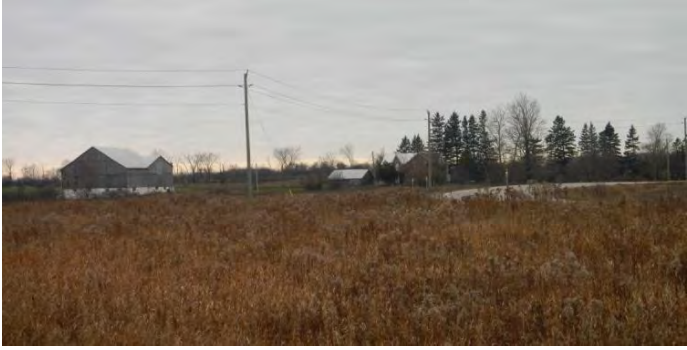
<b>Municipal Address:</b> 282446 County Road 10		
<b>Lot:</b>	<b>Concession:</b>	
<b>Municipality:</b> Grand Valley		
<b>County/RM:</b> Dufferin		
<b>Resource Type:</b> Farm Complex		<b>Landmark (Y/N?)</b> No
<b>Associated Dates:</b> No associated dates.		
<b>Description of Resource (physical design):</b> Farm complex located on south side of road. 1 1/2 storey Gothic Revival farmhouse features: dichromatic brick detailing, including banding and decorative elements, and ornate voussoirs; lancet windows; and gabled bargeboard. Outbuildings include: large, gabled wood barn; small gabled shed behind house; and a concrete silo. A few small deciduous and conifers located around house and along driveway. Tree break of mature conifers delineate western property boundary.		
<b>Notable Features:</b> dichromatic brickwork; gabled bargeboard		
<b>Associations:</b> No known associations.

<b>Context:</b> Open, gently rolling terrain; large tree stand to south. Property located near curve in highway as it meets Amaranth/East Luther Townline.		
<b>Completed by (name):</b> N. Oakley		<b>Heritage Resource/Landscape Number:</b>  CHL 16
<b>Date Completed:</b> Nov. 12, 2012

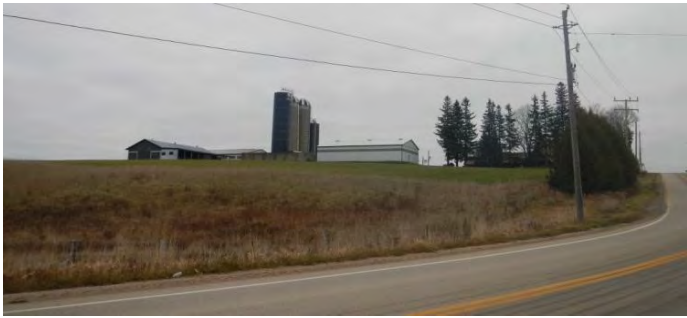
<b>Built Heritage Resource Name:</b> Mauzener Farm

<b>Municipal Address:</b> 282393 County Road 10		
<b>Lot:</b>	<b>Concession:</b>	
<b>Municipality:</b> Grand Valley		
<b>County/RM:</b> Dufferin		
<b>Resource Type:</b> Farm complex		<b>Landmark (Y/N?)</b> Yes
<b>Associated Dates:</b> No associated dates.		
<b>Description of Resource (physical design):</b> Large farm complex located on north side of road. 1 1/2 storey log farmhouse features: central brick chimney; two front gabled dormers with board and batten siding; and two one storey rear additions. House appears to be of contemporary construction. Outbuildings include a complex of several large, steel barns, and concrete and steel silos. Several large conifers and deciduous trees set around house and front lawn.		
<b>Notable Features:</b> No notable features.		
<b>Associations:</b> No known associations.		
<b>Context:</b> Generally open, hilly terrain. Property set on hill overlooking Grand River and County Road 25.

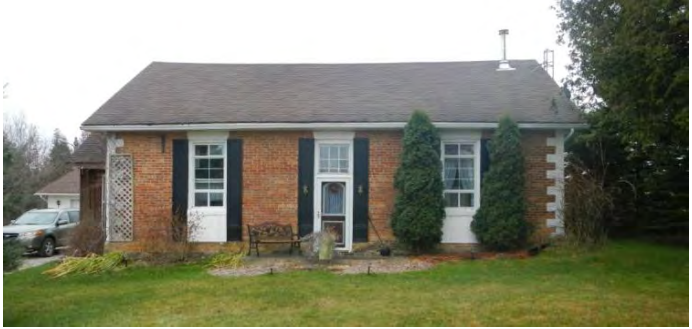
<b>Municipal Address:</b> 282358 Concession 4/5		
<b>Lot:</b>	<b>Concession:</b>	
<b>Municipality:</b> Grand Valley		
<b>County/RM:</b> Dufferin		
<b>Resource Type:</b> House	<b>Landmark (Y/N?)</b> Yes	
<b>Associated Dates:</b> No associated dates.		
<b>Description of Resource (physical design):</b> Former schoolhouse, converted into residence, on south side of road. One storey gabled brick structure features: painted brick quoins and voussoirs; central front door with transom; enclosed front portico; and gabled garage to rear. Large sideyard with trees and bushes along road.		
<b>Notable Features:</b> No notable features.		
<b>Associations:</b> No known associations.		
<b>Context:</b> Generally open terrain. Property set near bottom of valley, with Grand River to east.		
<b>Completed by (name):</b> N. Oakley	<b>Heritage Resource/Landscape Number:</b>	
<b>Date Completed:</b> Nov. 12, 2012	BHR 4

BHR4	282358 Concession 4/5	8	N	N	N	N	N	N	No further mitigation recommended.
BHR5	503270 Highway 89	2	N	N	N	N	N	N	No further mitigation recommended.
BHR6	Highway 89	2	N	N	N	N	N	N	No further mitigation recommended.
BHR7	Gandier Church	3	N	N	N	N	N	N	No further mitigation recommended.
BHR8	502098 Highway 89	2	N	N	N	N	R	N	No further mitigation recommended.
BHR9	402087 County Road 15	5	N	N	N	N	N	N	No further mitigation recommended.
BHR10	402343 County Road 15	4	N	N	N	N	N	N	No further mitigation recommended.
BHR11	174521 County Road 25	6	N	N	N	N	N	N	No further mitigation recommended.
BHR12	Former Erasmus (Wesley) Post Office	3	I	I	N	N	N	N	<ul style="list-style-type: none"> <li>• Avoid construction within a 60 m bufferzone of structures on the property;</li> <li>• in the event that construction within a 60 m bufferzone cannot be avoided, it is recommended that maximum acceptable vibration, or peak particle velocity (PPV), levels be determined by a qualified engineer prior to Project construction and that construction activities be monitored to ensure that maximum PPV levels are not exceeded.</li> </ul>

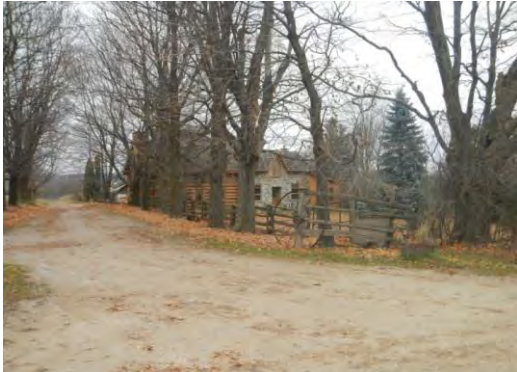
<b>Municipal Address:</b> 282331 Concession 4/5		
<b>Lot:</b>	<b>Concession:</b>	
<b>Municipality:</b> Grand Valley		
<b>County/RM:</b> Dufferin		
<b>Resource Type:</b> Linear		<b>Landmark (Y/N?)</b> No
<b>Associated Dates:</b> No associated dates.		
<b>Description of Resource (physical design):</b> Farm complex located on north side of road. Features one and a half storey farmhouse: either contemporary construction or contemporary cladding of logs and faux stone. Property also features a large, gabled wood barn with several additions and a gabled steel garage and paddock. Driveway and road lined with large deciduous trees, and several conifers and deciduous trees are located throughout the property. Property boundaries demarcated by split rail fencing.		
<b>Notable Features:</b> No notable features.		
<b>Associations:</b> No known associations.		
<b>Context:</b> Set on hill overlooking valley of Grand River. Open fields and gently rolling terrain to north, south and west. Turbines visible to north.

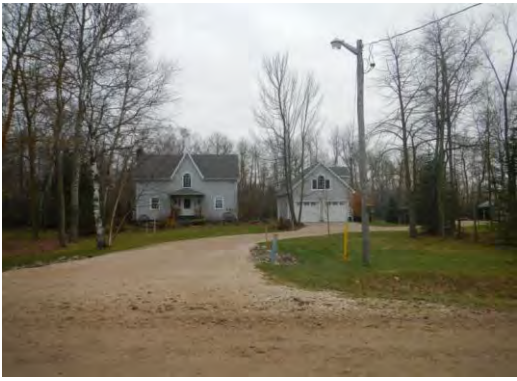
<b>Municipal Address:</b> 282252 Concession 4/5		
<b>Lot:</b>	<b>Concession:</b>	
<b>Municipality:</b> Grand Valley		
<b>County/RM:</b> Dufferin		
<b>Resource Type:</b> House		<b>Landmark (Y/N?)</b> No
<b>Associated Dates:</b> No associated dates.		
<b>Description of Resource (physical design):</b> 1 1/2 storey Gothic Revival cottage located on south side of road. House features: board and batten siding; central front door with porch and sidelights; and vinyl windows. Site also features 1 1/2 storey garage with two gabled attic dormers. Property is heavily wooded.		
<b>Notable Features:</b> No notable features.		
<b>Associations:</b> No known associations.		
<b>Context:</b> Generally flat, open fields to north, west and east; heavily wooded lot to south. Small irrigation/drainage ditch along west side of property.		
<b>Completed by (name):</b> N. Oakley		<b>Heritage Resource/Landscape Number:</b> does not meet criteria

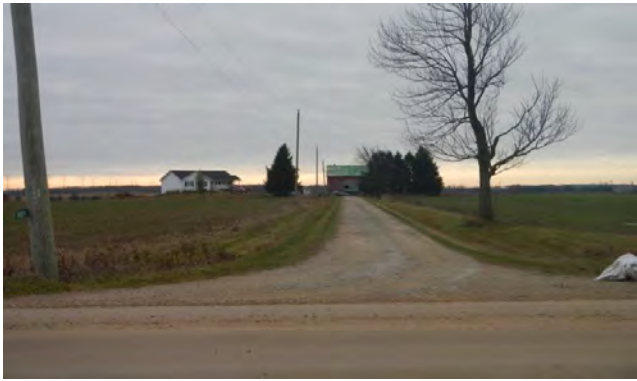
<b>Municipal Address:</b> 282050 Concession 4/5		
<b>Lot:</b>	<b>Concession:</b>	
<b>Municipality:</b> Grand Valley		
<b>County/RM:</b> Dufferin		
<b>Resource Type:</b> Farm complex		<b>Landmark (Y/N?)</b> No
<b>Associated Dates:</b> No associated dates.		
<b>Description of Resource (physical design):</b> Farm complex, including two houses and associated outbuildings, located on south side of road, east on long driveway. Contemporary bungalow located east of older farmhouse. Two storey brick vernacular farmhouse features: hipped roof; chimneys at centre and to southeast of house; and enclosed two storey corner balcony. Older farmhouse site surrounded by mature conifers. Large gabled barn and two gabled steel sheds to rear.		
<b>Notable Features:</b> No notable features.		
<b>Associations:</b> No known associations.		
<b>Context:</b> Flat, open terrain. Property surrounded by fields. Transmission line to east.

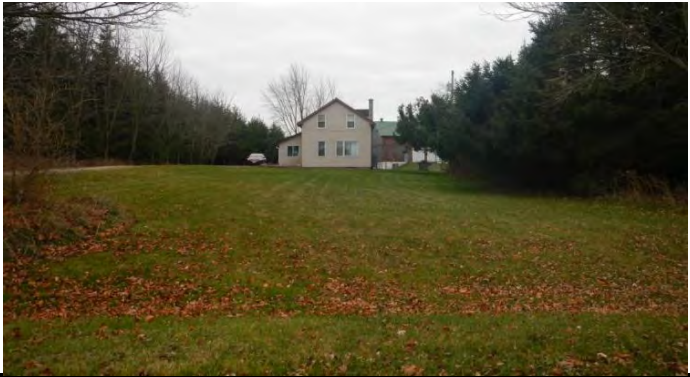
<b>Municipal Address:</b> 281314 Concession 4/5		
<b>Lot:</b>	<b>Concession:</b>	
<b>Municipality:</b> Grand Valley		
<b>County/RM:</b> Dufferin		
<b>Resource Type:</b> House		<b>Landmark (Y/N?)</b> No
<b>Associated Dates:</b> No associated dates.		
<b>Description of Resource (physical design):</b> House located on south side of road, at dead end. 1 1./ storey vernacular farmhouse, features vinyl cladding and windows. Large, gabled bank barn at rear of property. Thick tree break of mature conifers along east and west property lines.		
<b>Notable Features:</b> No notable features.		
<b>Associations:</b> No known associations.		
<b>Context:</b> Gently rolling terrain. Treed lot to west, north, and east. Property set at top of small ridge running north-south.		
<b>Completed by (name):</b> N. Oakley		<b>Heritage Resource/Landscape Number:</b> does not meet criteria

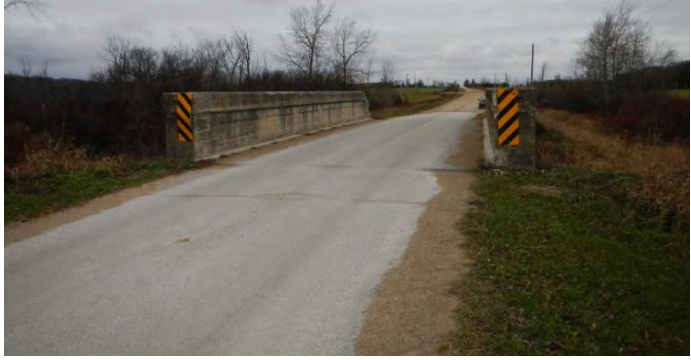
<b>Municipal Address:</b> Black Creek and Sideroad 24/25		
<b>Lot:</b>	<b>Concession:</b>	
<b>Municipality:</b> Grand Valley		
<b>County/RM:</b> Dufferin		
<b>Resource Type:</b> Bridge		<b>Landmark (Y/N?)</b> No
<b>Associated Dates:</b> No associated dates.		
<b>Description of Resource (physical design):</b> Bridge over small creek, constructed from reinforced, poured concrete. Minor relief detailing, possibly dated to mid-20th century.		
<b>Notable Features:</b> No notable features.		
<b>Associations:</b> No known associations.		
<b>Context:</b> Gently rolling terrain. Creek in small, tree-lined valley; surrounded by open, cultivated fields.		
<b>Completed by (name):</b> N. Oakley		<b>Heritage Resource/Landscape Number:</b> does not meet criteria
<b>Date Completed:</b> Nov. 12, 2012

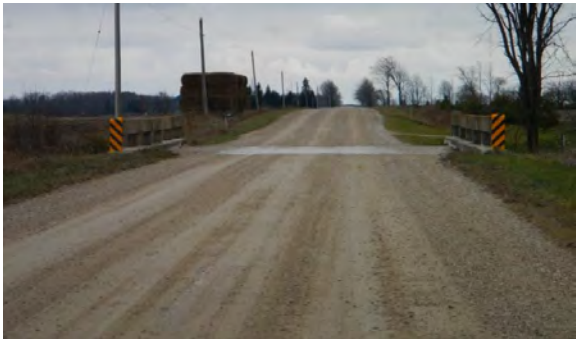
<b>Municipal Address:</b> Sideroad 24/25		
<b>Lot:</b>	<b>Concession:</b>	
<b>Municipality:</b> Grand Valley		
<b>County/RM:</b> Dufferin		
<b>Resource Type:</b> Bridge		<b>Landmark (Y/N?)</b> No
<b>Associated Dates:</b> No associated dates.		
<b>Description of Resource (physical design):</b> Bridge over drainage ditch, constructed from reinforced, poured concrete; barrier on six posts, set on foundation. Possibly dated to mid-20th century.		
<b>Notable Features:</b> No notable features.		
<b>Associations:</b> No known associations.		
<b>Context:</b> Gently rolling terrain. Some trees along drainage ditch; surrounded by open, cultivated fields.		
<b>Completed by (name):</b> N. Oakley		<b>Heritage Resource/Landscape Number:</b> does not meet criteria
<b>Date Completed:</b> Nov. 12, 2012

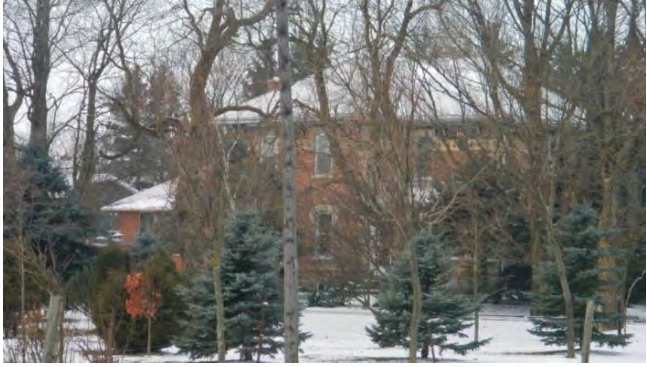
<b>Municipal Address:</b> 503270 Highway 89		
<b>Lot:</b>	<b>Concession:</b>	
<b>Municipality:</b> Grand Valley		
<b>County/RM:</b> Dufferin		
<b>Resource Type:</b> Farm Complex		<b>Landmark (Y/N?)</b> No
<b>Associated Dates:</b> 1899 (date of establishment)		
<b>Description of Resource (physical design):</b> Farm complex located on south side of road. 2 storey, ell-shaped brick farmhouse features: hipped roof; dichromatic brickwork including banding and voussoirs; dual eave brackets; rear one storey addition; and three bay front façade. Outbuildings include a large gable bank barn and garage at rear of property. Rail fence along road. Large conifer tree break along western property line; several large conifers and deciduous trees around house.		
<b>Notable Features:</b> Dichromatic brickwork; bracketed eaves		
<b>Associations:</b> No known associations.

<b>Context:</b> Gently rolling landscape; complex is set at top of small rise along Highway 89. Open fields to east, west and south; line of mature conifers along north side of road. Turbines to south and southwest.		
<b>Completed by (name):</b> N. Oakley		<b>Heritage Resource/Landscape Number:</b>  BHR 5
<b>Date Completed:</b> Dec. 3, 2012

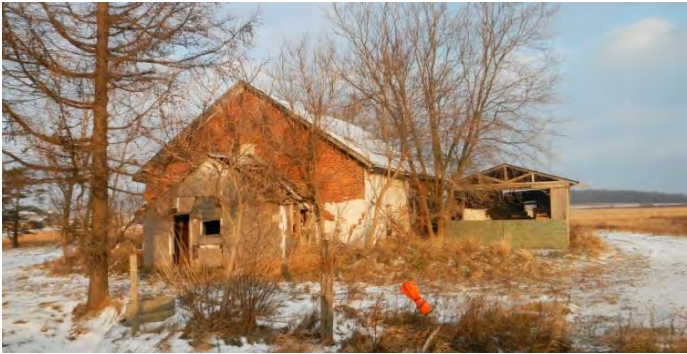
<b>Municipal Address:</b> Highway 89		
<b>Lot:</b>	<b>Concession:</b>	
<b>Municipality:</b> Melancthon		
<b>County/RM:</b> Dufferin		
<b>Resource Type:</b> Institution		<b>Landmark (Y/N?)</b> Yes
<b>Associated Dates:</b>		
<b>Description of Resource (physical design):</b> Former schoolhouse or church located on north side of road. One storey, gable roof brick structure in poor condition; features front portico and small side addition, three bay side elevations, and cracking plaster cladding. Labelstone is indecipherable. Small shed to east of structure.		
<b>Notable Features:</b> labelstone		
<b>Associations:</b> Associated with the settlement and development of the local community.		
<b>Context:</b> Gently rolling landscape; building set at curve in highway. Surrounded by open fields; turbines located to the north and south.		
<b>Completed by (name):</b> N. Oakley		<b>Heritage Resource/Landscape Number:</b>  BHR 6

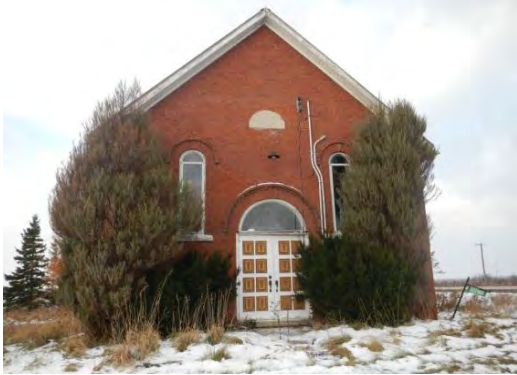
<b>Built Heritage Resource Name:</b> Gandier Church

<b>Municipal Address:</b> 502180 Highway 89		
<b>Lot:</b>	<b>Concession:</b>	
<b>Municipality:</b> Grand Valley		
<b>County/RM:</b> Dufferin		
<b>Resource Type:</b> Church		<b>Landmark (Y/N?)</b> Yes
<b>Associated Dates:</b> 1916 (established)		
<b>Description of Resource (physical design):</b> One storey, gable roof brick church on south side of road. Design features include: labelstone; brick voussoirs and stone lintels; ornate front doors with transom; and brick chimney. Labelstone reads: "Gandier Church, 1916, Keldon". Small parking lot to south of building; a few small bushes are located at the front entrance and along the road. Several of the original hung windows have been replaced.		
<b>Notable Features:</b> Labelstone; ornate front doors; brick voussoirs and stone lintels.		
<b>Associations:</b> Associated with the settlement and development of the local community. Associated with Alfred Gandier, a student at Knox College who began Presbyterian services in the area in 1881. Gandier later became principal of both Knox and Emmanuel Colleges. The original church was erected in 1886, but was destroyed by a forest fire the following year.

<b>Context:</b> Open, gently rolling terrain. Turbines visible to southeast. Contemporary bungalow immediately to south.		
<b>Completed by (name):</b> N. Oakley		<b>Heritage Resource/Landscape Number:</b>  <div style="text-align: right;">BHR 7</div>
<b>Date Completed:</b> Dec. 3, 2012

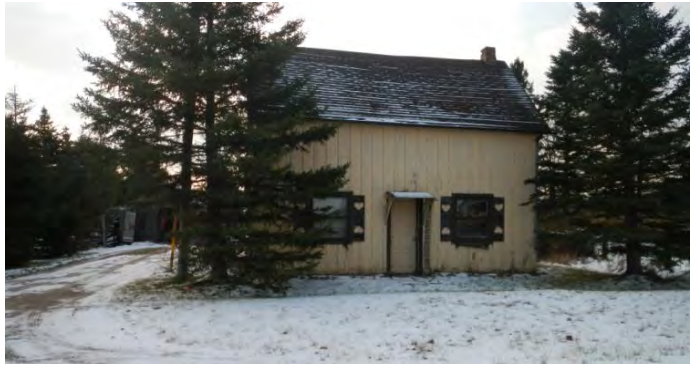
<b>Municipal Address:</b> 502098 Highway 89		
<b>Lot:</b>	<b>Concession:</b>	
<b>Municipality:</b> Grand Valley		
<b>County/RM:</b> Dufferin		
<b>Resource Type:</b> House		<b>Landmark (Y/N?)</b> No
<b>Associated Dates:</b>		
<b>Description of Resource (physical design):</b> Simple, 1 1/2 storey gable roof cottage. Design features include: board and batten siding; brick chimney; narrow, central front door flanked by hung windows; and rear addition.		
<b>Notable Features:</b> Narrow front door and simple design suggests early construction; located in Keldon.		
<b>Associations:</b> Associated with the settlement and development of Keldon, a historic settlement on the banks of the Grand River.		
<b>Context:</b> property set on western bank of the Grand River in Keldon. Treed lot located to south, and open fields to north.		
<b>Completed by (name):</b> N. Oakley		<b>Heritage Resource/Landscape Number:</b>  BHR 8

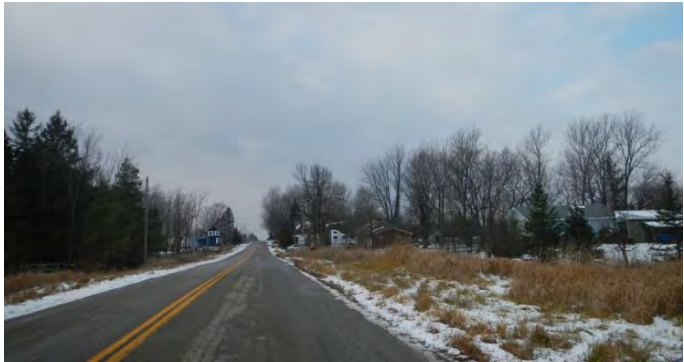
<b>Municipal Address:</b> Monticello		
<b>Lot:</b>	<b>Concession:</b>	
<b>Municipality:</b> Grand Valley		
<b>County/RM:</b> Dufferin		
<b>Resource Type:</b> Cultural Heritage Landscape		<b>Landmark (Y/N?)</b> Yes
<b>Associated Dates:</b>		
<b>Description of Resource (physical design):</b> Monticello Cultural Heritage Landscape is located at the intersection of County Road 15 and Sideroad 21/22. The area was first settled in the mid- to late-19th century. Among the early settlers to the area was Frank L. Holmes, who named Monticello after the town in the United States from which he had emigrated. Holmes also established a post office in 1878 at the northeast corner of the intersection: a building which still stands today. Contemporary residential infill is located along County Road 15 to the east and west of the intersection.		
<b>Notable Features:</b> former Monticello Post Office, 1 1/2 storey Gothic Revival farmhouse established 1878

<b>Associations:</b> Associated with the settlement and development of the local community. Further associated with the Monticello United Church Cultural Heritage Landscape.		
<b>Context:</b> Monticello Cultural Heritage Landscape is located at the intersection of County Road 15 and Sideroad 21/22. Gently rolling terrain; transmission line located to north of settlement; surrounded by fields; Luther Swamp is located to the southwest.		
<b>Completed by (name):</b> N. Oakley		<b>Heritage Resource/Landscape Number:</b>  <div style="text-align: right;">CHL 18</div>
<b>Date Completed:</b> Dec. 3, 2012

CHL18	Monticello	5	N	N	N	N	N	N	No further mitigation recommended.
CHL19	Monticello United Church	5	N	N	N	N	N	N	No further mitigation recommended.
CHL20	401256 County Road 15	5	N	N	N	N	N	N	No further mitigation recommended.
CHL21	402078 County Road 15	5	N	N	N	N	N	N	No further mitigation recommended.
CHL22	Colbeck	5	N	N	N	N	N	N	No further mitigation recommended.
CHL23	402252 County Road 15	6	N	N	N	N	R	N	No further mitigation recommended.
CHL24	402287 County Road 15	6	N	N	N	N	R	N	No further mitigation recommended.
CHL25	173056 County Road 25	10	N	N	N	N	N	N	No further mitigation recommended.

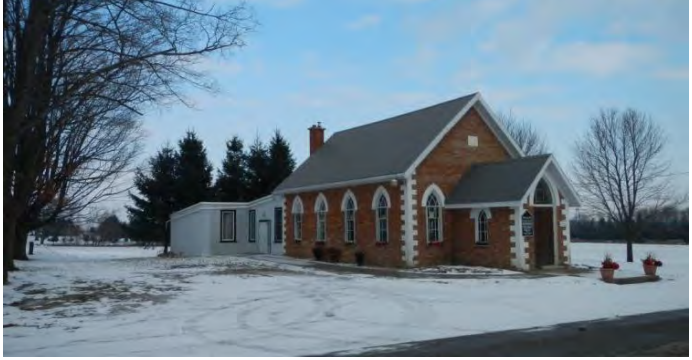
<b>Built Heritage Resource Name:</b> Monticello United Church

<b>Municipal Address:</b> 401247 County Road 15		
<b>Lot:</b> 23	<b>Concession:</b> 10 and 11	
<b>Municipality:</b> Grand Valley		
<b>County/RM:</b> Dufferin		
<b>Resource Type:</b> Cultural Heritage Landscape		<b>Landmark (Y/N?)</b> Yes
<b>Associated Dates:</b> 1883 (establishment of church)		
<b>Description of Resource (physical design):</b> Monticello United Church Cultural Heritage Landscape is located on both sides of County Road 15. The Cultural Heritage Landscape consists of the United Church, Parsonage and Cemetery. The Church was constructed in 1883, using brick hauled from the Fuller brickyard in East Garafraxa, and timber from the George Wood farm which was sawn by the Billings Bros.		
<b>Notable Features:</b> Monticello United Church features: painted stone quoins; a front portico with large front door and arched transom; original, arched hung windows; and a labelstone. Monticello parsonage features: stone quoins and lintels; dual bracketed eaves; 3-

<b>Associations:</b> Associated with the settlement and development of the local community. Many reverends who serviced the local area lived at the parsonage over the years. Associated with Jas. Colbeck, an early settler in the area who sold the land used for the cemetery and was the first interred there.		
<b>Context:</b> Gently rolling landscape, surrounded by open fields. Transmission line to north.		
<b>Completed by (name):</b> N. Oakley		<b>Heritage Resource/Landscape Number:</b>  <div style="text-align: right;">CHL 19</div>
<b>Date Completed:</b> Dec. 3, 2012

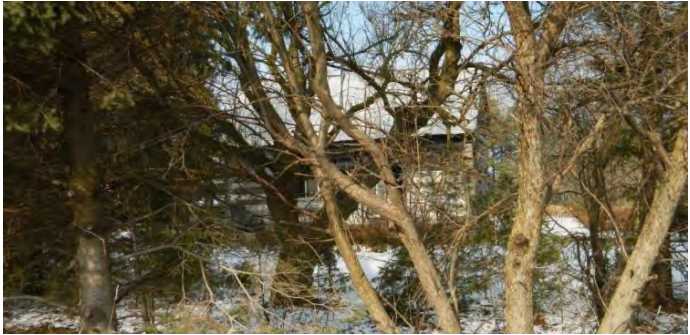
<b>Municipal Address:</b> 402087 County Road 15		
<b>Lot:</b> 26	<b>Concession:</b> 11	
<b>Municipality:</b> Grand Valley		
<b>County/RM:</b> Dufferin		
<b>Resource Type:</b> House		<b>Landmark (Y/N?)</b> No
<b>Associated Dates:</b> No known associated dates.		
<b>Description of Resource (physical design):</b> One storey log cabin on north side of road. Full visual assessment obscured by thick bush and trees along road.		
<b>Notable Features:</b> Rare example of log construction in area.		
<b>Associations:</b> Associated with the early settlement and development of the area.		
<b>Context:</b> Gently rolling terrain. Small creek or river to the east; generally open fields surround. Turbines visible to northeast; transmission line visible to south, passing to the northwest.		
<b>Completed by (name):</b> N. Oakley		<b>Heritage Resource/Landscape Number:</b>  <div style="text-align: right;">BHR 9</div>

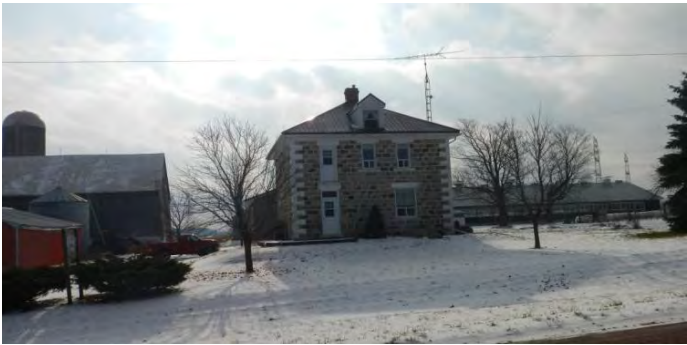
<b>Municipal Address:</b> 402078 County Road 15		
<b>Lot:</b>	<b>Concession:</b>	
<b>Municipality:</b> Grand Valley		
<b>County/RM:</b> Dufferin		
<b>Resource Type:</b> Farm complex		<b>Landmark (Y/N?)</b> No
<b>Associated Dates:</b>		
<b>Description of Resource (physical design):</b> Simonhof Farm complex located on south side of road. Two storey polychromatic fieldstone farmhouse features: painted stone quoins, lintels and voussoirs; central, gabled front attic dormer; central brick chimney; second floor door above offset front door; contemporary windows; and a rear addition. Outbuildings include a mix of gabled barns and silos, including a large gabled bank barn.		
<b>Notable Features:</b> Rare stone farmhouse construction in area, using polychromatic fieldstone.		
<b>Associations:</b> No known associations.		
<b>Context:</b> Open, gently rolling terrain. Small creek to east; transmission line in field to south of property; turbines visible to northeast.

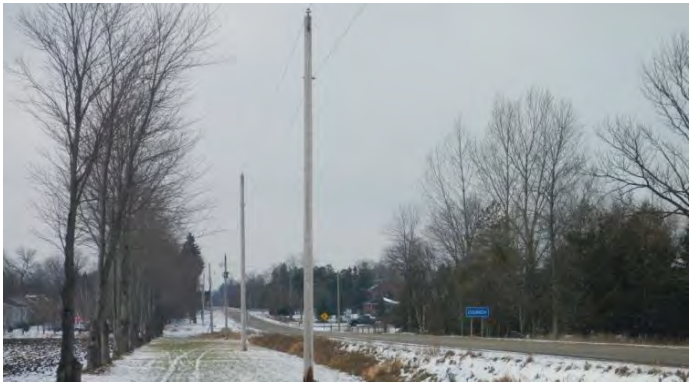
<b>Municipal Address:</b> Colbeck		
<b>Lot:</b>	<b>Concession:</b>	
<b>Municipality:</b> Grand Valley		
<b>County/RM:</b> Dufferin		
<b>Resource Type:</b> Cultural Heritage Landscape		<b>Landmark (Y/N?)</b> No
<b>Associated Dates:</b> 1869 (first post office established in settlement)		
<b>Description of Resource (physical design):</b> Colbeck Cultural Heritage Landscape is located at the intersection of County Road 15 and Sideroad 27/28. The area was one of the first regions in the Township settled in the mid 19th century, and was considered one of the best farming sections in the Township. At its height, the village featured two sawmills, a general store and post office, S.S. no. 5 and the East Luther Cheese and Butter Company. St. Clement's Church, one of the few Anglican churches in the Township, was erected in the southeast corner of the intersection in 1883. The church was deconsecrated in 1953, after which the Colbeck and Monticello Women's Institute bought the building for use as a community centre; its original bell and communion rail were donated to

<b>Notable Features:</b> No notable features		
<b>Associations:</b> Associated with the Colbeck family, among the first settlers in the Township. Further associated with the settlement and development of the local area.		
<b>Context:</b> Gently rolling landscape; located at intersection of County Road 15 and Sideroad 27/28.		
<b>Completed by (name):</b> N. Oakley		<b>Heritage Resource/Landscape Number:</b>  <div style="text-align: right;">CHL 22</div>
<b>Date Completed:</b> Dec. 3, 2012

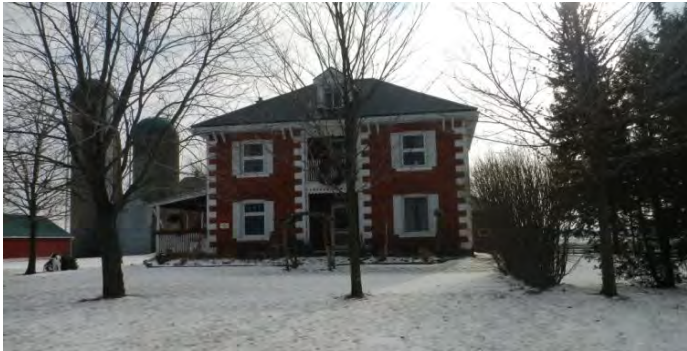
<b>Municipal Address:</b> 402252 County Road 15		
<b>Lot:</b> 29	<b>Concession:</b> 10	
<b>Municipality:</b> Grand Valley		
<b>County/RM:</b> Dufferin		
<b>Resource Type:</b> Farm complex		<b>Landmark (Y/N?)</b> No
<b>Associated Dates:</b> 1873 (establishment); 1900 (construction of brick farmhouse)		
<b>Description of Resource (physical design):</b> Deaksvew Farm complex located on the south side of road. Two storey, U-shaped brick farmhouse constructed 1900 features: central balcony with bargeboard; paired eave brackets; painted brick quoins; a central gabled attic dormer; side porch; and a rear addition. Outbuildings include: a large gambrel bank barn with ventilators; several low profile, steel clad sheds; and concrete silos. Mature deciduous tree line along road to west.		
<b>Notable Features:</b> Painted brick quoins; central balcony with bargeboard; paired eave brackets; bank barn

<b>Associations:</b> Associated with the settlement and development of the local community. Associated with George Deaken and family, who first settled in the Township in 1854, eventually purchasing 200 acres on this property in 1873. Deaken's original log house was situated behind the present day brick farmhouse, and was in existence until at least the 1980s.		
<b>Context:</b> Gently rolling landscape; farm is set on small rise, surrounded by open fields. Turbines visible to the north and south.		
<b>Completed by (name):</b> N. Oakley		<b>Heritage Resource/Landscape Number:</b>  CHL 23
<b>Date Completed:</b> Dec. 3, 2012
