**RE: Grand Valley Wind Farms – Phase 3 Wind Project**  
**Location: Dufferin County**  
**FIT number: FIT-FBK61WV**  
**MTC DPR File no. 22EA019**

#### **9 RECOMMENDATIONS FOR FURTHER WORK**

GRAND VALLEY WIND FARMS – PHASE 3 WIND PROJECT  
HERITAGE ASSESSMENT REPORT

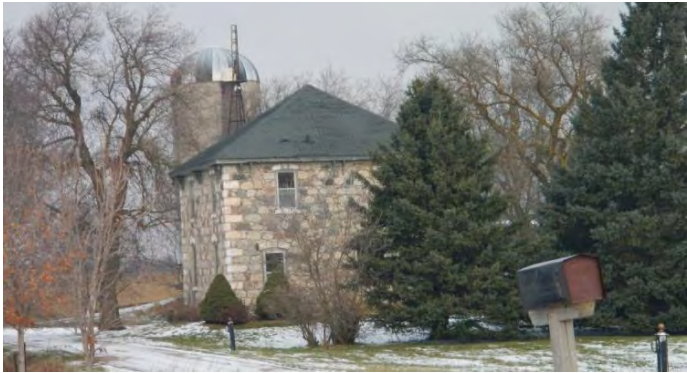
<b>Municipal Address:</b> 402287 County Road 15		
<b>Lot:</b>	<b>Concession:</b>	
<b>Municipality:</b> Grand Valley		
<b>County/RM:</b> Dufferin		
<b>Resource Type:</b> Farm complex		<b>Landmark (Y/N?)</b> No
<b>Associated Dates:</b> No known associated dates.		
<b>Description of Resource (physical design):</b> Farm complex located on north side of road, set on long driveway. Two storey stone farmhouse features: projecting stone voussoirs and lintels; shaped window trim; paired eave brackets; and a hipped roof. Several large conifers and deciduous trees are located around house and throughout property. Outbuildings include: ell-shaped gable barn; several low profile gabled sheds; and a concrete silo.		
<b>Notable Features:</b> Rare stone construction, including stone voussoirs and lintels; shaped window trim; paired eave brackets.		
<b>Associations:</b> No known associations.

<b>Context:</b> Open, gently rolling landscape. Large cedar treebreak along western property line. Turbines visible to north and south.		
<b>Completed by (name):</b> N. Oakley		<b>Heritage Resource/Landscape Number:</b>
<b>Date Completed:</b> Dec. 3, 2012

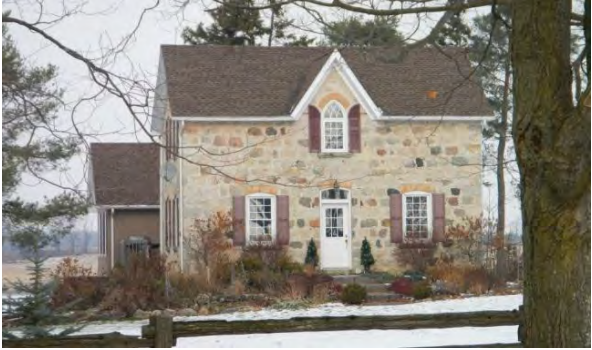
<b>Municipal Address:</b> 402343 County Road 15		
<b>Lot:</b>	<b>Concession:</b>	
<b>Municipality:</b> Grand Valley		
<b>County/RM:</b> Dufferin		
<b>Resource Type:</b> House		<b>Landmark (Y/N?)</b> No
<b>Associated Dates:</b> No known associated dates		
<b>Description of Resource (physical design):</b> 1 1/2 storey polychromatic fieldstone Gothic Revival cottage on north side of road. Design features include: central front door with transom; 3-over-3 hung windows; lancet gable window; shutters, stone lintels and brick voussoirs; and a board and batten rear addition. Several contemporary, low profile, steel clad barns located to east of house. Rail fence and large deciduous trees line road. Conifer treebreak along western property line.		
<b>Notable Features:</b> Rare stone construction; use of polychromatic fieldstone.		
<b>Associations:</b> No known associations.

<b>Context:</b> Open, gently rolling landscape. Turbines visible to north.		
<b>Completed by (name):</b> N. Oakley		<b>Heritage Resource/Landscape Number:</b>  BHR 10
<b>Date Completed:</b> Dec. 3, 2012

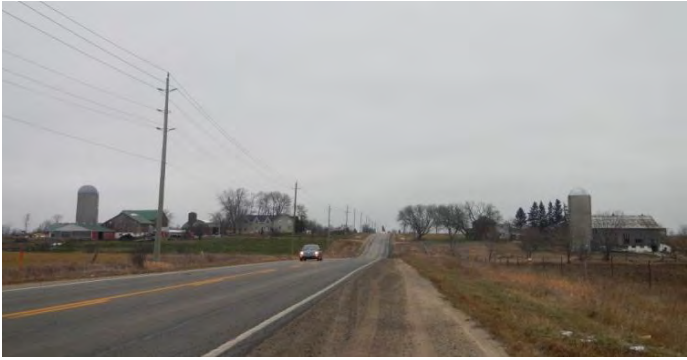
<b>Municipal Address:</b> 173056 County Road 25		
<b>Lot:</b> 30	<b>Concession:</b> 1	
<b>Municipality:</b> Grand Valley		
<b>County/RM:</b> Dufferin		
<b>Resource Type:</b> Farm complex		<b>Landmark (Y/N?)</b> No
<b>Associated Dates:</b> No known associated dates.		
<b>Description of Resource (physical design):</b> Farm complex located on west side of road. 1 1/2 storey Gothic Revival farmhouse features: faux stone cladding; original gable lancet window; wide central front entrance with sidelights and transom; and a large rear 1/2 story extension. Outbuildings include: a large gabled barn; concrete silo; and several modern sheds to rear. Large deciduous trees are located around house.		
<b>Notable Features:</b> No notable features		
<b>Associations:</b> Associated with the settlement and development of the local community.		
<b>Context:</b> Rolling terrain; farm set on rise overlooking Highway 89. Small creek to south. Transmission line visible to west.

<b>Completed by (name):</b> N. Oakley		<b>Heritage Resource/Landscape Number:</b>  CHL 25
<b>Date Completed:</b> Dec. 3, 2012

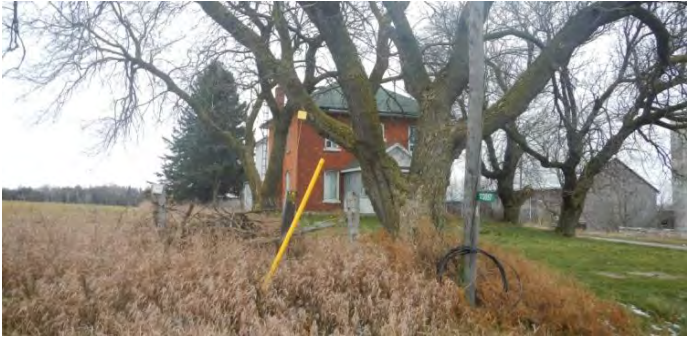
<b>Municipal Address:</b> 173057 County Road 25		
<b>Lot:</b> 31	<b>Concession:</b> 1	
<b>Municipality:</b> Grand Valley		
<b>County/RM:</b> Dufferin		
<b>Resource Type:</b> Farm complex		<b>Landmark (Y/N?)</b> No
<b>Associated Dates:</b> No known associated dates.		
<b>Description of Resource (physical design):</b> Farm complex located on east side of road. Two storey brick vernacular farmhouse features: brick voussoirs and stone lintels; front enclosed porch; and rear addition with two car attached garage. Outbuildings include: a large gabled barn built into side of hill; and a concrete silo. Large deciduous trees line the driveway and southern property line; several mature conifers to rear of property.		
<b>Notable Features:</b> No notable features		
<b>Associations:</b> A century farm associated with Mary MacGillis, who received the original Crown deed in 1836; the land was severed into 100 acre parcels and passed through several property owners before James Burke bought the farm in 1937. Farm operations switched to dairy operations in 1967, at which time the barn was remodeled and the addition to the farmhouse was constructed. Associated with patterns of settlement, development, and changes in agricultural production in the area.

<b>Context:</b> Rolling terrain; farm set on rise overlooking Highway 89. Small creek to south. Transmission line visible to west.		
<b>Completed by (name):</b> N. Oakley		<b>Heritage Resource/Landscape Number:</b>  CHL 26
<b>Date Completed:</b> Dec. 3, 2012

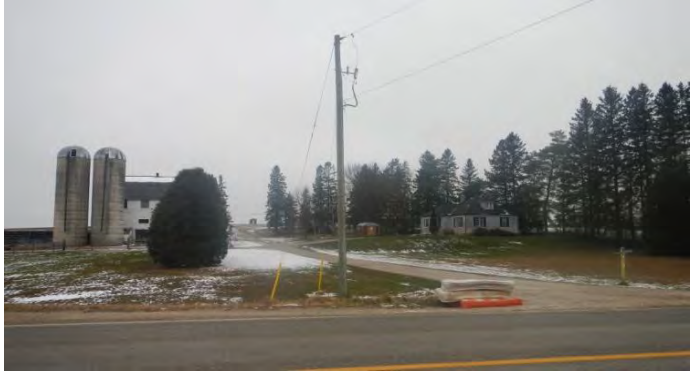
<b>Municipal Address:</b> 174236 County Road 25		
<b>Lot:</b>	<b>Concession:</b>	
<b>Municipality:</b> Grand Valley		
<b>County/RM:</b> Dufferin		
<b>Resource Type:</b> Farm complex		<b>Landmark (Y/N?)</b> No
<b>Associated Dates:</b> built 1862		
<b>Description of Resource (physical design):</b> Farm complex located on west side of road; Bryan Montgomery farms. 1 storey vernacular farmhouse, built 1862 features: hipped gable attic dormer; chimney and rear addition. Outbuildings include: large gabled barn with front addition; two concrete silos; modern, low profile steel barns to rear of property.		
<b>Notable Features:</b> Early example of simple, vernacular farmhouse construction.		
<b>Associations:</b> No known associations.		
<b>Context:</b> Set on side of valley, on bank of Grand River. Mature conifer treebreak to north of farmhouse. Turbines visible to northeast. Open field at top of hill to north, at rear of property; generally open fields to east, across road and Grand River.

<b>Completed by (name):</b> N. Oakley		<b>Heritage Resource/Landscape Number:</b>  CHL 27
<b>Date Completed:</b> Dec. 3, 2012

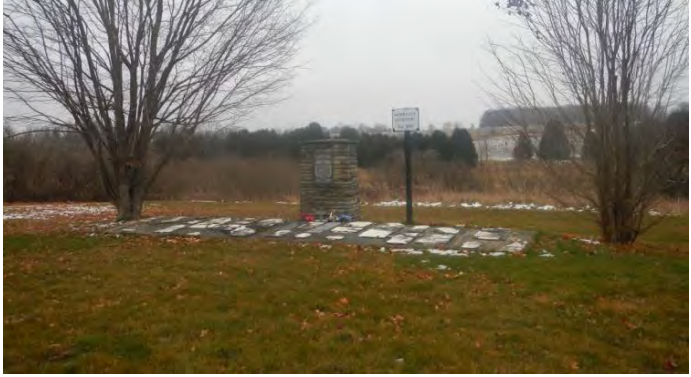
<b>Built Heritage Resource Name:</b> McDougall Cemetery

<b>Municipal Address:</b> County Road 25		
<b>Lot:</b> 31	<b>Concession:</b> 6 N	
<b>Municipality:</b> Grand Valley		
<b>County/RM:</b> Dufferin		
<b>Resource Type:</b> Cemetery		<b>Landmark (Y/N?)</b> Yes
<b>Associated Dates:</b> established 1870; cairn erected 1956		
<b>Description of Resource (physical design):</b> Small cemetery set on east side of road. Site features: a stone cairn, erected 1956, "in memory of those who are at rest"; a paved strip in front of cairn with grave markers laid out in front; deciduous bushes on either side of memorial. Several gravestones are broken; most date back to 1860s and 1870s.		
<b>Notable Features:</b>  Old gravemarkers dating back to 1860s and 1870s.		
<b>Associations:</b> Associated with the early settlement and development of the local community.		
<b>Context:</b> Set on small rise overlooking Grand River to the east; line of bushes and post and wire fence along property lines. Turbines visible to north and northeast.

Potential visual impacts have been identified for views from McDougall Cemetery. It is recommended that the proponent work with the Town of Grand Valley to determine if a visual barrier such as fencing or tree plantings should be installed to protect the cultural heritage values of the cemetery.

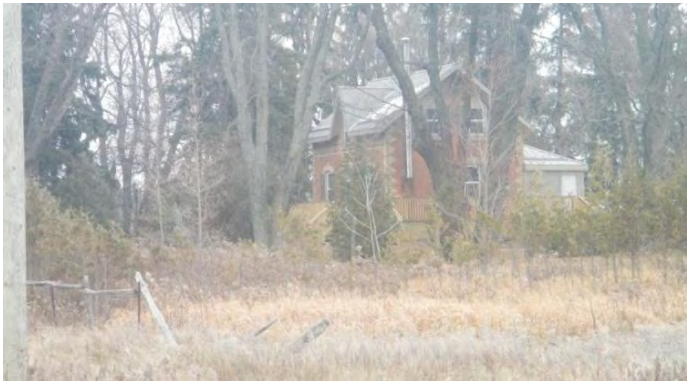
<b>Municipal Address:</b> 174521 County Road 25		
<b>Lot:</b>	<b>Concession:</b>	
<b>Municipality:</b> Grand Valley		
<b>County/RM:</b> Dufferin		
<b>Resource Type:</b> House		<b>Landmark (Y/N?)</b> No
<b>Associated Dates:</b> No known associated dates.		
<b>Description of Resource (physical design):</b> 1 1/2 storey brick Gothic Revival cottage on east side of road, set on narrow setback. House features: dichromatic brickwork, including banding, quoins and voussoirs; open front deck; and rear, vinyl clad addition. House set on heavily forested site with split rail fence along front of property; front visual assessment obscured by trees.		
<b>Notable Features:</b> Rare use of dichromatic brickwork in area.		
<b>Associations:</b> No known associations.		
<b>Context:</b> Gently rolling terrain. Large conifer treebreak along west side of road; turbines visible to southeast, west, and northwest. Smaller transmission line visible to north.

<b>Completed by (name):</b> N. Oakley		<b>Heritage Resource/Landscape Number:</b>  <div style="text-align: right;">BHR 11</div>
<b>Date Completed:</b> Dec. 3, 2012

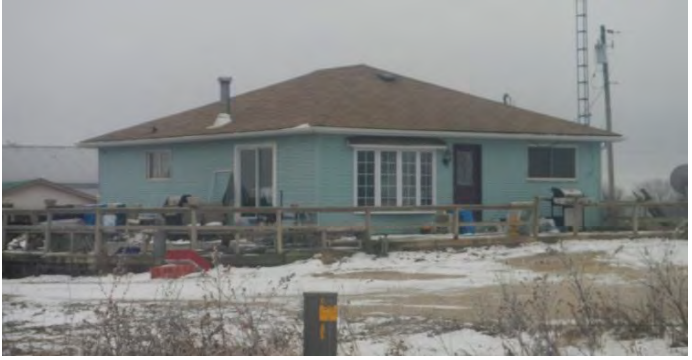
<b>Municipal Address:</b> 441158 Concession 12/13		
<b>Lot:</b> 22	<b>Concession:</b> 12	
<b>Municipality:</b> Grand Valley		
<b>County/RM:</b> Dufferin		
<b>Resource Type:</b> Farm complex		<b>Landmark (Y/N?)</b> No
<b>Associated Dates:</b> 1850s (Harry Hills Sr. and family settled in area at this time)		
<b>Description of Resource (physical design):</b> Farm complex located on south side of road. One storey, hipped roof vernacular cottage features: hipped roof; vinyl siding and windows; and large deck. Outbuildings include a low profile, steel clad barn and shed at rear of property. Several large deciduous trees along road to west and east; a few large conifers on site.		
<b>Notable Features:</b> No notable features		
<b>Associations:</b> Part of historic Hills family settlement: property is location of former farm of William Hills, son of Harry Hills; an early settler in the area. Also associated with Erasmus (Wesley) Post Office, 441118, 441032 and 441023 Concession 12/13 and 035426 Sideroad 21/22; these properties owned by other members of the Hill family.

<b>Context:</b> Gently rolling, open terrain. Transmission line to south.		
<b>Completed by (name):</b> N. Oakley		<b>Heritage Resource/Landscape Number:</b>  <div style="text-align: right;">CHL 29</div>
<b>Date Completed:</b> Dec. 3, 2012

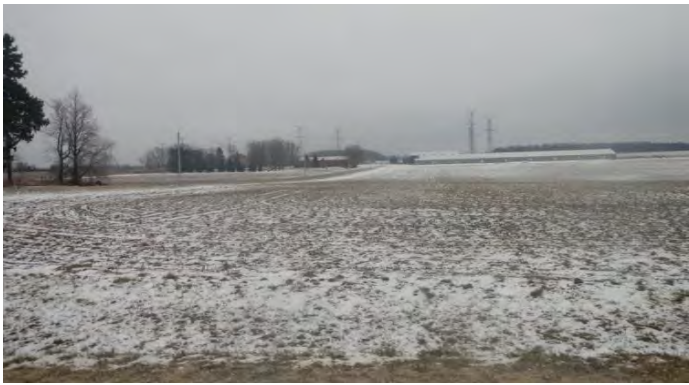
<b>Municipal Address:</b> 441118 Concession 12/13		
<b>Lot:</b> 20 S	<b>Concession:</b> 12	
<b>Municipality:</b> Grand Valley		
<b>County/RM:</b> Dufferin		
<b>Resource Type:</b> Farm complex		<b>Landmark (Y/N?)</b> No
<b>Associated Dates:</b> 1850s (Harry Hills Sr. and family settled in area at this time)		
<b>Description of Resource (physical design):</b> Farm complex located on south side of road, set on long driveway. Property features: 2 storey, hipped roof vernacular farmhouse; several low profile, gabled steel barns; and several large conifers and deciduous trees around farmhouse site.		
<b>Notable Features:</b> No notable features		
<b>Associations:</b> 441118 Concession 12/13 is associated with the Harry Hills and his family, among the early settlers to the area. Also associated with 441158, the former Erasmus (Wesley) post office, 441032 and 441023 Concession 12/13 and 035426 Sideroad 21/22; these properties owned by other members of the Hill family. Property is location of second farm of Harry Hills; original log house and barn replaced with brick farmhouse built by Harry's son Cecil.

<b>Context:</b> Gently rolling terrain; property surrounded by open fields. Transmission line immediately to south. Former Erasmus (Wesley) post office located at road directly north.		
<b>Completed by (name):</b> N. Oakley		<b>Heritage Resource/Landscape Number:</b>  <div style="text-align: right;">CHL 30</div>
<b>Date Completed:</b> Dec. 3, 2012

CHL30	441118 Concession 12/13	3	I	I	N	N	N	N	<ul style="list-style-type: none"> <li>• Avoid construction within a 60 m bufferzone of structures on the property;</li> <li>• in the event that construction within a 60 m bufferzone cannot be avoided, it is recommended that maximum acceptable vibration, or peak particle velocity (PPV), levels be determined by a qualified engineer prior to Project construction and that construction activities be monitored to ensure that maximum PPV levels are not exceeded.</li> </ul>
CHL31	441032 Concession 12/13	3	N	N	N	N	R	N	No further mitigation recommended.
CHL32	441023 Concession 12/13	3	N	N	N	N	R	N	No further mitigation recommended.
CHL33	Luther Marsh	5 and 7	N	N	N	N	N	N	No further mitigation recommended.
CHL34	322345 Concession 6/7	7	N	N	N	N	R	N	No further mitigation recommended.
CHL35	362169 Concession 8/9	6	I	I	N	N	N	N	<ul style="list-style-type: none"> <li>• Avoid construction within a 60 m bufferzone of structures on the property;</li> <li>• in the event that construction within a 60 m bufferzone cannot be avoided, it is recommended that maximum acceptable vibration, or peak particle velocity (PPV), levels be determined by a qualified engineer prior to Project construction and that construction activities be monitored to ensure that maximum PPV levels are not exceeded.</li> </ul>

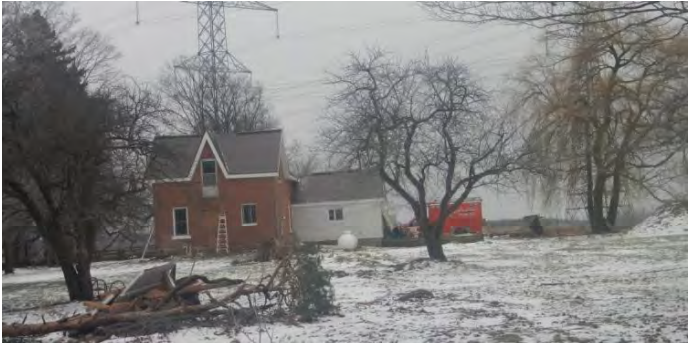
<b>Municipal Address:</b> 441032 Concession 12/13		
<b>Lot:</b> 19	<b>Concession:</b> 12	
<b>Municipality:</b> Grand Valley		
<b>County/RM:</b> Dufferin		
<b>Resource Type:</b> House		<b>Landmark (Y/N?)</b> No
<b>Associated Dates:</b> 1850s (Harry Hills Sr. and family settled in area at this time)		
<b>Description of Resource (physical design):</b> 1 1/2 storey, t-shaped brick Gothic Revival cottage on south side of road. House design features include: door in front gable; vinyl clad, gabled side addition; and vinyl windows. Front section of house has been extensively altered; bricking banding and quoins still evident in rear section.		
<b>Notable Features:</b> No notable features		
<b>Associations:</b> 441032 Concession 12/13 is associated with the Harry Hills and his family, among the early settlers to the area. Also associated with 441158, the former Erasmus (Wesley) post office, 441118 and 441023 Concession 12/13 and 035426 Sideroad 21/22; these properties owned by other members of the Hill family. Property is formerly owned by Truman Hills, son of Harry Hills.

<b>Context:</b> Gently rolling landscape, with open fields to north, south and east. Luther Swamp and bushy, swampy area located to southwest. Transmission line crosses property from southeast to northwest. Site also features a gabled wood shed, large deciduous trees along the road and throughout property.		
<b>Completed by (name):</b> N. Oakley		<b>Heritage Resource/Landscape Number:</b>  CHL 31
<b>Date Completed:</b> Dec. 3, 2012

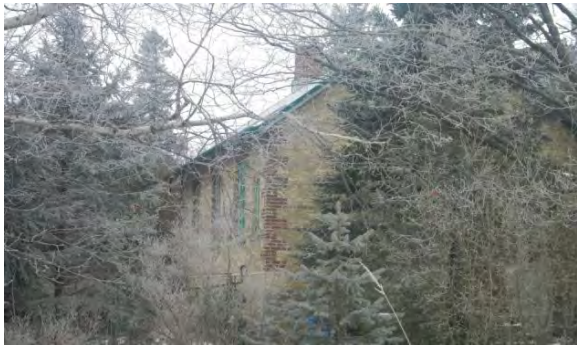
<b>Municipal Address:</b> 035464 Sideroad 21/22		
<b>Lot:</b> 21	<b>Concession:</b> 13	
<b>Municipality:</b> Grand Valley		
<b>County/RM:</b> Dufferin		
<b>Resource Type:</b> Schoolhouse		<b>Landmark (Y/N?)</b> Yes
<b>Associated Dates:</b> 1899 (opened)		
<b>Description of Resource (physical design):</b> Former Welsey School S.S. no. 9 schoolhouse located on west side of road, converted into residence. Gabled brick structure features: dichromatic brickwork including quoins and round front symbol; plaque stating "Wesley SS no 5"; enclosed front portico; and hung windows. Site is heavily forested.		
<b>Notable Features:</b> Dichromatic brickwork; hung windows		
<b>Associations:</b> Associated with the settlement and development of the local community. On land The school opened in 1900, and featured papered interior walls and a blackboard made of painted wood. Porches were built in 1903 and 1915. The building was painted in 1906. Other improvements include: chemical toilets in 1941; hydro in 1950 and a telephone in 1963. A school reunion was held, possibly at the time of its closing, in 1965.

<b>Context:</b> Open, gently rolling terrain.		
<b>Completed by (name):</b> N. Oakley		<b>Heritage Resource/Landscape Number:</b>  BHR 13
<b>Date Completed:</b> Dec. 3, 2012

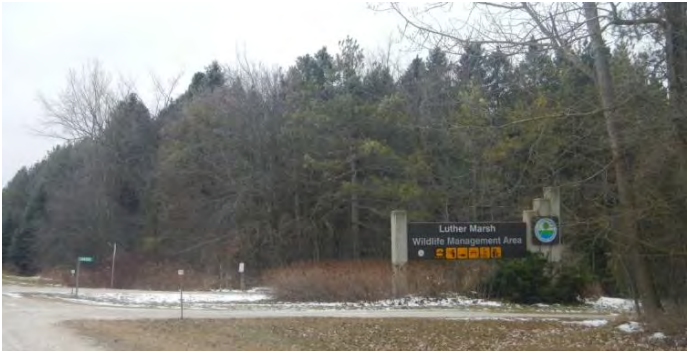
<b>Built Heritage Resource Name:</b> Luther Marsh

<b>Municipal Address:</b> 034588 Sideroad 21/22		
<b>Lot:</b>		<b>Concession:</b>
<b>Municipality:</b> Grand Valley		
<b>County/RM:</b> Dufferin		
<b>Resource Type:</b> Conservation Area	<b>Landmark (Y/N?)</b> Yes	
<b>Associated Dates:</b> 1952		
<b>Description of Resource (physical design):</b> Luther Marsh is a Wildlife Management Area, over 10,000 acres in size, located west of Sideroad 21/22. The Wildlife Management Area is managed by the Grand River Conservation Authority and features: Luther Lake and Dam; associated marshland; reforested areas; and basic recreational facilities including an observation deck.		
<b>Notable Features:</b> Dam across Black Creek		
<b>Associations:</b> Symbolic of the marginal lands associated with East Luther Township. Associated with the damming of Black Creek in 1952, which enlarged Luther Swamp into Luther Lake. This damming created a reservoir to help regulate water flow associated with the Grand River. Several farms were expropriated at the time of the damming. The Marsh has been recognized as an Area of Natural Scientific Interest (ANSI) by the provincial government, and provides recreational and hunting opportunities to local residents and visitors. c

<b>Context:</b> Low-lying, generally flat terrain, featuring open water, marshes, and reforested areas.		
<b>Completed by (name):</b> N. Oakley	<b>Heritage Resource/Landscape Number:</b>  <div style="text-align: right;">CHL 33</div>	
<b>Date Completed:</b> Dec. 3, 2012

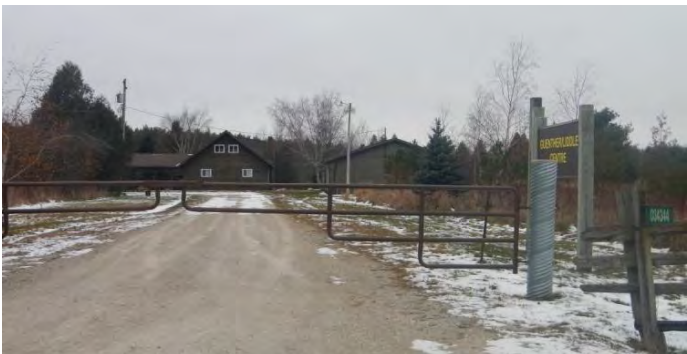
<b>Built Heritage Resource Name:</b> Guenther/Liddle Centre

<b>Municipal Address:</b> 034344 Sideroad 21/22		
<b>Lot:</b>	<b>Concession:</b>	
<b>Municipality:</b> Grand Valley		
<b>County/RM:</b> Dufferin		
<b>Resource Type:</b> Institution		<b>Landmark (Y/N?)</b> No
<b>Associated Dates:</b> 1965; 2012		
<b>Description of Resource (physical design):</b> Complex of buildings located on west side of road. Buildings consist of simple, gable-roofed utilitarian structures, painted brown and 1-2 storeys in height. Formerly the Luther Marsh Centre, the Centre was renamed in the Spring of 2012 to commemorate Robert Guenther and Carl Liddle, two Conservation Officers who drowned in Luther Marsh in 1965. Originally established conservation outpost, the complex has become a training centre for the Ontario Ministry of Natural Resources (MNR), the Grand River Conservation Authority, and the Canadian Wildlife Service. It is also used as an outdoor education centre for the local public.

<b>Notable Features:</b> No notable features		
<b>Associations:</b> Associated with Robert Guenther and Carl Liddle, two Conservation Officers who drowned in Luther Marsh in 1965. Associated with the conservation and appreciation of Luther Swamp and its natural resources.		
<b>Context:</b> Located adjacent to the Luther Marsh Wildlife Management Area. Generally flat terrain. Open fields to east; wooded area to south, north and west.		
<b>Completed by (name):</b> N. Oakley		<b>Heritage Resource/Landscape Number:</b>  BHR 14
<b>Date Completed:</b> Dec. 3, 2012

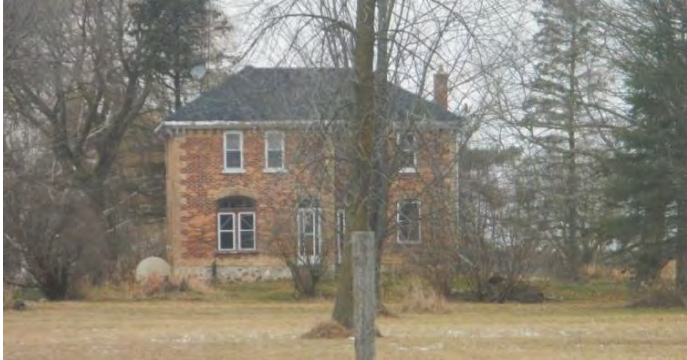
<b>Municipal Address:</b> Concession 6/7		
<b>Lot:</b>	<b>Concession:</b>	
<b>Municipality:</b> Grand Valley		
<b>County/RM:</b> Dufferin		
<b>Resource Type:</b> House		<b>Landmark (Y/N?)</b> No
<b>Associated Dates:</b> No known associated dates		
<b>Description of Resource (physical design):</b> House located on north side of road, set on long driveway. Two storey polychromatic brick farmhouse features: exposed stone foundation; dichromatic brickwork including quoins, voussoirs and gable banding; and eave brackets. A large gable barn and shed are located at the rear of property. Large deciduous trees line driveway and western property line. Several large conifers and deciduous trees located around house and rear of property. No address given.		
<b>Notable Features:</b> Polychromatic brickwork; dichromatic brick detailing including quoins, voussoirs and gable banding; exposed stone foundation; and eave brackets.

<b>Associations:</b> No known associations.		
<b>Context:</b> Open, gently rolling terrain. Transmission line immediately to west; turbines visible to east and northeast.		
<b>Completed by (name):</b> N. Oakley		<b>Heritage Resource/Landscape Number:</b>  <div style="text-align: right;">BHR 15</div>
<b>Date Completed:</b> Dec. 3, 2012

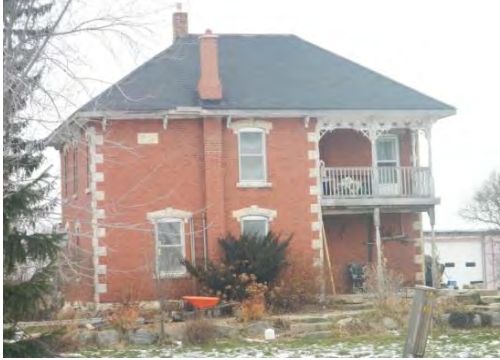
<b>Municipal Address:</b> 322191 Concession 6/7		
<b>Lot:</b>		<b>Concession:</b>
<b>Municipality:</b> Grand Valley		
<b>County/RM:</b> Dufferin		
<b>Resource Type:</b> Farm complex	<b>Landmark (Y/N?)</b> No	
<b>Associated Dates:</b> No known associated dates.		
<b>Description of Resource (physical design):</b> Farm complex on north side of road, at intersection with Sideroad 27/28. Two storey brick farmhouse features: two storey corner balcony with bargeboard; ornate stone voussoirs and lintels; and dual bracketed eaves. Outbuildings include: a large gable barn to rear of property; and steel gabled shed. Mature conifer treebreak along roads to west and south.		
<b>Notable Features:</b> Two storey corner balcony with bargeboard; rare use of ornate stone voussoirs and lintels; dual bracketed eaves.		
<b>Associations:</b> No known associations.		
<b>Context:</b> Open, gently rolling terrain. Transmission line to west; turbines visible to northeast and east.

<b>Completed by (name):</b> N. Oakley	<b>Heritage Resource/Landscape Number:</b>	
<b>Date Completed:</b> Dec. 3, 2012	BHR 16

BHR/ CHL #	Address/Name	Figure #	Potential Negative Impact						Recommended Mitigation
			Destruction	Alteration	Shadows	Isolation	Obstruction of Views	Change in Land Use	
BHR16	322191 Concession 6/7	7	I	I	N	N	N	N	<ul style="list-style-type: none"> <li>• Avoid construction within a 60 m bufferzone of structures on the property;</li> <li>• in the event that construction within a 60 m bufferzone cannot be avoided, it is recommended that maximum acceptable vibration, or peak particle velocity (PPV), levels be determined by a qualified engineer prior to Project construction and that construction activities be monitored to ensure that maximum PPV levels are not exceeded.</li> </ul>
BHR17	362027 Concession 8/9	5	I	I	N	N	N	N	<ul style="list-style-type: none"> <li>• Avoid construction within a 60 m bufferzone of structures on the property;</li> <li>• in the event that construction within a 60 m bufferzone cannot be avoided, it is recommended that maximum acceptable vibration, or peak particle velocity (PPV), levels be determined by a qualified engineer prior to Project construction and that construction activities be monitored to ensure that maximum PPV levels are not exceeded.</li> </ul>

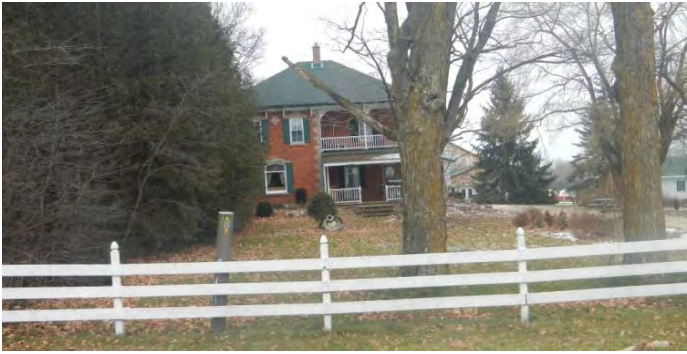
<b>Municipal Address:</b> 322345 Concession 6/7		
<b>Lot:</b>	<b>Concession:</b>	
<b>Municipality:</b> Grand Valley		
<b>County/RM:</b> Dufferin		
<b>Resource Type:</b> Farm complex		<b>Landmark (Y/N?)</b> No
<b>Associated Dates:</b> 1887 (established)		
<b>Description of Resource (physical design):</b> Farm complex on north side of road. Two storey brick farmhouse features: two storey corner balcony and bargeboarding; stone voussoirs, quoins and diamond labelstone, "1887" on front elevation. Additional buildings on site include: a one storey contemporary bungalow; gable barn; and a small, one storey stone hut with surrounding stone wall to east of farmhouse. Large deciduous trees along road to east and west of property. A white fence is located along the road.		
<b>Notable Features:</b> two storey corner balcony and bargeboarding; stone voussoirs, quoins and diamond labelstone. Stone hut may be one of only remaining lime kilns in area.

<b>Associations:</b> Associated with early settlement and development in the community. Possibly associated with historic lime production in area.		
<b>Context:</b> Set on side of valley sloping down to Grand River to east. Turbines to north; open fields to south and west; heavily treed area/valley across field to north and northeast. Site is dominated by large, mature conifers and deciduous trees; visibility of site is low due to two rows of trees along road. Large conifer tree break along western property line.		
<b>Completed by (name):</b> N. Oakley		<b>Heritage Resource/Landscape Number:</b>
<b>Date Completed:</b> Dec. 3, 2012

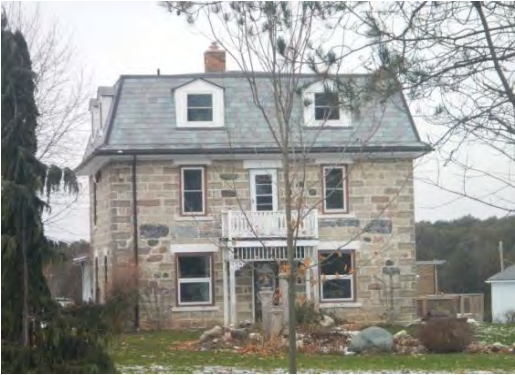
<b>Built Heritage Resource Name:</b>

<b>Municipal Address:</b> 362169 Concession 8/9		
<b>Lot:</b> 27	<b>Concession:</b> 9	
<b>Municipality:</b> Grand Valley		
<b>County/RM:</b> Dufferin		
<b>Resource Type:</b> House		<b>Landmark (Y/N?)</b> No
<b>Associated Dates:</b> No known associated dates		
<b>Description of Resource (physical design):</b> House located on north side of road. Two storey polychromatic fieldstone farmhouse features: shingled mansard roof; dual gabled attic dormers on each elevation; central balcony with bargeboard; and a central chimney. Site also features a garage with matching stonework; concrete property markers at road to the east and west of the house; and two two large deciduous trees to the southeast of the house, along the road.		
<b>Notable Features:</b> Rare use of polychromatic fieldstone construction and mansard roof in area; two large deciduous trees along road to southeast of house

<b>Associations:</b> No known associations.		
<b>Context:</b> Rolling terrain; property set on side of valley sloping down east to Grand River/Hall Bridge on Sideroad 27/28. Transmission lines visible to east and west. Reforested stand to south; open fields to north and west. Large conifer treebreaks along east and west property lines.		
<b>Completed by (name):</b> N. Oakley		<b>Heritage Resource/Landscape Number:</b>  CHL 35
<b>Date Completed:</b> Dec. 3, 2012

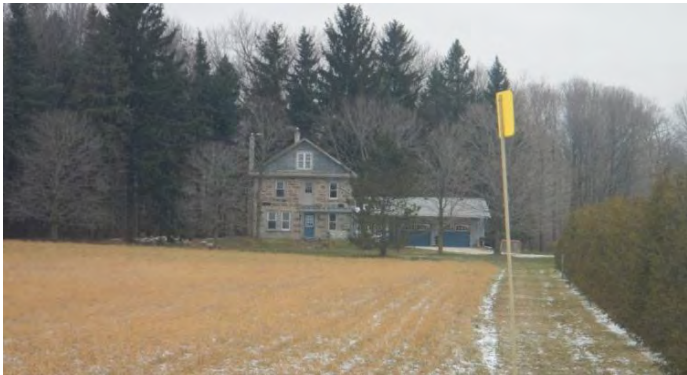
<b>Built Heritage Resource Name:</b>

<b>Municipal Address:</b> 362027 Concession 8/9		
<b>Lot:</b>	<b>Concession:</b>	
<b>Municipality:</b> Grand Valley		
<b>County/RM:</b> Dufferin		
<b>Resource Type:</b> Farm complex		<b>Landmark (Y/N?)</b> No
<b>Associated Dates:</b> No known associated dates		
<b>Description of Resource (physical design):</b> Farm complex on north side of road, set on long driveway. Two storey polychromatic fieldstone farmhouse features: gable roof with returned eave, and shingled gable; hung windows; central second floor door; and attached 2 car garage to rear. Outbuildings include two large steel, gabled barns with low profiles.		
<b>Notable Features:</b> Rare use of polychromatic fieldstone construction in area.		
<b>Associations:</b> No known associations		
<b>Context:</b> Gently rolling terrain. Cedar hedge treebreak along west side of driveway, to east of house. Stand of large mature conifers immediately north of house.

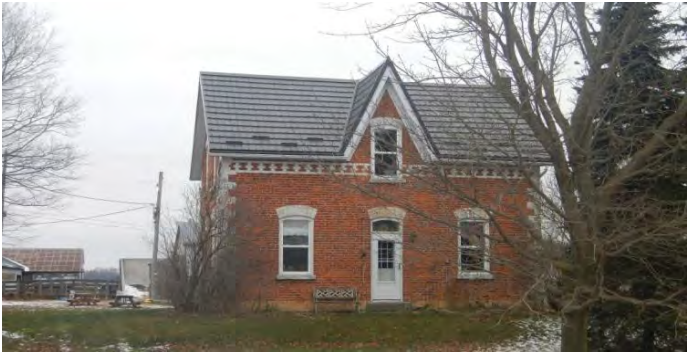
<b>Built Heritage Resource Name:</b>

<b>Municipal Address:</b> 361285 Concession 8/9		
<b>Lot:</b> 23	<b>Concession:</b> 9	
<b>Municipality:</b> Grand Valley		
<b>County/RM:</b> Dufferin		
<b>Resource Type:</b> Farm complex		<b>Landmark (Y/N?)</b> No
<b>Associated Dates:</b> No known associated dates		
<b>Description of Resource (physical design):</b> Farm complex located on north side of road. 1 1/2 storey, T-shaped brick Gothic Revival farmhouse features: painted brick quoins, voussoirs and banding at eaves; and attic ventilators. Outbuildings include: a large gable wood barn and several contemporary barns and sheds to rear of property.		
<b>Notable Features:</b> Painted brickwork including quoins, voussoirs and banding at eaves.		
<b>Associations:</b> No known associations		
<b>Context:</b> Open, gently rolling terrain. Large tree stand to north, across field. Transmission line and turbines visible to east.

CHL36	361285 Concession 8/9	5	N	N	N	N	N	N	No further mitigation recommended.
CHL37	Grand Valley	8 and 10	N	N	N	N	N	N	No further mitigation recommended.

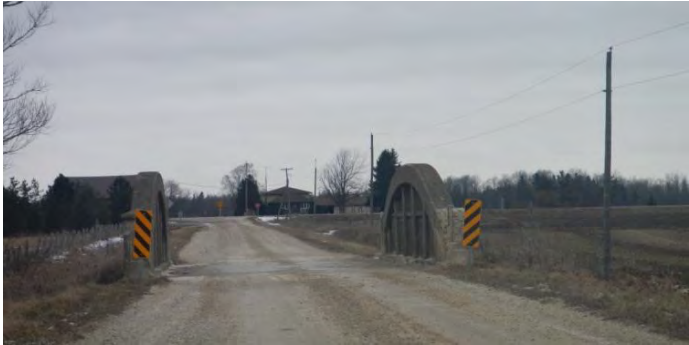
<b>Built Heritage Resource Name:</b>

<b>Municipal Address:</b> Sideroad 27/28		
<b>Lot:</b>	<b>Concession:</b>	
<b>Municipality:</b> Grand Valley		
<b>County/RM:</b> Dufferin		
<b>Resource Type:</b> Bridge		<b>Landmark (Y/N?)</b> No
<b>Associated Dates:</b> No known associated dates		
<b>Description of Resource (physical design):</b> Reinforced concrete arch bridge across small creek or drainage ditch, just south of Highway 89. Concrete arch held up by three pillars with concrete gates located between. Some relief detailing on pillars and end columns. One former end column remains.		
<b>Notable Features:</b> Rare, arched construction of small concrete bridges in area.		
<b>Associations:</b> Associated with local agricultural development and the creation of a network of drainage ditches to increase total arable land available.		
<b>Context:</b> Open, gently rolling, almost flat landscape. Turbines to east.

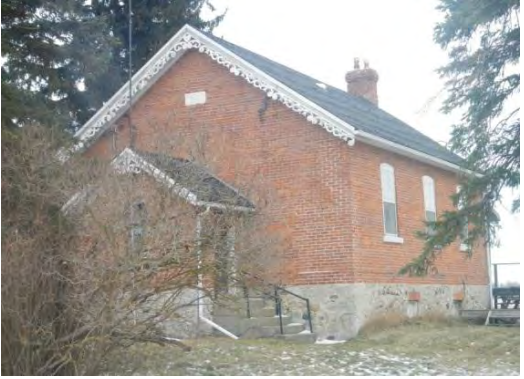
<b>Built Heritage Resource Name:</b> Keldon School S.S. no. 10

<b>Municipal Address:</b> 115435 Sideroad 27/28		
<b>Lot:</b>	<b>Concession:</b>	
<b>Municipality:</b> Grand Valley		
<b>County/RM:</b> Dufferin		
<b>Resource Type:</b> Schoolhouse		<b>Landmark (Y/N?)</b> Yes
<b>Associated Dates:</b> 1899 (establishment); 1965 (closure)		
<b>Description of Resource (physical design):</b> Former Keldon schoolhouse no. 10, now converted into residence on east side of road. Design features include: front portico; labestone "S.S. no. 10 1899"; brick chimney to rear; brick voussoirs and stone lintels; and a fieldstone foundation.		
<b>Notable Features:</b> Fieldstone foundation and brick construction; labelstone		
<b>Associations:</b> Associated with the settlement and development of the local community. The school has been relocated from its original setting on Lot 27, Concession 13. The school was closed in 1965.

<b>Context:</b> Located north of Colbeck.		
<b>Completed by (name):</b> N. Oakley		<b>Heritage Resource/Landscape Number:</b>  BHR 19
<b>Date Completed:</b> Dec. 3, 2012

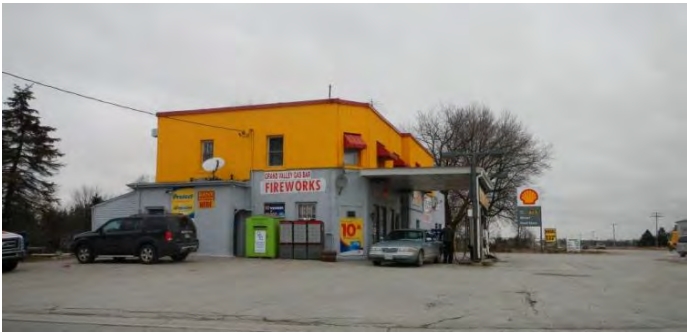
<b>Built Heritage Resource Name:</b> Osborne Service Station

<b>Municipal Address:</b> 202373 County Road 10		
<b>Lot:</b> 31	<b>Concession:</b> 1	
<b>Municipality:</b> Grand Valley		
<b>County/RM:</b> Dufferin		
<b>Resource Type:</b> Gas Station		<b>Landmark (Y/N?)</b> Yes
<b>Associated Dates:</b> circa 1937 (building constructed); 1951 (gas station opened)		
<b>Description of Resource (physical design):</b> Two storey gas station located on the northeast corner of the intersection of County Road 25 and County Road 109. Original structure built by William Stuckey circa 1939; Osborne Foreman opened his gas station at the location in 1951. Building design features include: yellow metal cladding on second storey; red window treatments; and covered gas pump.		
<b>Notable Features:</b> location at busy intersection; continuing use as gas station.		
<b>Associations:</b> Associated with Alex Talbot, original land owner; William Stuckey, who constructed the original building on site; and Osborne 'Ozzie' Foreman.

<b>Context:</b> Open, gently rolling terrain. Ridge to north of property.		
<b>Completed by (name):</b> N. Oakley		<b>Heritage Resource/Landscape Number:</b>  BHR 20
<b>Date Completed:</b> Dec. 3, 2012

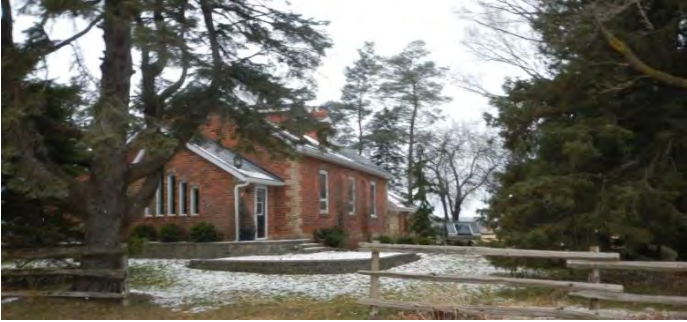
<b>Built Heritage Resource Name:</b>

<b>Municipal Address:</b> 214314 10th Line		
<b>Lot:</b>	<b>Concession:</b>	
<b>Municipality:</b> Amaranth		
<b>County/RM:</b> Dufferin		
<b>Resource Type:</b> Schoolhouse or church		<b>Landmark (Y/N?)</b> Yes
<b>Associated Dates:</b> No known associated dates		
<b>Description of Resource (physical design):</b> Former church or schoolhouse, converted into residence on west side of road. Design features include: dichromatic brickwork including quoins and voussoirs; and several additions including gabled attic dormers and a two car garage. Several mature conifers and a rail fence line road to south and east. Treebreak of mature conifers along northern property line		
<b>Notable Features:</b> Dichromatic brickwork.		
<b>Associations:</b> Associated with the settlement and development of the local community.		
<b>Context:</b> Generally open, flat terrain. Property set at intersection of 10th line and 15th Sideroad. Swampy bush to east. Turbines visible to north; large transmission poles along east side of road, connecting to collector station to south of property.

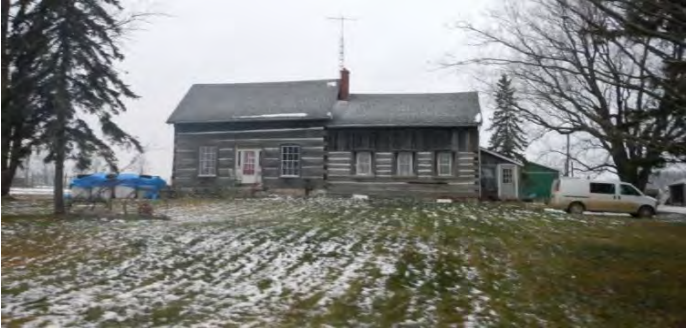
<b>Built Heritage Resource Name:</b>

<b>Municipal Address:</b> 214460 10th Line		
<b>Lot:</b>	<b>Concession:</b>	
<b>Municipality:</b> Amaranth		
<b>County/RM:</b> Dufferin		
<b>Resource Type:</b> Farm complex		<b>Landmark (Y/N?)</b> No
<b>Associated Dates:</b> No known associated dates.		
<b>Description of Resource (physical design):</b> Farm complex located on west side of road. One storey log cabin features: gable roof; gabled roof log side addition; 3-over-2 hung windows; brick chimney. Outbuildings include low profile steel barns to rear of property; herd of caribou or elk in paddock to south of property.		
<b>Notable Features:</b> Rare log construction in area.		
<b>Associations:</b> No known associations.		
<b>Context:</b> Generally flat terrain. Swampy bush to east; mix of open fields and trees to west. Large transmission poles along east side of road, connecting to collector station to south.

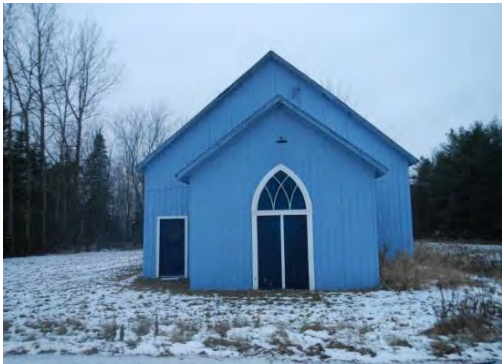
<b>Built Heritage Resource Name:</b>

<b>Municipal Address:</b> Campania		
<b>Lot:</b>		<b>Concession:</b>
<b>Municipality:</b> Amaranth		
<b>County/RM:</b> Dufferin		
<b>Resource Type:</b> Church	<b>Landmark (Y/N?)</b> Yes	
<b>Associated Dates:</b> No known associated dates.		
<b>Description of Resource (physical design):</b> Gabled church located at southwest corner of intersection of 10th Line and 20th Sideroad. Design features include: purple cladding; front gabled portico; lancet windows with 2-over-2 hung windows. As late as 1997, the church has been used for the storage of machinery by the Amaranth Township Roads Department.		
<b>Notable Features:</b> location at intersection; purple cladding; lancet windows with 2-over-2 hung windows.		
<b>Associations:</b> Associated with the settlement and development of the local community. Campania was first established as a post office settlement in 1894: the post office operated until 1912. The settlement also included an Orange Lodge, school and Methodist Church; only the church remains today.

<b>Context:</b> Generally flat area. Church is set in stand of mature conifers, with a conifer tree stand to the north. A long deciduous treebreak is located immediately south of the church; open fields to the east and northeast.		
<b>Completed by (name):</b> N. Oakley	<b>Heritage Resource/Landscape Number:</b>	
<b>Date Completed:</b> Dec. 3, 2012

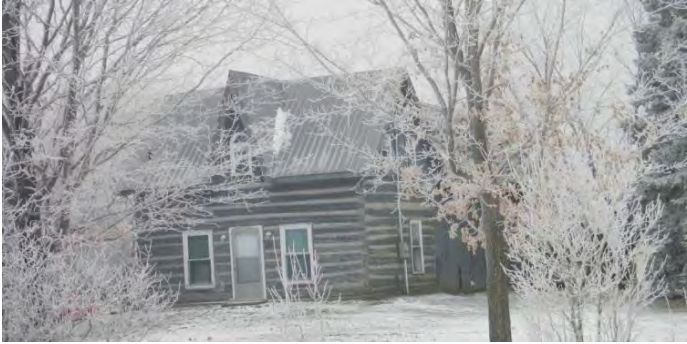
<b>Built Heritage Resource Name:</b>

<b>Municipal Address:</b> 214596 10th Line		
<b>Lot:</b>	<b>Concession:</b>	
<b>Municipality:</b> Amaranth		
<b>County/RM:</b> Dufferin		
<b>Resource Type:</b> House		<b>Landmark (Y/N?)</b> No
<b>Associated Dates:</b> No known associated dates		
<b>Description of Resource (physical design):</b> 1 1/2 storey Gothic Revival log cottage located on west side of road. Design features include: board and batten cladding at gables; 1 1/2 storey board and batten rear addition with gabled attic dormers and porch; vinyl lancet gable window; and hung windows. A small gabled shed is located south of the house. Full visual assessment obscured by mix of conifers and deciduous trees around house.		
<b>Notable Features:</b> Rare Gothic Revival log construction in area.		
<b>Associations:</b> No known associations.		
<b>Context:</b> Generally flat area. Swampy bush located to the south and southwest. Open field to east; mature conifer treestand to north.

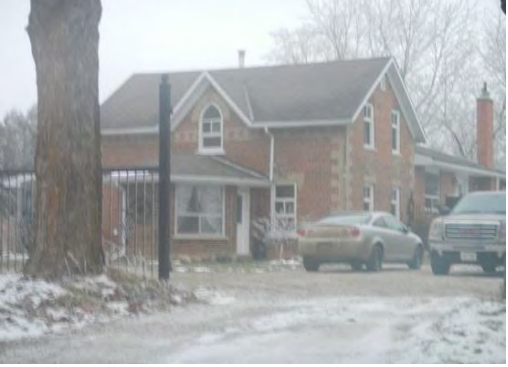
<b>Built Heritage Resource Name:</b>

<b>Municipal Address:</b> 254135 9th Line		
<b>Lot:</b>	<b>Concession:</b>	
<b>Municipality:</b> Amaranth		
<b>County/RM:</b> Dufferin		
<b>Resource Type:</b> House		<b>Landmark (Y/N?)</b> No
<b>Associated Dates:</b> No known associated dates.		
<b>Description of Resource (physical design):</b> 1 1/2 storey brick Gothic Revival cottage. Design features include: dichromatic brickwork including quoins, voussoirs, and banding at eaves; front portico one storey contemporary rear addition. Large, wrought iron gate along road; large deciduous trees line roadway.		
<b>Notable Features:</b> dichromatic brickwork, including quoins, voussoirs and banding at eaves; large deciduous trees lining road		
<b>Associations:</b> No known associations.		
<b>Context:</b> Open, gently rolling terrain.		
<b>Completed by (name):</b> N. Oakley		<b>Heritage Resource/Landscape Number:</b>  BHR 26

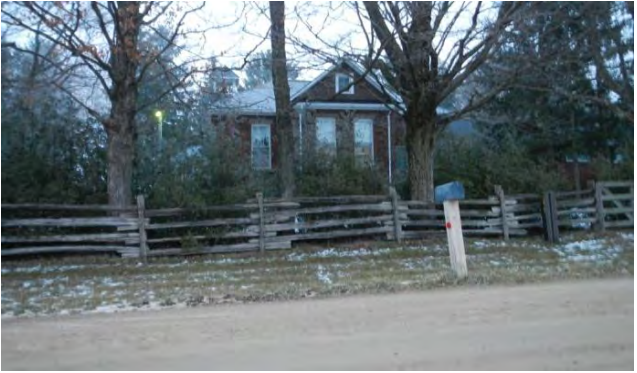
<b>Built Heritage Resource Name:</b> Former Schoolhouse

<b>Municipal Address:</b> 9th Line		
<b>Lot:</b>	<b>Concession:</b>	
<b>Municipality:</b> Amaranth		
<b>County/RM:</b> Dufferin		
<b>Resource Type:</b> Schoolhouse		<b>Landmark (Y/N?)</b> Yes
<b>Associated Dates:</b>		
<b>Description of Resource (physical design):</b> Former schoolhouse located on southeast corner of 9th line and 5th Sideroad. Design features include: polychromatic brick construction; bell tower; shingling at gables; vinyl 3-over-2 hung windows; stone window headers and lintels. Full visual assessment obscured by large deciduous and conifer trees and rail fence along road.		
<b>Notable Features:</b> location at intersection; rare use of polychromatic brick in area; bell tower; stone window headers and lintels; large deciduous trees lining road		
<b>Associations:</b> Associated with the settlement and development of the local community.

<b>Context:</b> Rolling, open landscape. Treed river valley to north of property.		
<b>Completed by (name):</b> N. Oakley		<b>Heritage Resource/Landscape Number:</b>
<b>Date Completed:</b> Dec. 3, 2012		
		BHR 28

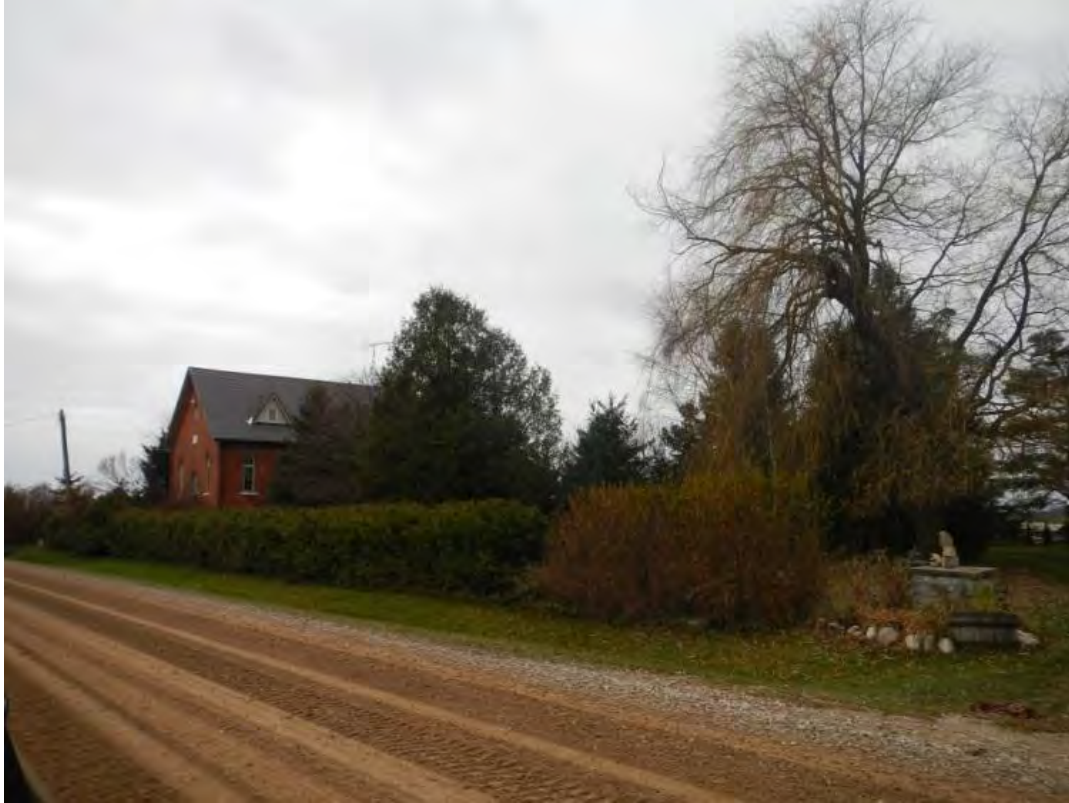
**Photo 65: 114408 Sideroad 27/28 from north (Map 5)**

The most common potential negative impact is with respect to vibration caused by construction activities related to the construction of access roads and the underground collector line. It is recommended that construction activities be avoided within 60 m of identified cultural heritage resources. Where construction within 60 m cannot be avoided, it is recommended that maximum acceptable vibration levels, or peak particle velocity (PPV) levels, should be determined by a qualified engineer prior to any construction activities. Construction within the 60 m bufferzone should be monitored to ensure that acceptable PPV levels are not exceeded. All construction activities should cease if levels are exceeded until an acceptable solution can be identified.

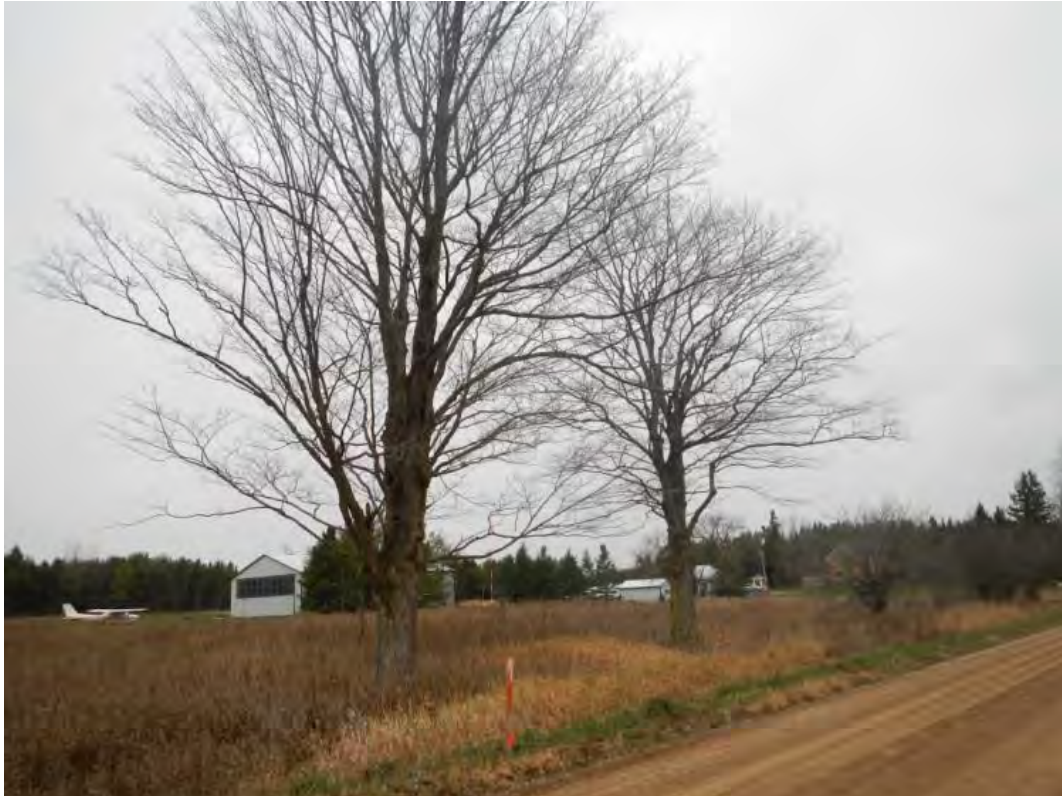
**Photo 66: 114520 Sideroad 27/28 (Map 5, inset 2)**
