**RE: Grand Valley Wind Farms – Phase 3 Wind Project**  
**Location: Dufferin County**  
**FIT number: FIT-FBK61WV**  
**MTC DPR File no. 22EA019**

#### **9 RECOMMENDATIONS FOR FURTHER WORK**

GRAND VALLEY WIND FARMS – PHASE 3 WIND PROJECT  
HERITAGE ASSESSMENT REPORT

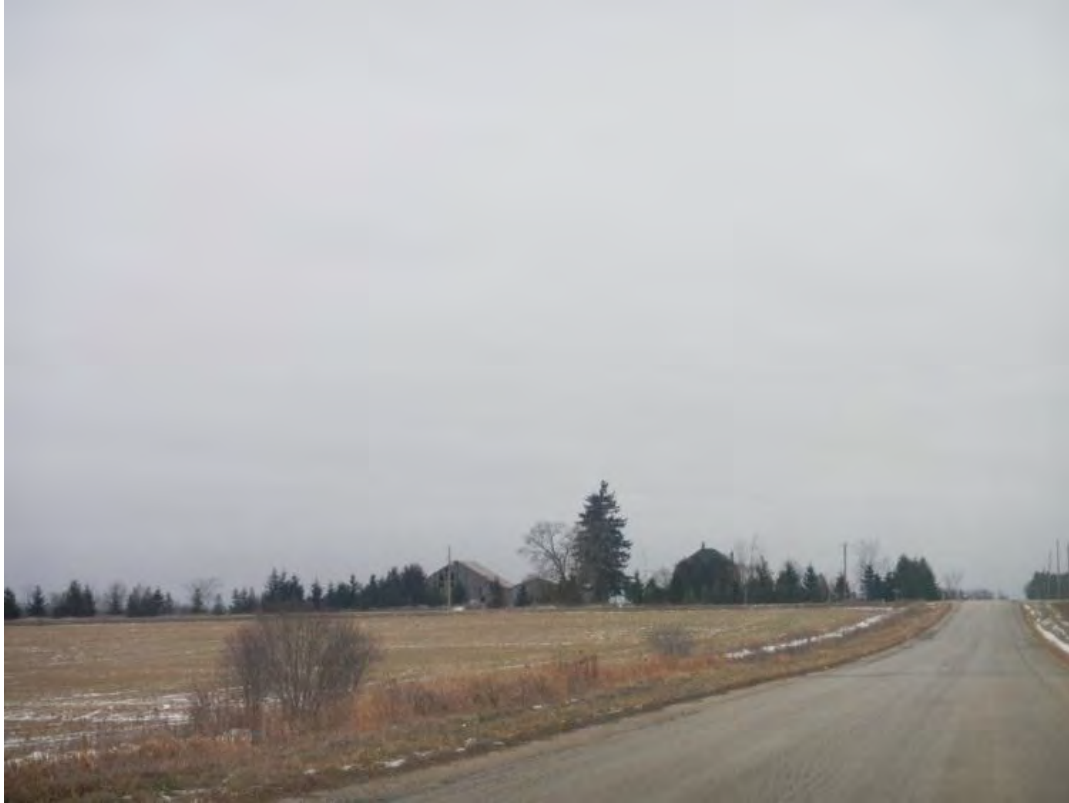
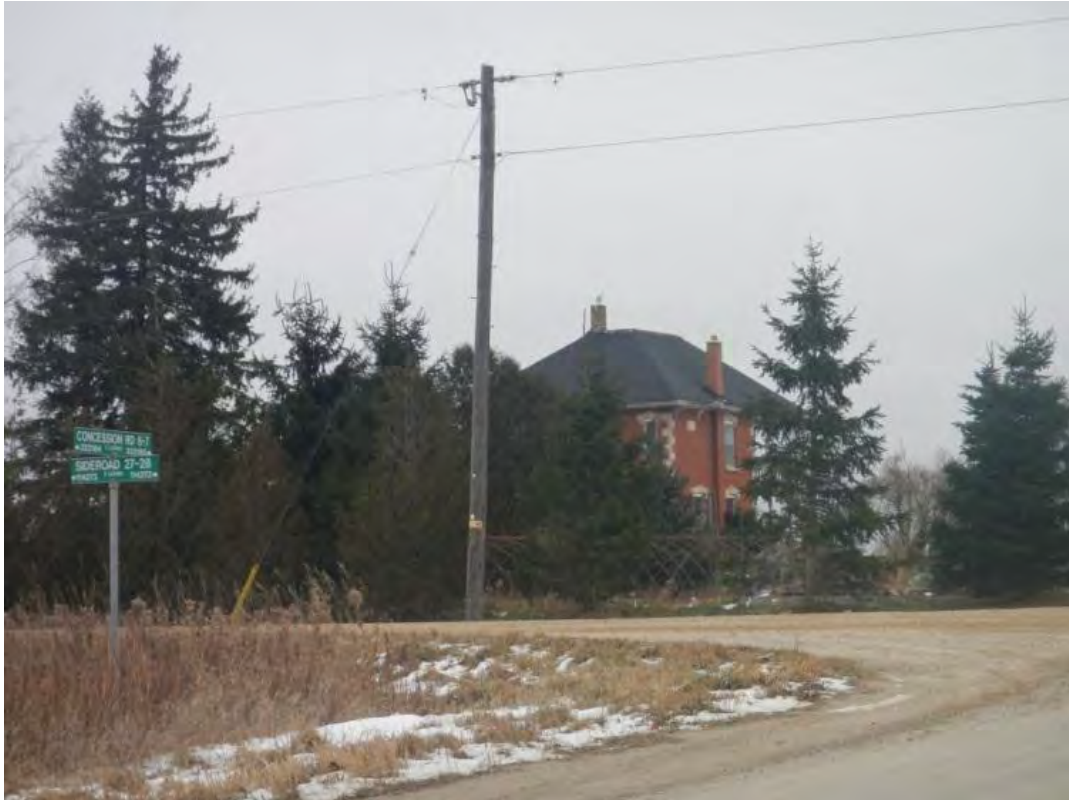
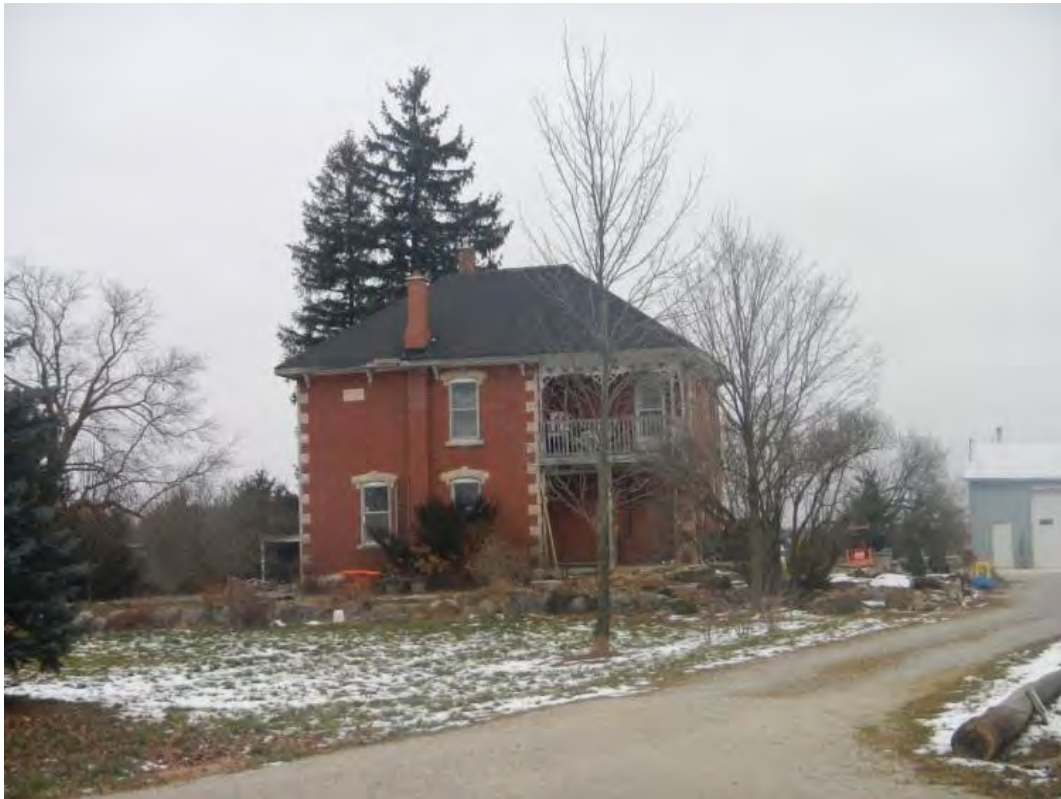
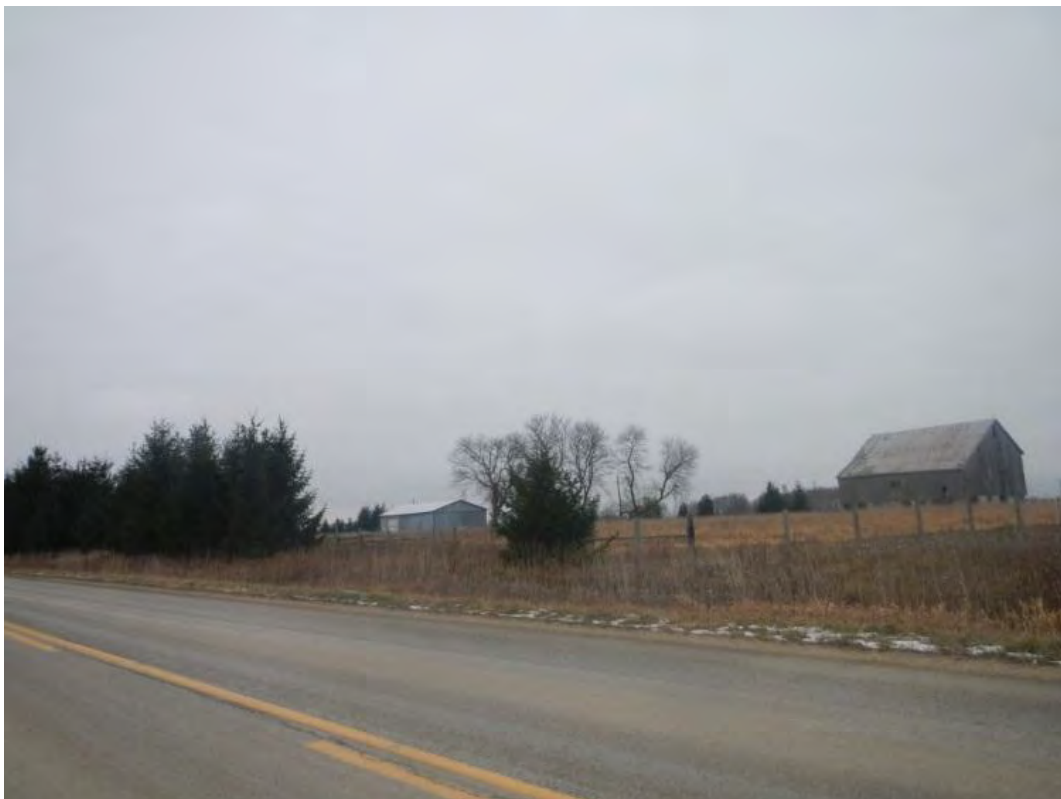
**Photo 239: 322191 Concession 6/7 (Map 6)**

**Photo 240: 322191 Concession 6/7 (Map 6)**

**Photo 241: 322191 Concession 6/7 (Map 6)**

**Photo 242: 322191 Concession 6/7 (Map 6)**

The most common potential negative impact is with respect to vibration caused by construction activities related to the construction of access roads and the underground collector line. It is recommended that construction activities be avoided within 60 m of identified cultural heritage resources. Where construction within 60 m cannot be avoided, it is recommended that maximum acceptable vibration levels, or peak particle velocity (PPV) levels, should be determined by a qualified engineer prior to any construction activities. Construction within the 60 m bufferzone should be monitored to ensure that acceptable PPV levels are not exceeded. All construction activities should cease if levels are exceeded until an acceptable solution can be identified.

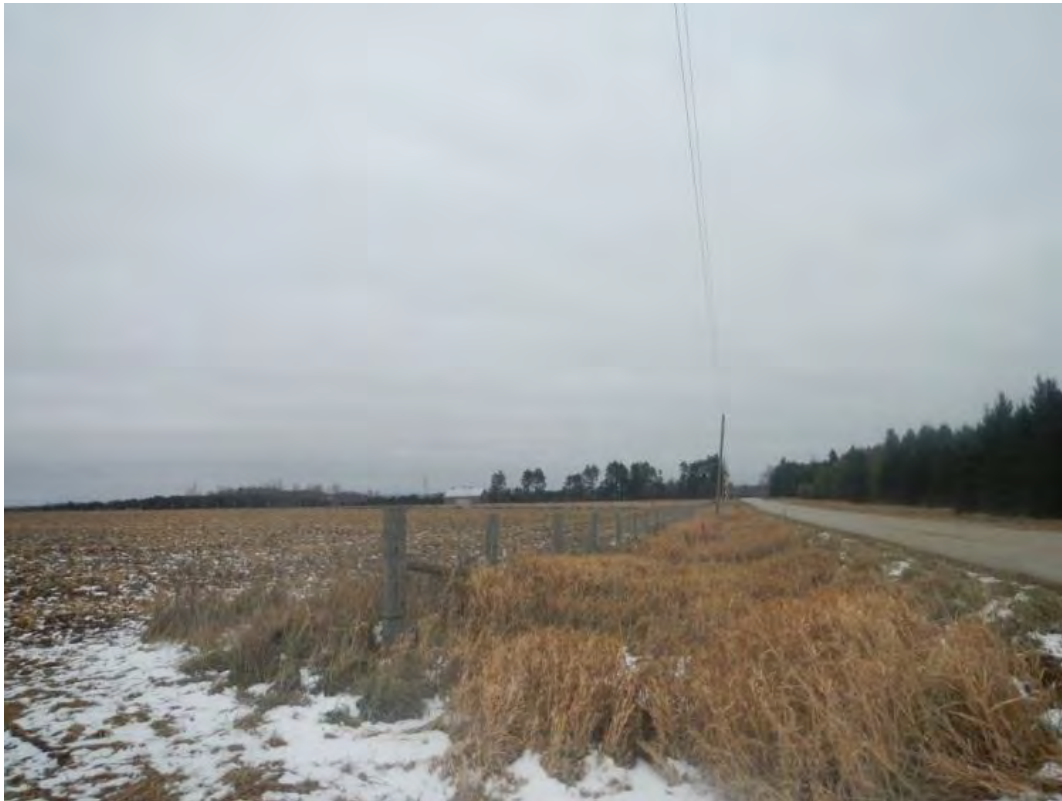
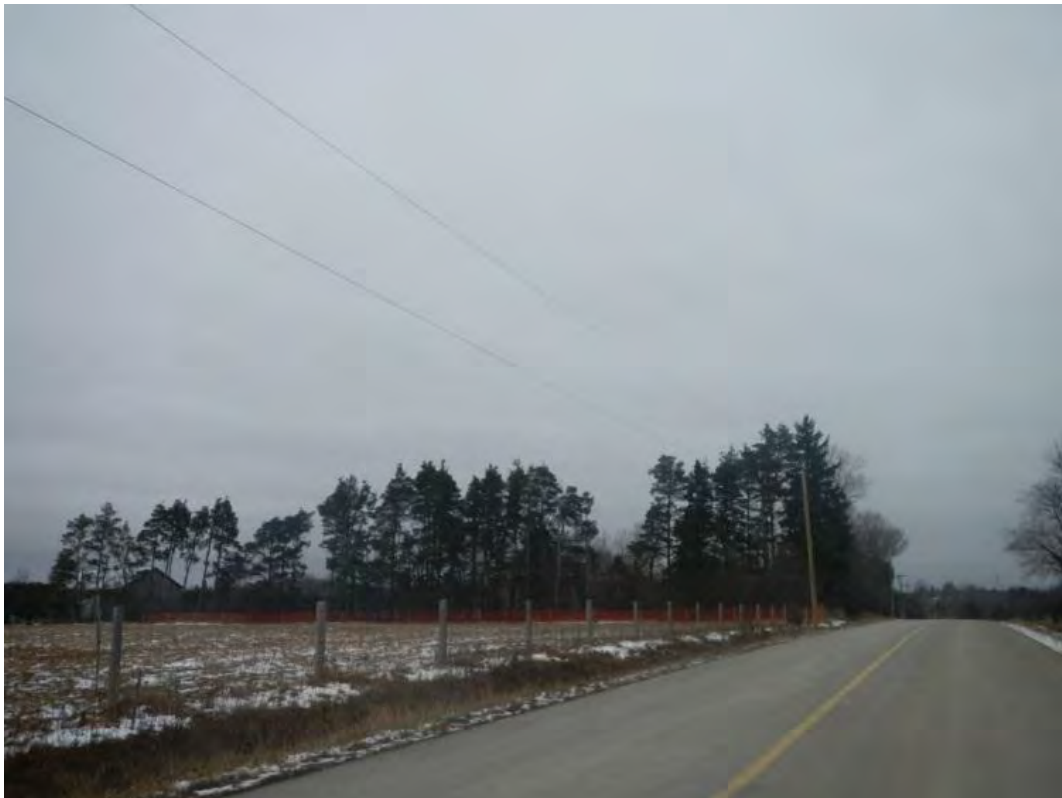
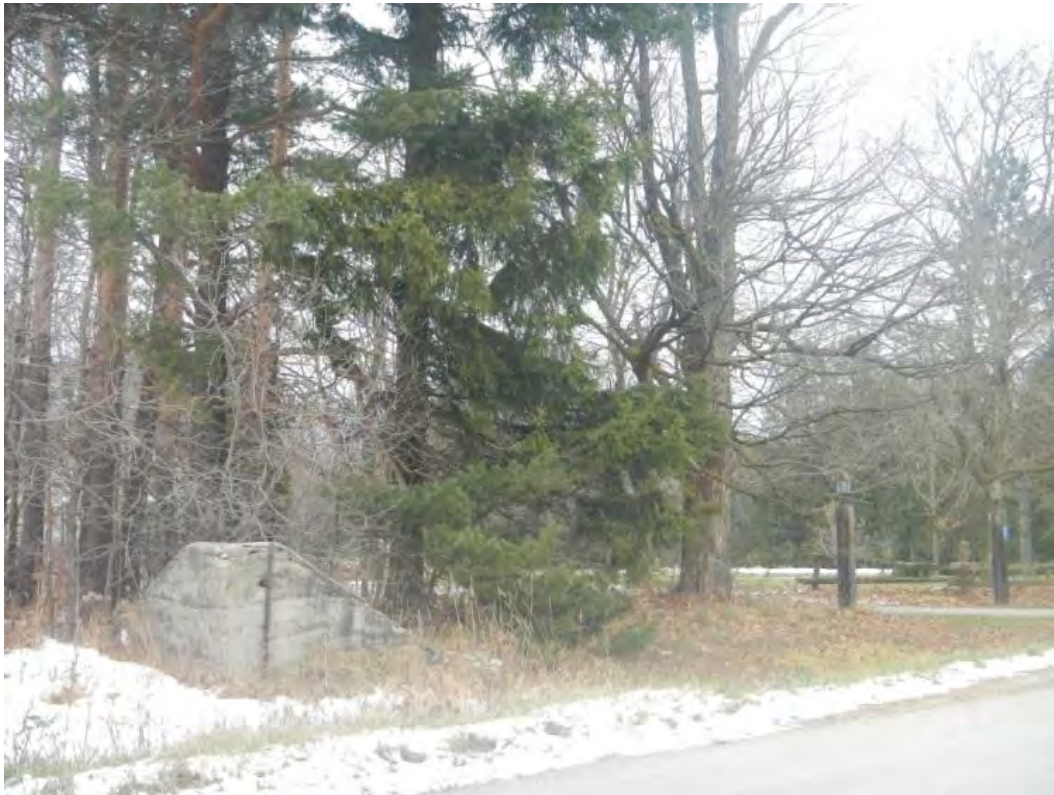
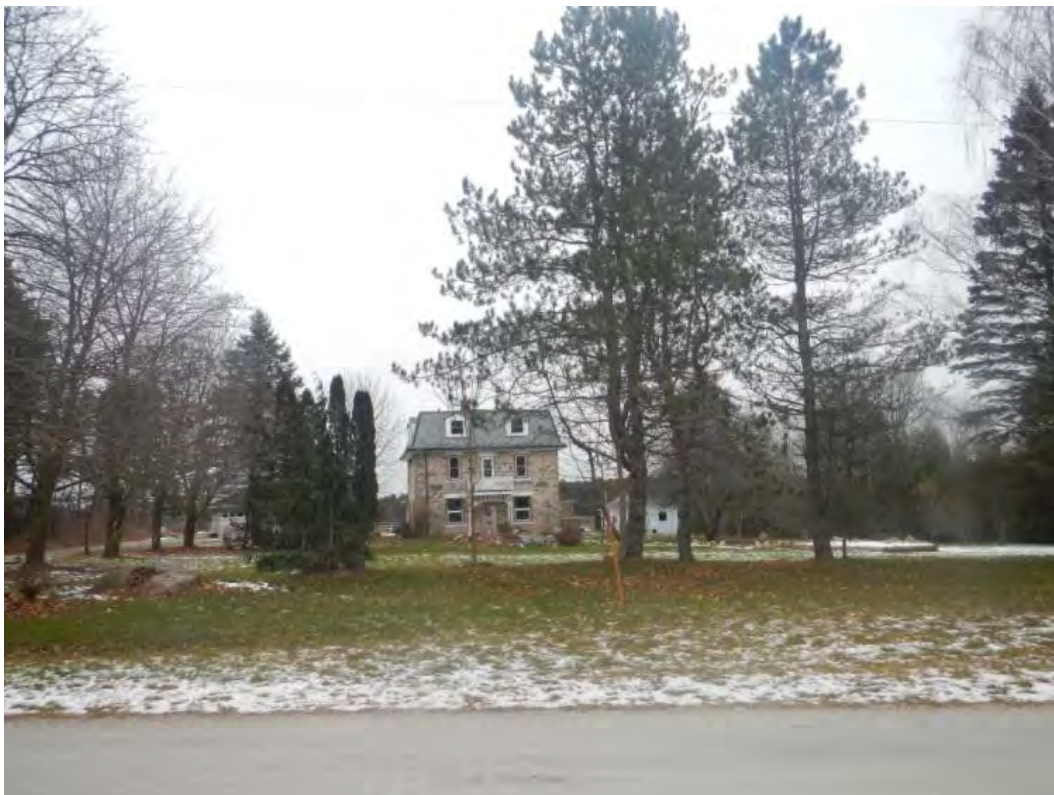
**Photo 249: 362169 Concession 8/9, facing east (Map 4)**

**Photo 250: 362169 Concession 8/9 (Map 5, inset 2)**

**Photo 251: 362169 Concession 8/9 (Map 5, inset 2)**

**Photo 252: 362169 Concession 8/9 (Map 5, inset 2)**
